A WATERSHED ANALYSIS OF LONG POND NORTH

Implications for Water Quality and
Land-Use Management

BI 493
Problems in Environmental Science
Colby College
Waterville, ME 04901
2007

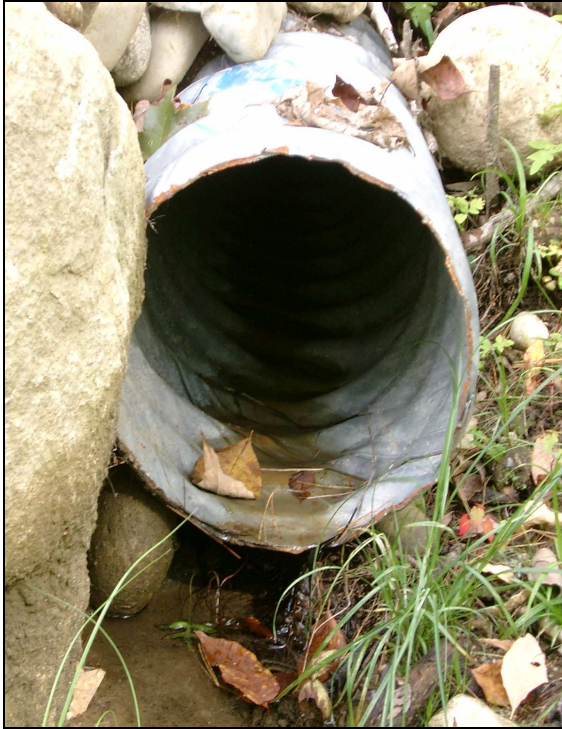
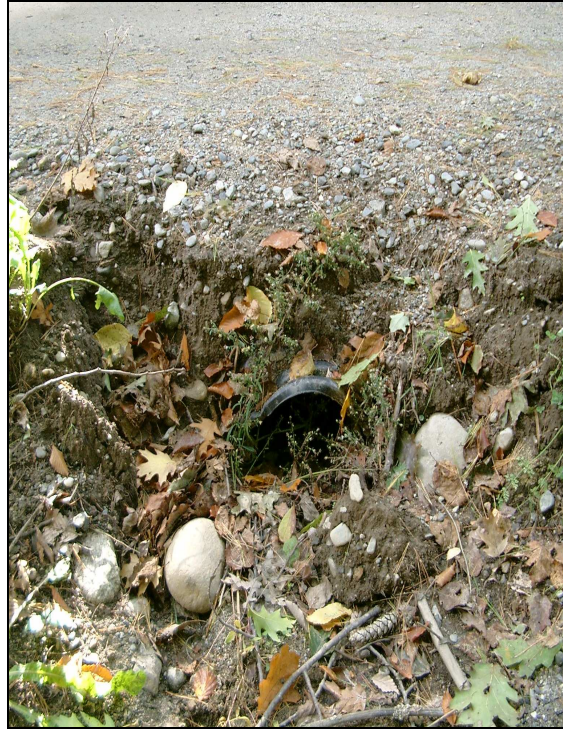
Figures 11 and 12. The picture on the left is a representation of a good culvert with proper drainage and depository pool taken during the road problem survey on 19-Sep-06. The picture on the right is a representation of a poorly maintained culvert as it is filled with debris, has no room for runoff, and no collection pool observed during the road problem survey on 19-Sep-06.

Culverts are also an important component of a healthy road in instances when water runs perpendicular to the road. Culverts are a healthy way for water to pass under the road and most often are plastic, metal or concrete tubes (Figure 11). These cannot perform properly when they are degraded, filled with sediment, or exposed at the road surface (Figure 12). Diversions are critical particularly to roads with steep slopes. Water bars, french drains, or open culverts (see Background) provide an outlet for water to exit the road surface preventing deep channels from forming on the road (Figure 13).

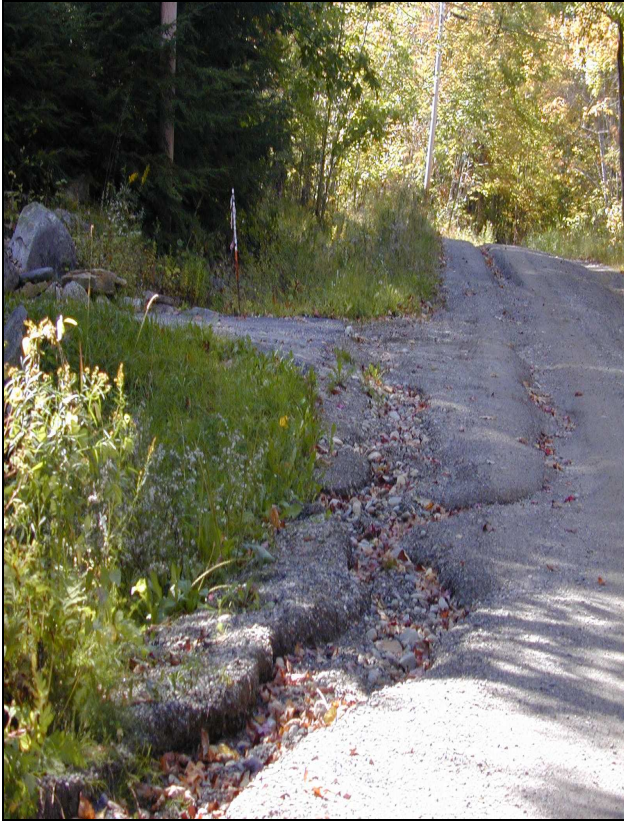
Figure 13. A diversion of some type and a ditch to carry water away from the road are needed to stop the erosion that has already occurred in the image taken during the road problem survey on 19-Sep-06.

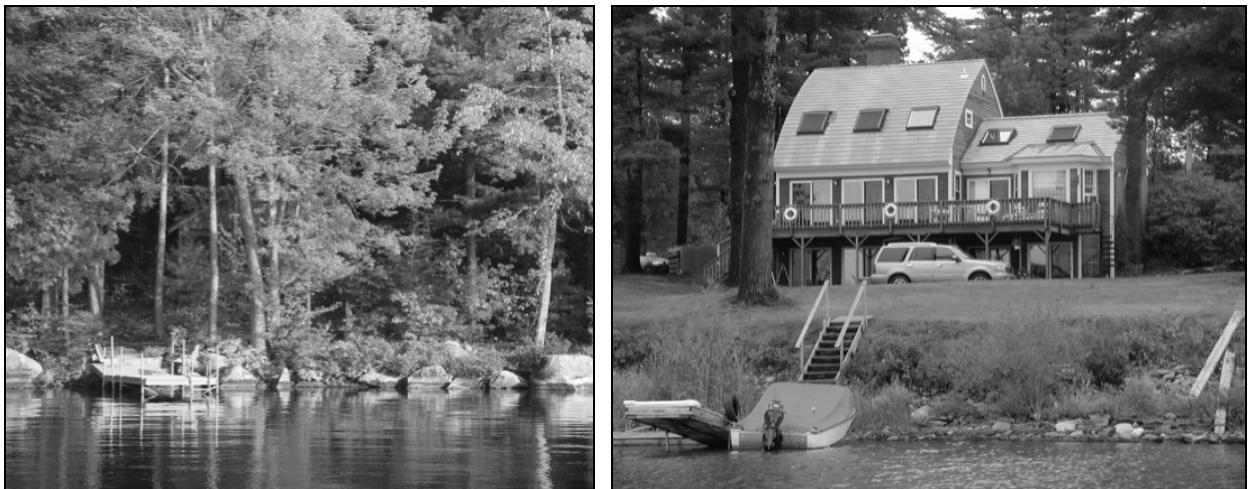
Figure 17. Buffer examples. Photo on left shows a good, adequate buffer. The house is set back from the water, vegetation includes shrub and canopy species, shoreline is protected with riprap. Photo on right shows a poor buffer, with open canopy, mowed grass, a straight path to the water, and little protective vegetation.
