## A Watershed Analysis of Pattee Pond: Implications for Water Quality and Land Use Management

Problems in Environmental Science course (Biology 493), Colby College

# A WATERSHED ANALYSIS OF PATTEE POND

IMPLICATIONS FOR WATER QUALITY  
AND LAND USE MANAGEMENT

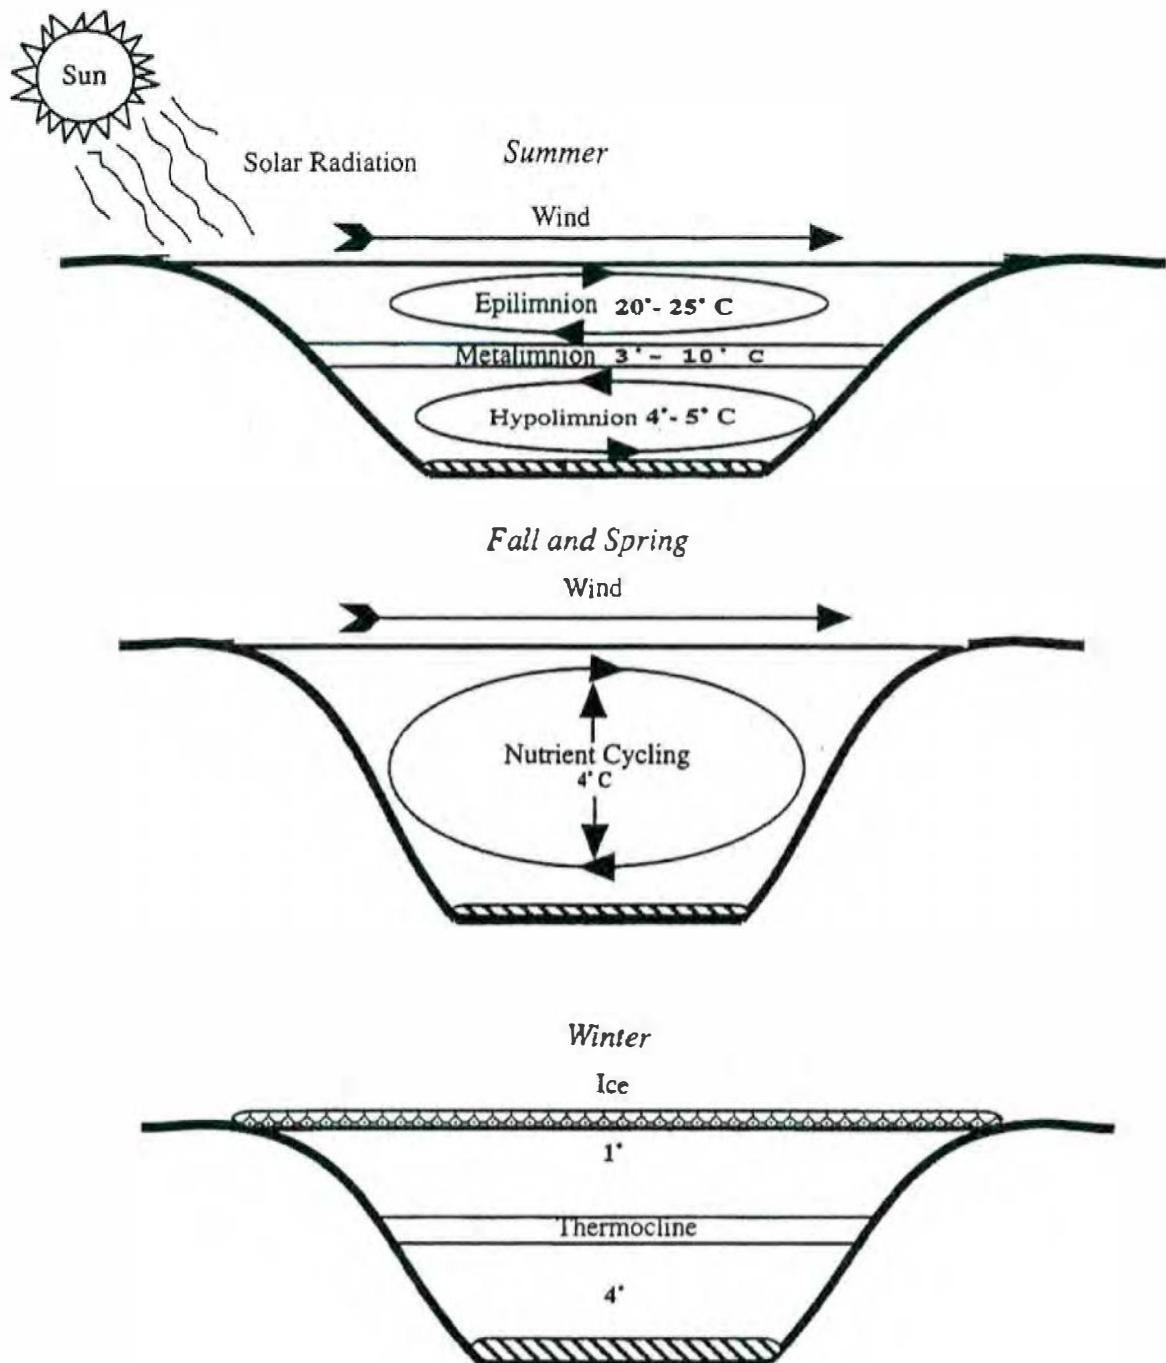
**Figure 1. Mixing by means of lake turnover in dimictic lakes. During the summer, lakes are stratified into three layers (epilimnion, metalimnion, and hypolimnion). During the fall and spring, the isothermal temperature and density facilitate the lake turnover and redistribution of nutrients. In the winter, the lake is again stratified with the slightly warmer water on the bottom of the lake and the ice at the surface.**

Below the epilimnion is a layer of sharp temperature decline, known as the metalimnion (Smith and Smith 2009). Within this stratum is the greatest temperature gradient in the lake, called the thermocline. The thermocline separates the epilimnion from the hypolimnion, the lowest stratum of a lake. The hypolimnion, only found in deeper lakes, is beyond the depth to which sufficient light can penetrate to facilitate effective photosynthesis (Figure 1). It is in the

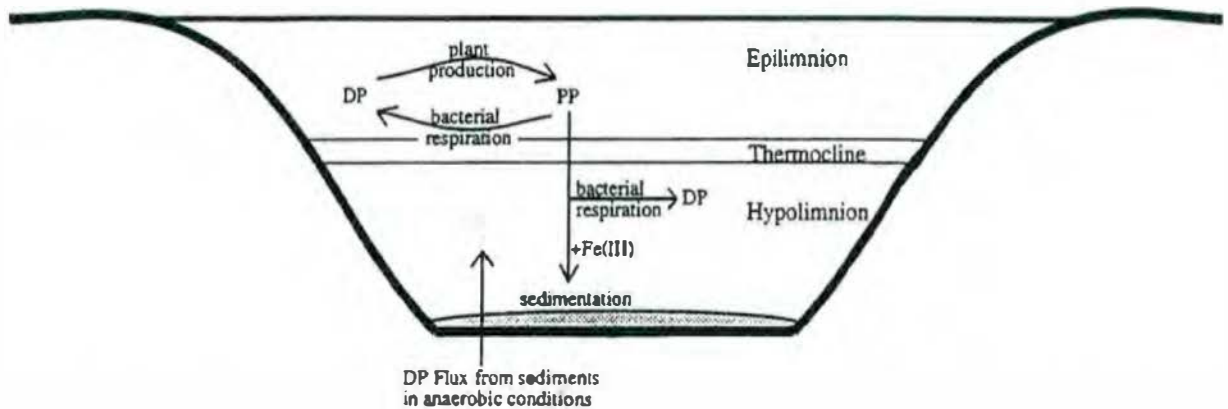
**Figure 2. A model of the cycle of the major forms of phosphorus, dissolved (DP) and particulate (PP), within a lake ecosystem. The sedimentation of DP through complexation with Fe (III) contributes to the build-up of DP in the sediments. Note the production of DP in the hypolimnion due to bacterial decomposition as well as from the release of DP from the Fe complex in the sediments during anaerobic conditions. The fact that the thermocline prevents DP from mixing between the surface and bottom water is critical to the cycle because it can allow DP to accumulate in bottom waters (adapted from Lerman 1978).**

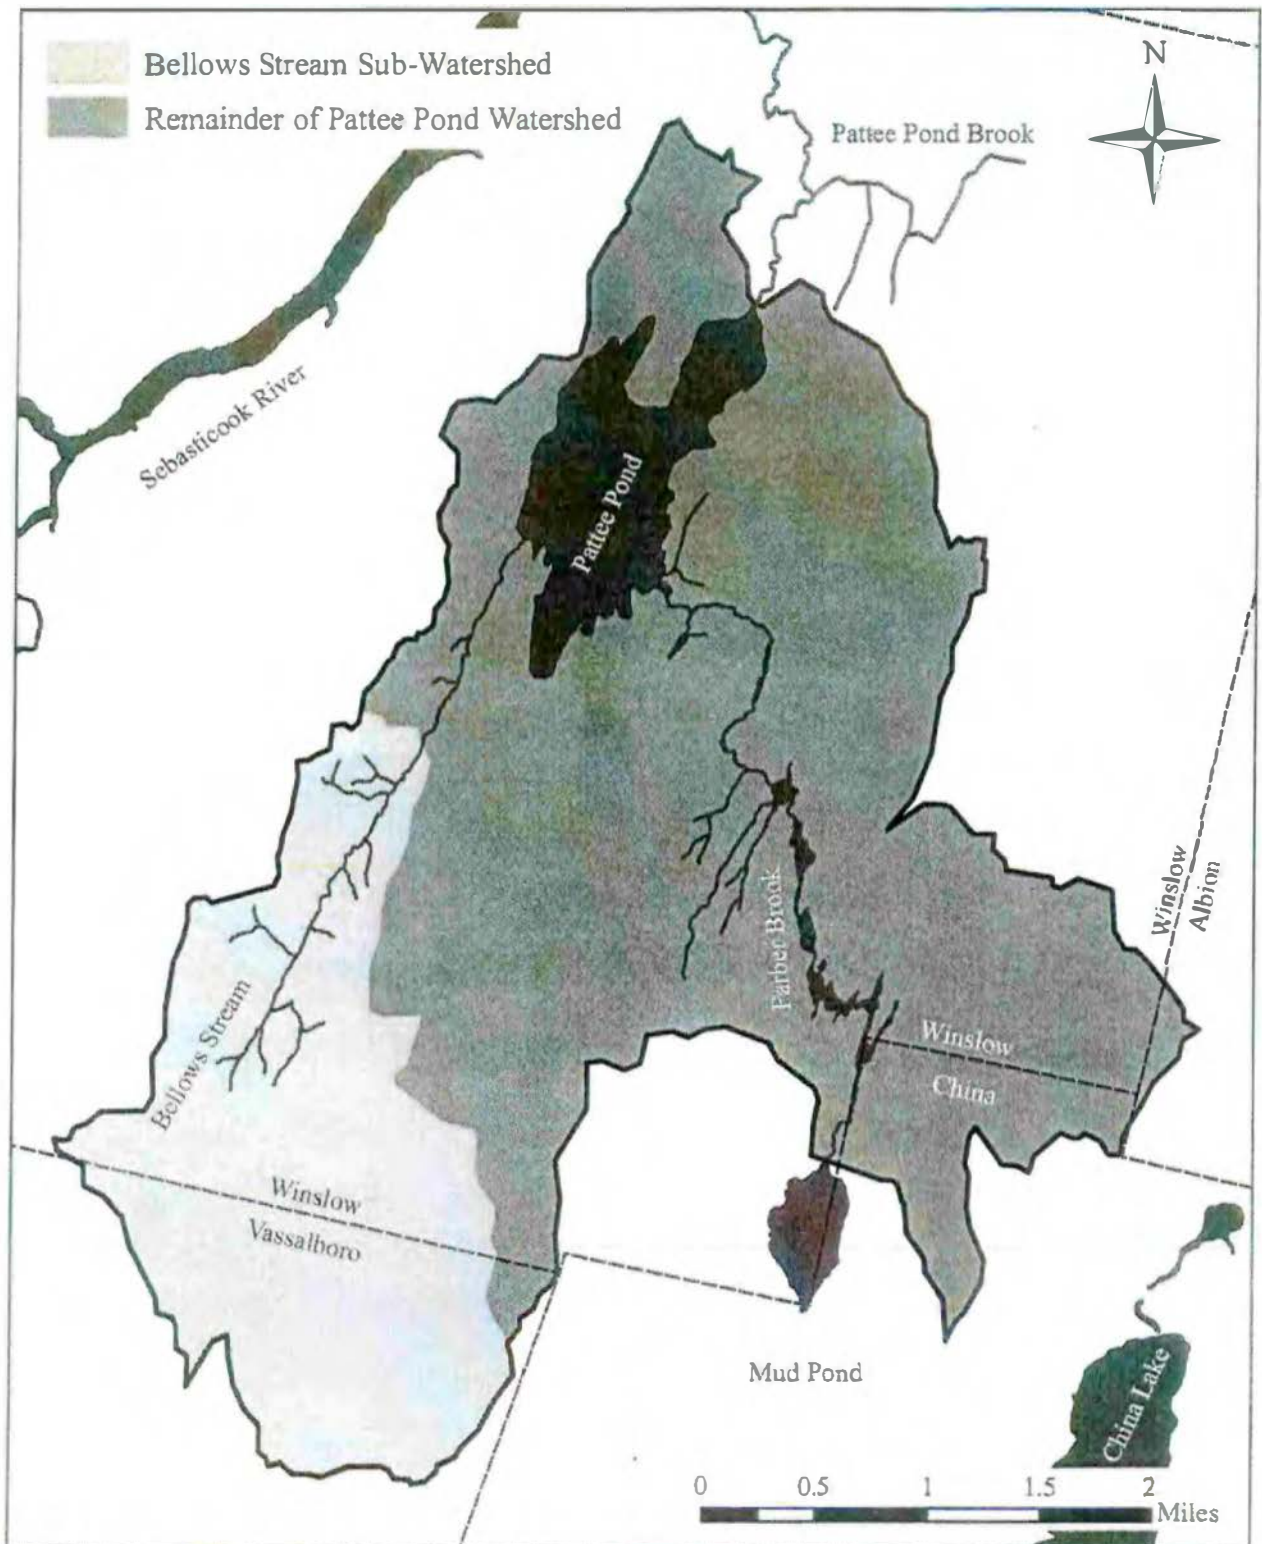
**Figure 7.** Overview map of Pattee Pond showing town boundaries, nearby waterbodies, major inlets and outlets. The Pattee Pond watershed is shaded; because certain areas of the watershed may have more impact on water quality than others, the Bellows Stream sub-watershed is also indicated.

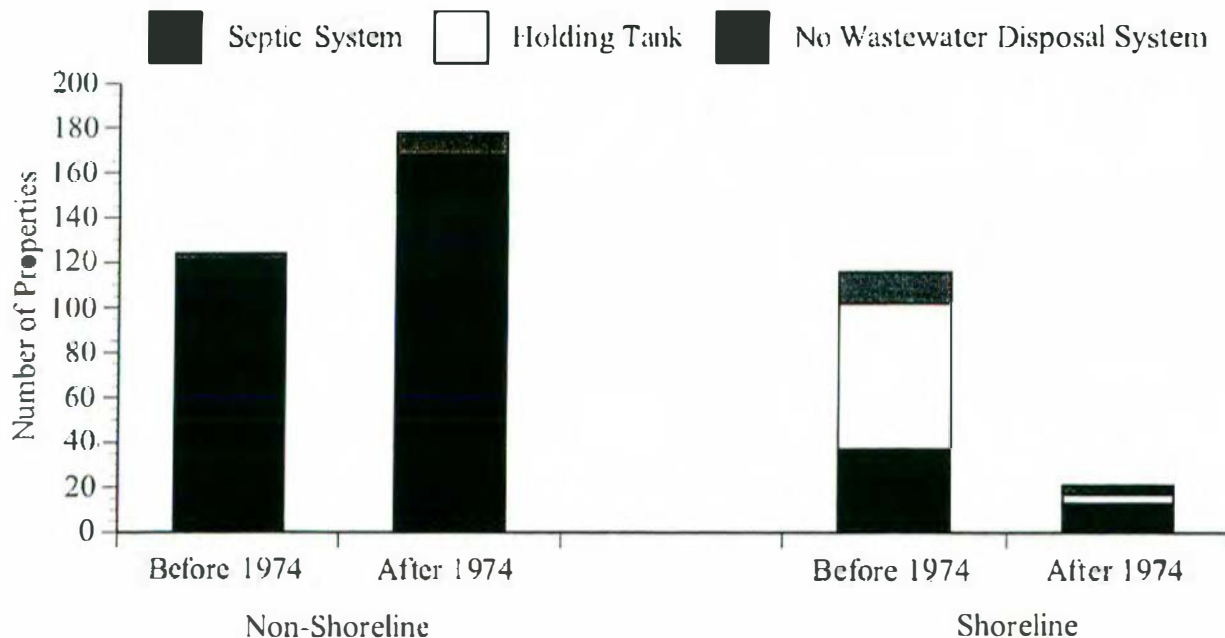
**Figure 23. Types of subsurface wastewater disposal systems for “grandfathered” residential properties in the Pattee Pond watershed. Data is from the Town of Winslow property cards for 302 non-shoreline and 137 shoreline residences.**

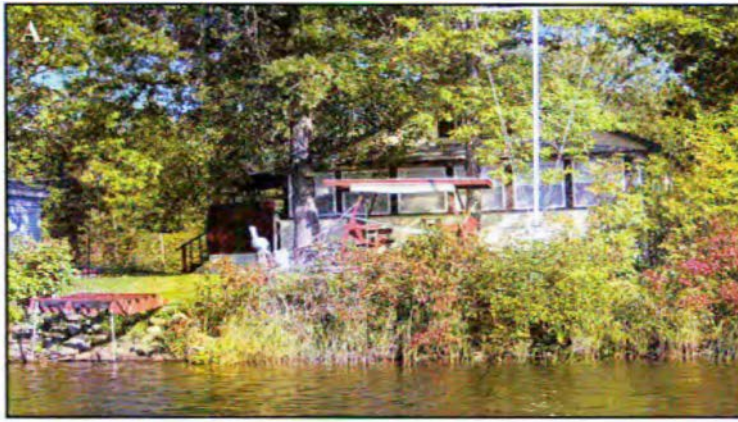
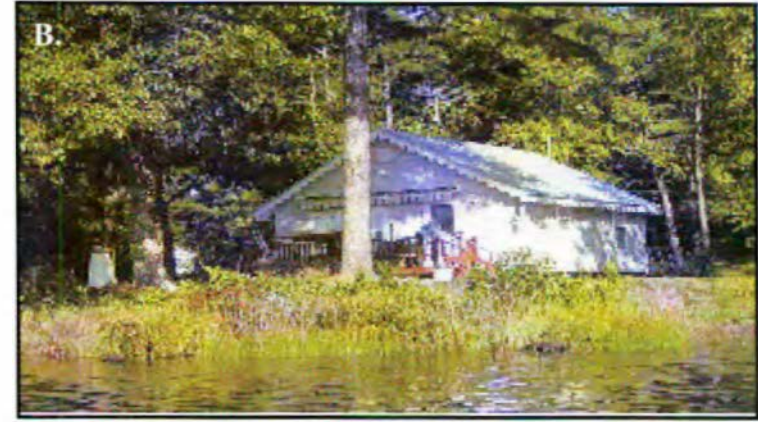
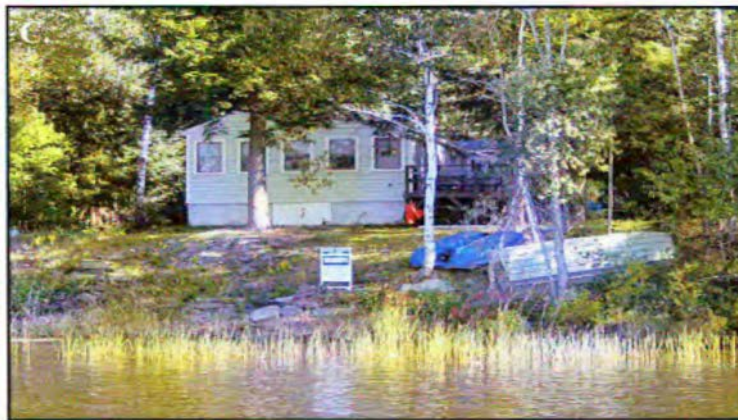
**Figure 25.** Examples of buffers on the Pattee Pond shoreline. **A:** A buffer on Pattee Pond given a good rating. The buffer extends along almost all of the shoreline and several feet inland towards the residence. It is comprised of dense, varied vegetation, and there is no paved pathway leading down to the dock. **B:** A buffer on Pattee Pond given an acceptable rating. The buffer extends along most of the shorefront and up to the residence, providing adequate buffering capacity. Adding trees and tall shrubs and covering the bare patch of land on the far right of the photograph could elevate this buffer to a good quality rating. **C:** A buffer on Pattee Pond given a fair rating. Although trees and shrubs are present, their densities are very low. An increase in vegetative land cover instead of dirt and scattered rocks would aid in runoff and erosion mitigation. **D:** A buffer on Pattee Pond given a poor rating. The house is very close to the shore, so that any precipitation landing on the roof travels directly into the lake. The dock may also provide a means for runoff to be channeled into the lake. Increased buffer vegetation is necessary to reduce the impacts these impermeable surfaces have on runoff potential.

Shoreline surveys of the properties surrounding Pattee Pond were conducted by boat on 22-Sep-08. The lake was divided into an East and West side, and one boat team surveyed each side. Survey forms were used to standardize data collection (see Appendix E), and each property was marked with a GPS point and scored for its buffer quality. The quality of a buffer was determined by a combination of factors, including slope of the property, percent of the shoreline that was vegetated, and relative amounts of vegetation types present. These scores were later used for a buffer quality rating calculation, in which the values were converted to a percent of the optimal buffer score. All buffer strips were grouped into the categories good (100-76 percent), acceptable (75-51 percent), fair (50-26 percent), and poor (25-0 percent) (Figure 25).

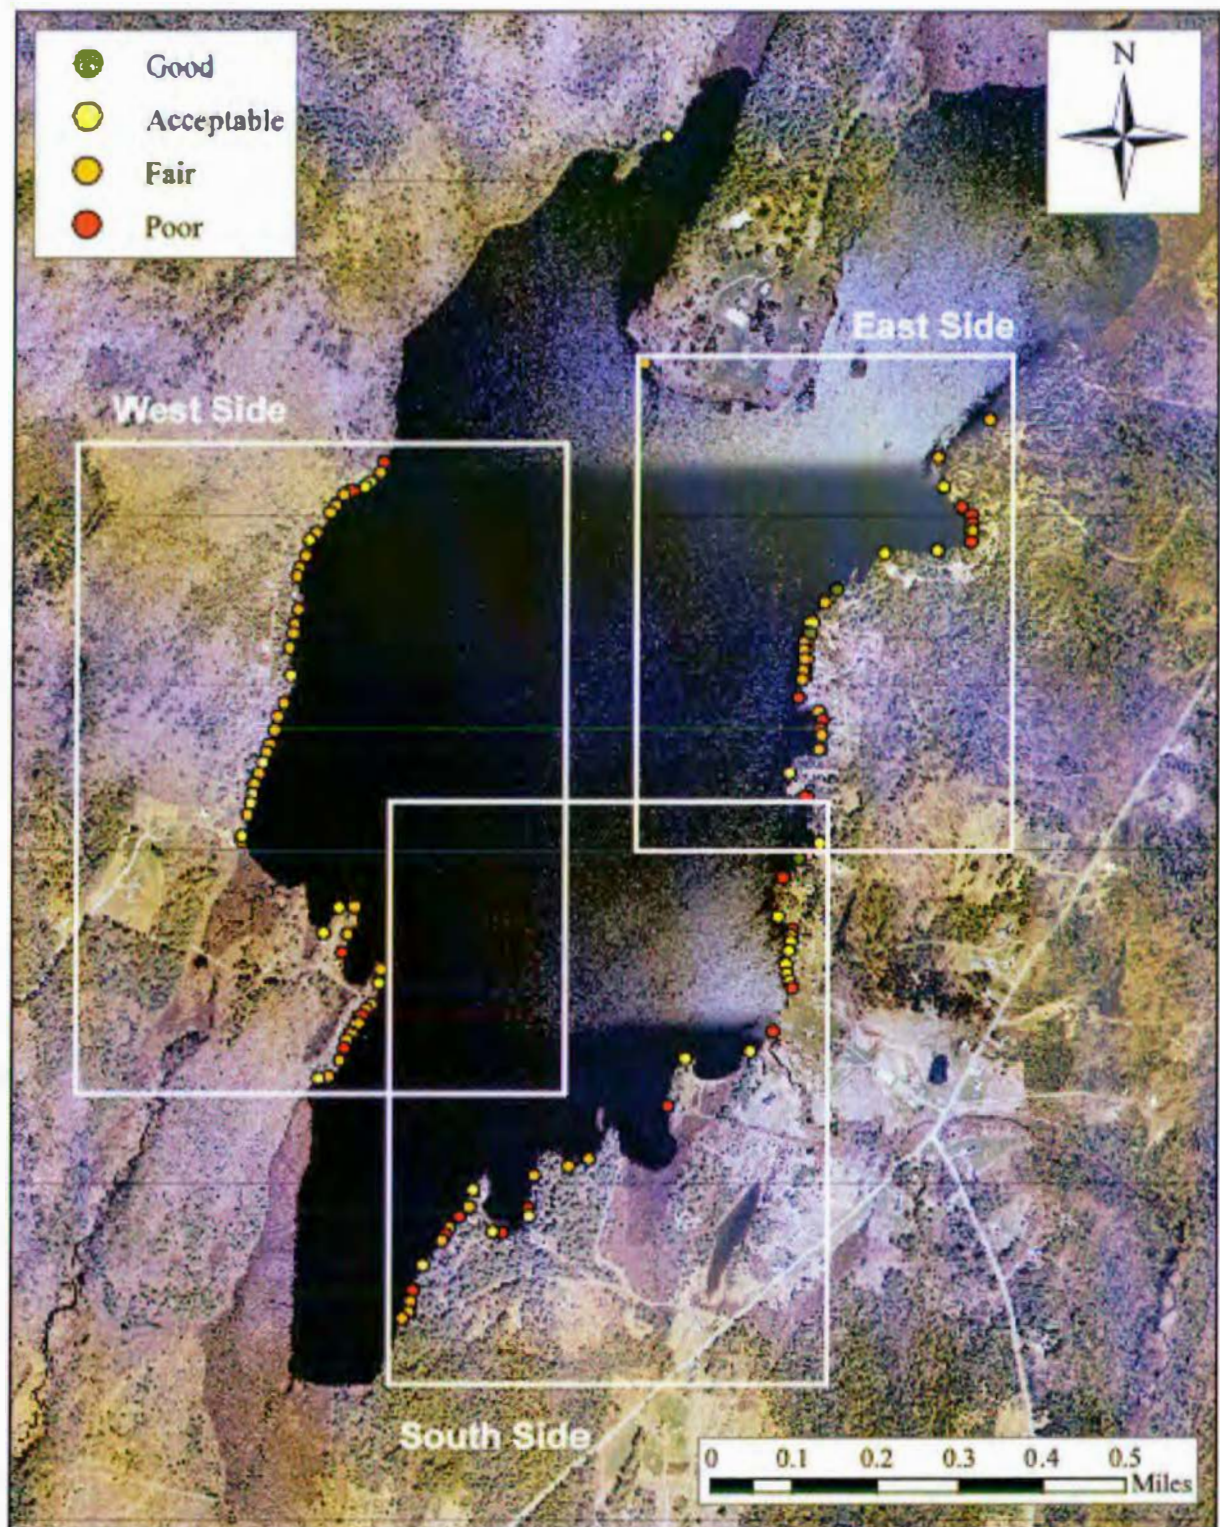
**Figure 28.** Buffer quality ratings for Pattee Pond (see Buffer Strips: Methods). Dots corresponding to quality ratings were placed at the location of each residential buffer strip. Residences along the lake were grouped into west, east, and south shorelines, and magnified for ease of viewing in Figures 29, 30, and 31.

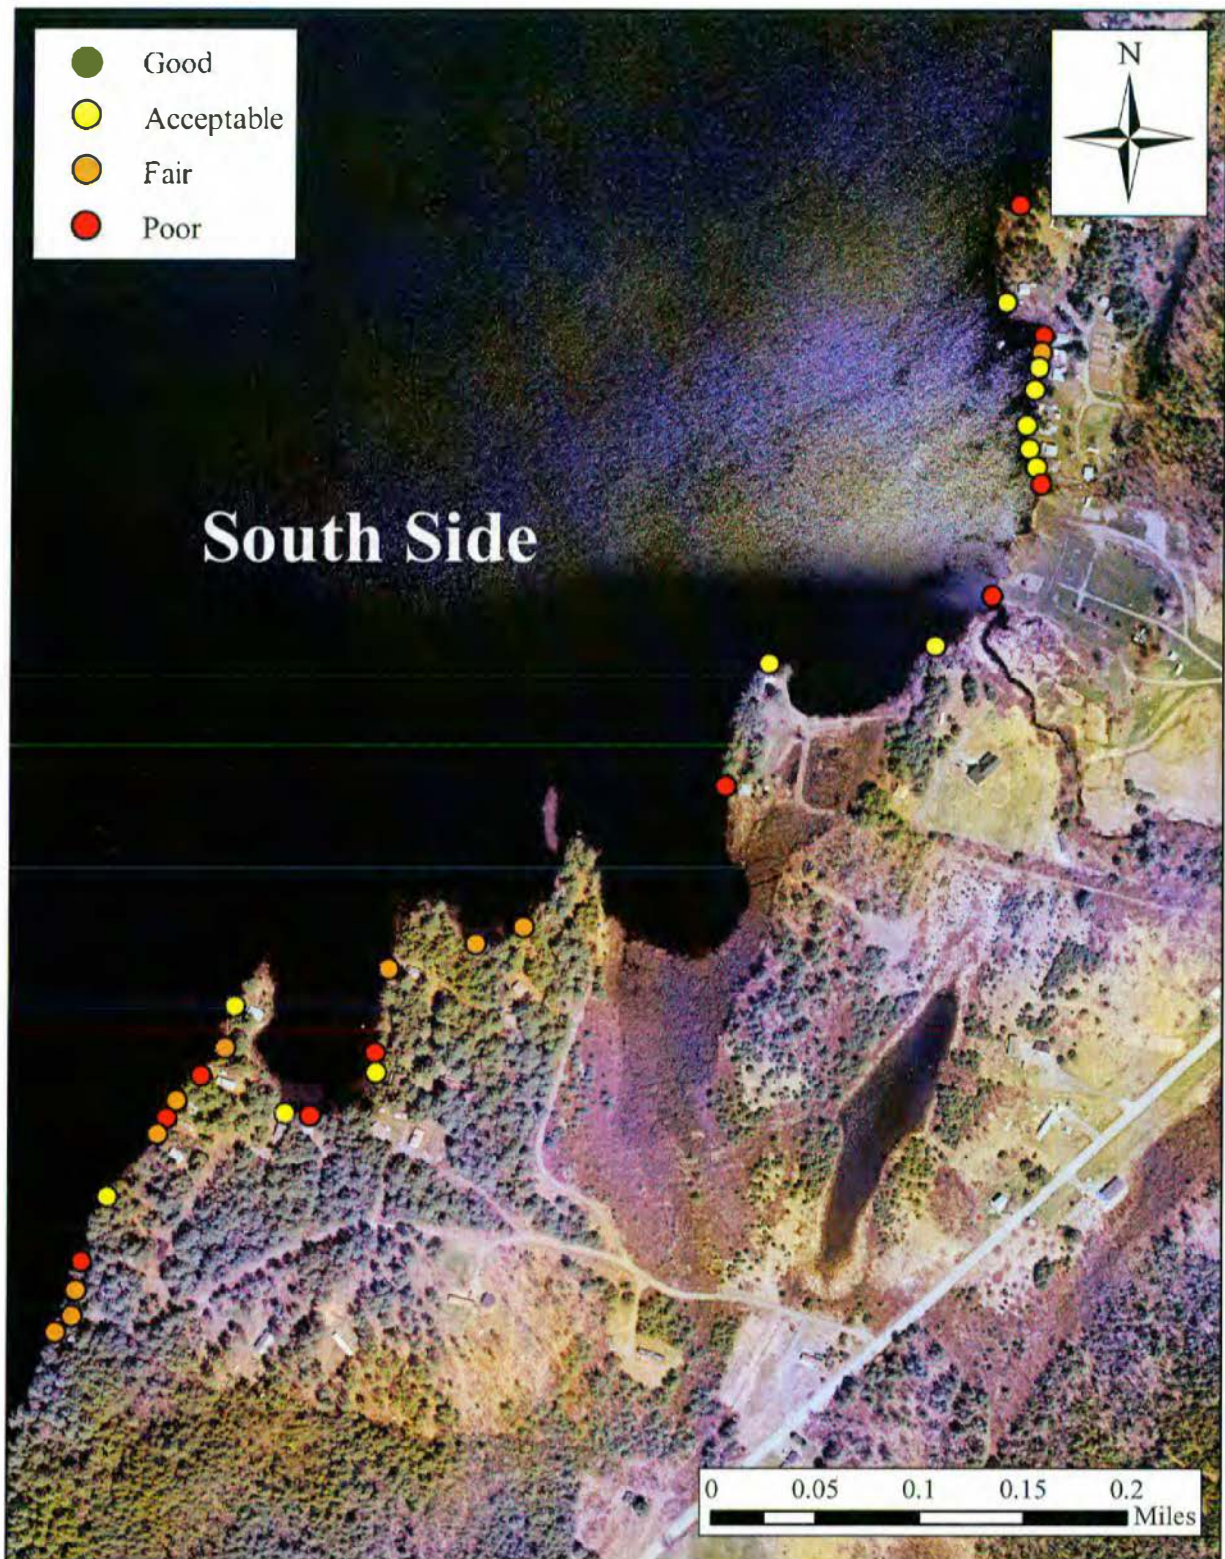
**Figure 31.** Buffer quality ratings for the south shoreline of Pattee Pond (see Buffer Strips: Methods). Dots corresponding to quality ratings were placed at the location of each residential buffer strip.

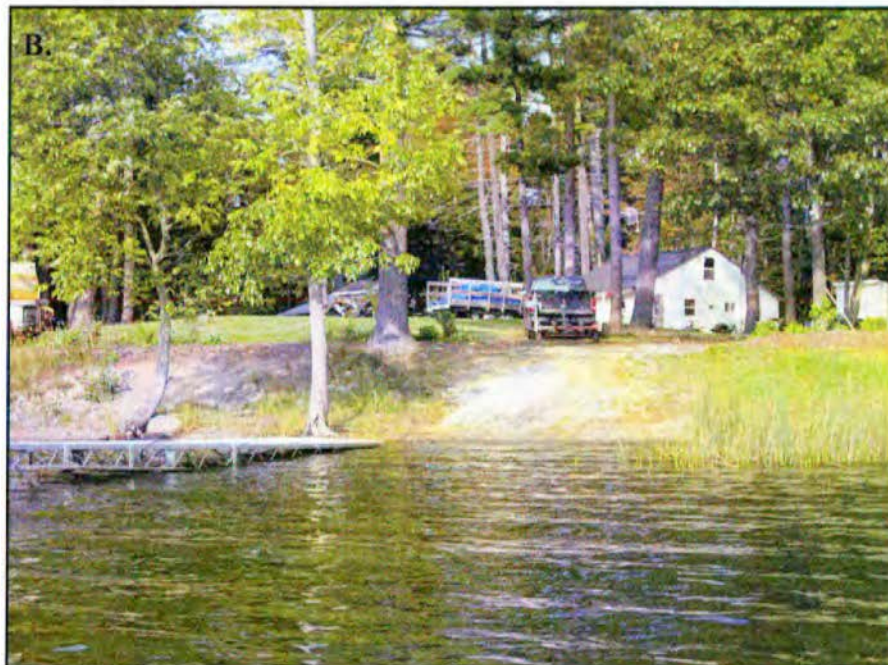
**Figure 32.** An example of a well-constructed private boat launch (A) and a poorly-constructed private boat launch (B) along the Pattee Pond shoreline. Boat launches composed of permeable material, such as mulch or wood chips, and lined with riprap, aid in slowing runoff so it can be absorbed before reaching the water, and stabilize the shoreline. Bare boat launches, especially on steep properties, channel water and increase erosion potential.

erosion problem along Pattee Pond occurs along the western shore, where lots are steep and extensive sediment loading occurs after heavy rain events. Private boat launches are also major sources of erosion, especially when poorly constructed, and were observed to occur on twice as many properties on the western shore (approximately six) than on the eastern shore (approximately three) (Figure 32). These act to interrupt buffer strip continuity and are major channels for runoff into Pattee Pond.

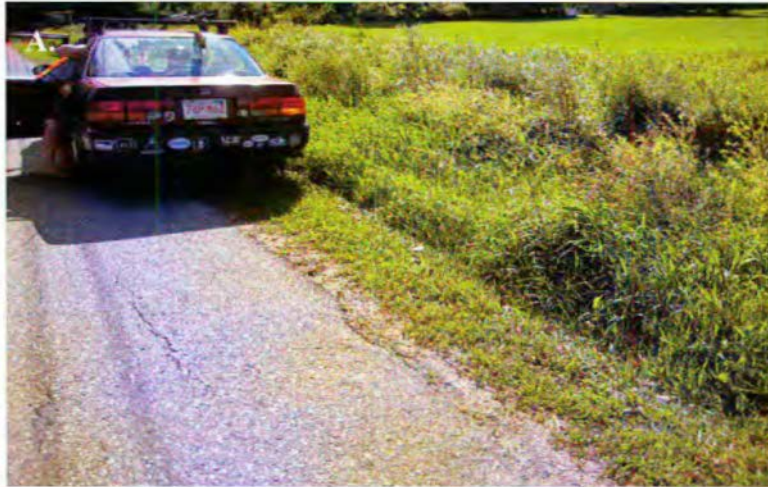
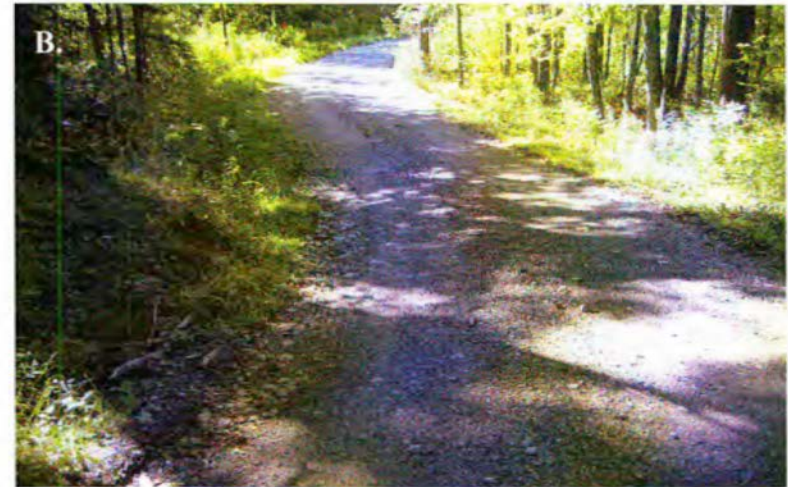
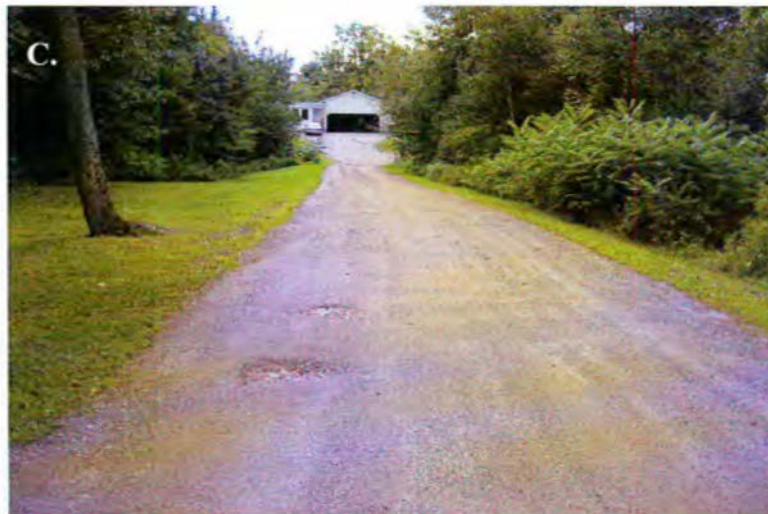
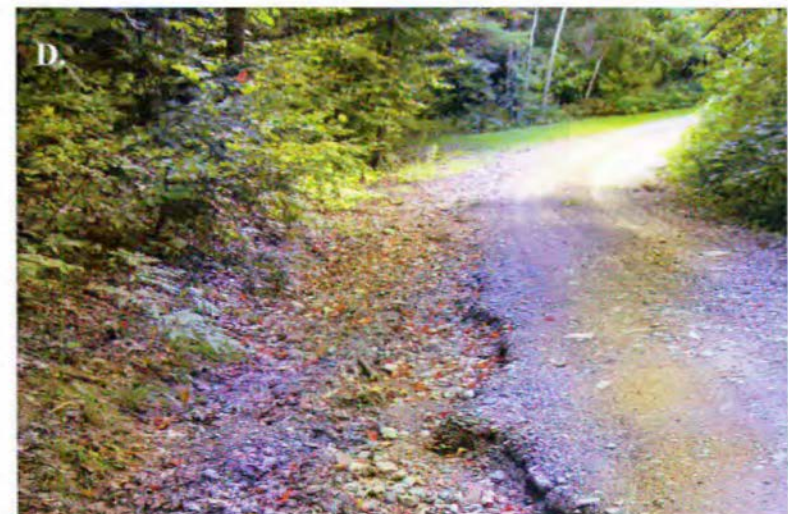
**Figure 34.** Examples of different quality roads in the Pattee Pond watershed. **A.** A road rated good. The surface is in good condition and has a sufficient crown. There is also a well-designed ditch with vegetation to absorb the runoff. **B.** A road given an acceptable rating. The road surface is not in as good condition and there are no ditches, but there is extensive vegetation on the sides of the road and no erosion problems evident. **C.** A road given a fair rating. The road has no crown and has evident potholes and water gullies running across the road. Repair is recommended. **D.** A road given a poor rating. There is extensive erosion on the side of the road and tire ruts run down the road. This road should be repaired quickly to prevent runoff from

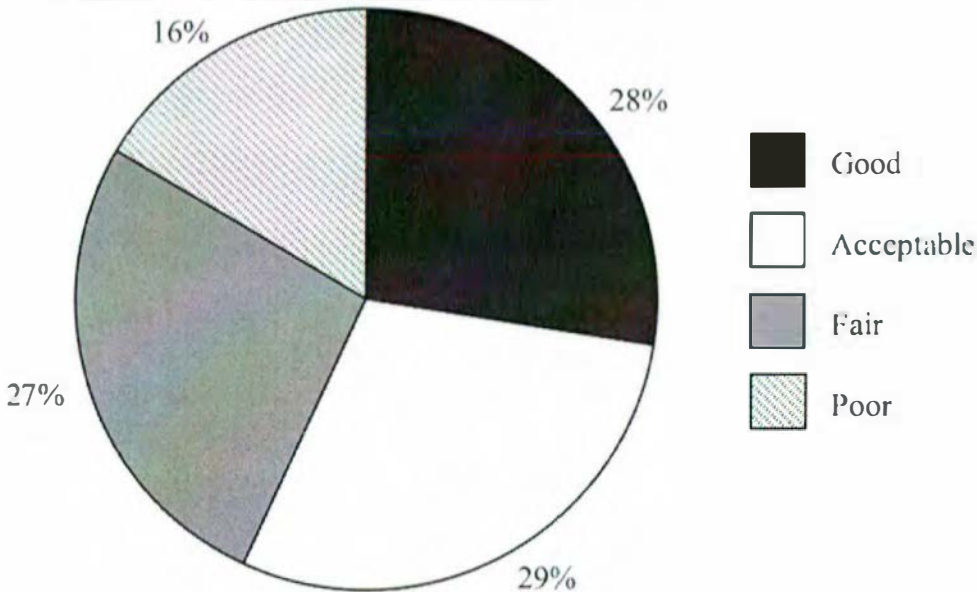
**Figure 35. Surface area of camp roads organized by quality rating. Quality was assigned by CEAT based on road surveys conducted on 15-Sep-08 and 18-Sep-08. CEAT recommends repairing the roads labeled as Fair or Poor.**

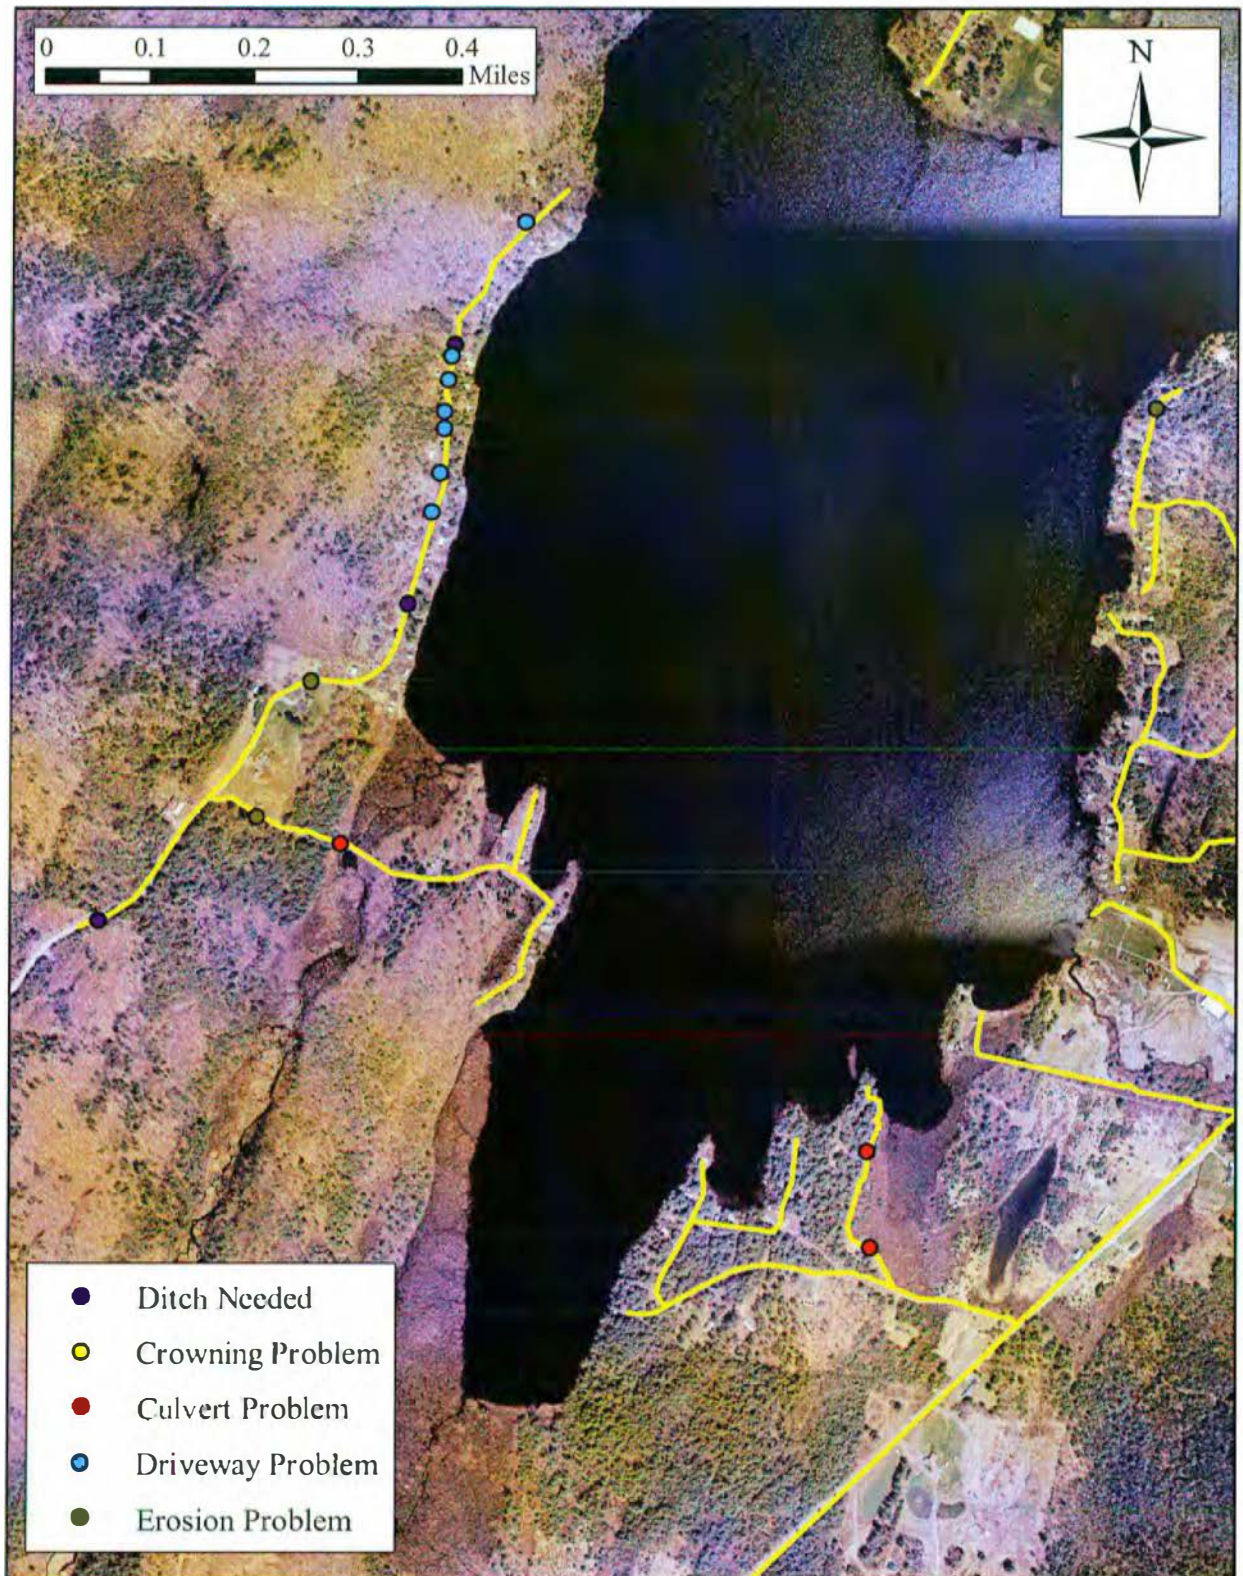
**Figure 36.** Ditch, culvert, driveway, and erosion problems on camp roads around Pattee Pond identified by CEAT during the 12-Sep-08 and 15-Sep-08 road surveys.

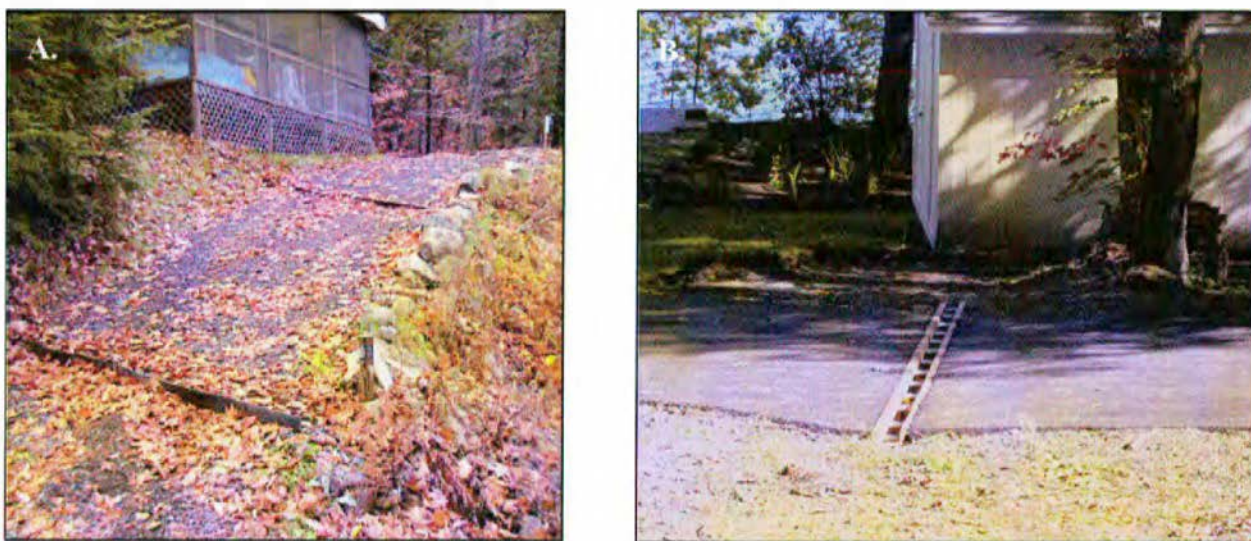
**Figure 37. Two examples of water diversions that can be used on driveways. A. Two rubber bars have been installed on this driveway to divert water towards the vegetated side of the driveway. B. An open top culvert installed across a driveway. Water flowing alongside or down the driveway can be diverted across by the open top culvert.**

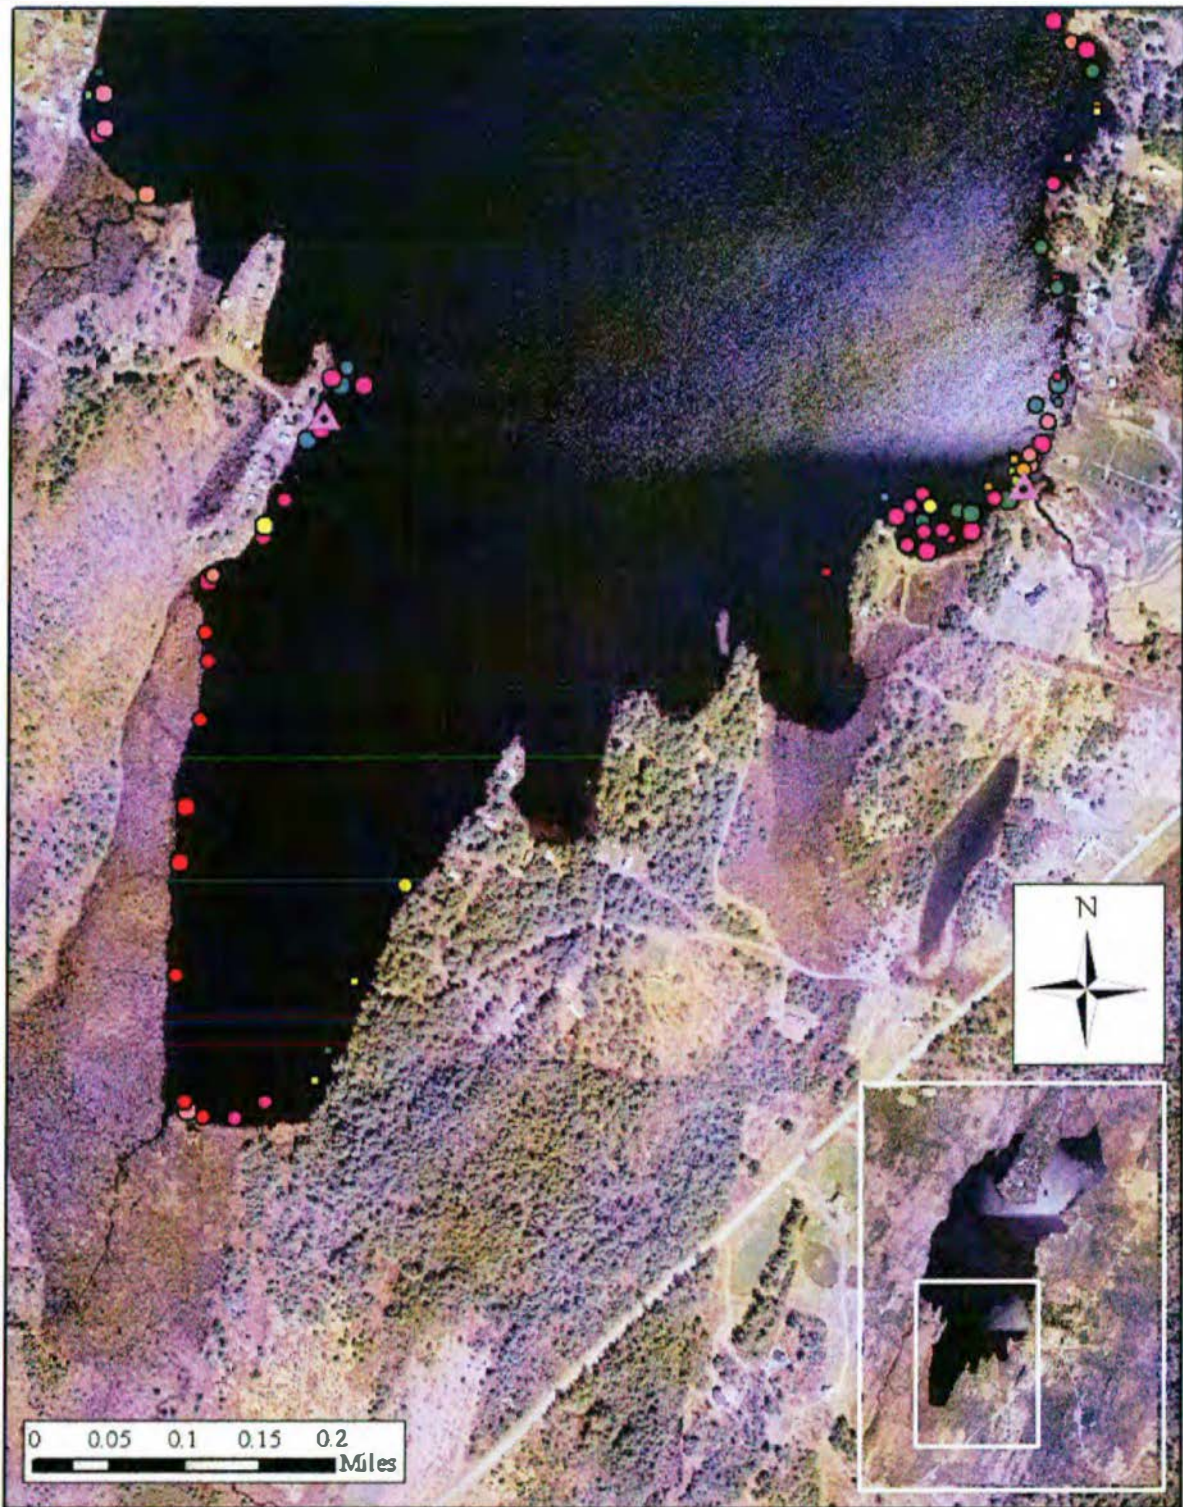
**Figure 41.** Macrophyte community distribution for the south shore of Pattee Pond based on macrophyte surveys performed on 22-Sep-08 and 25-Sep-08. The dominant plant species is indicated by dot color. A plant was considered dominant if that particular species composed more than 20% of a specific sample site. Dot size indicates the density of the macrophyte patch. Refer to Figure 38 for dominant plant species identification key.

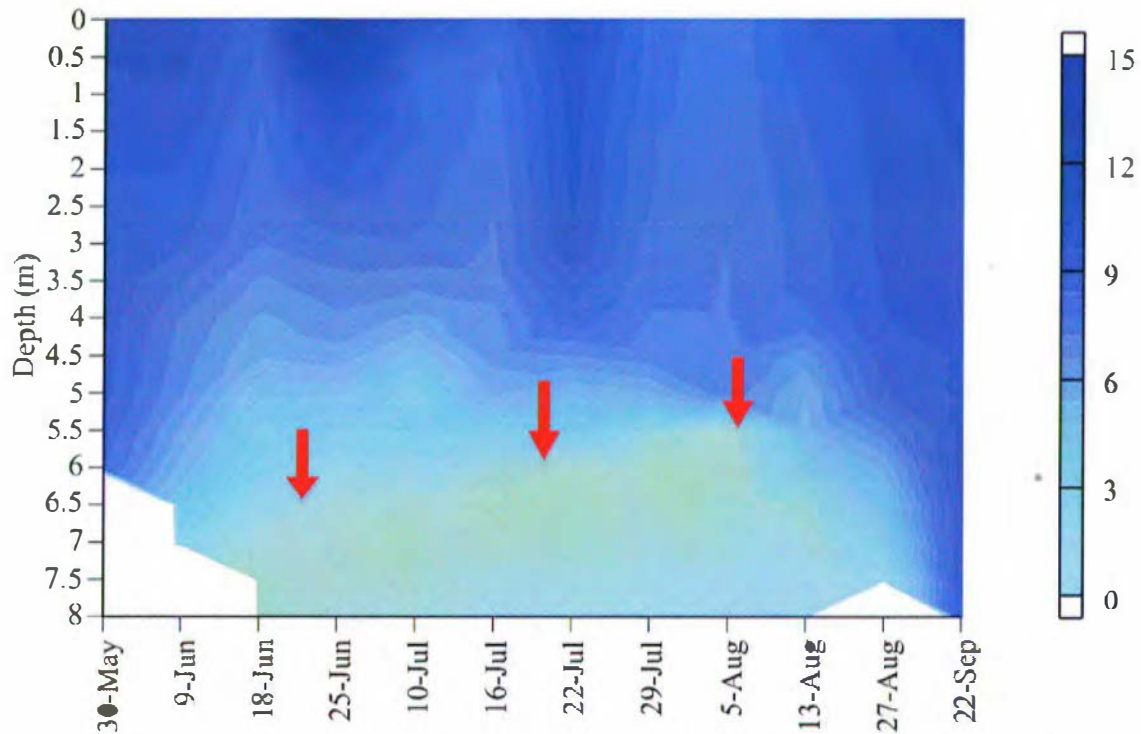
**Figure 43. Dissolved oxygen (ppm) profile at Site 1 in Pattee Pond as measured by CEAT from May to September 2008 (see Figure 42 for site locations). DO scale runs from high DO to low DO (dark blue to light blue). Arrows indicate depths experiencing anoxic conditions. Values lower than 1 ppm are defined as anoxic. White regions denote no data available.**

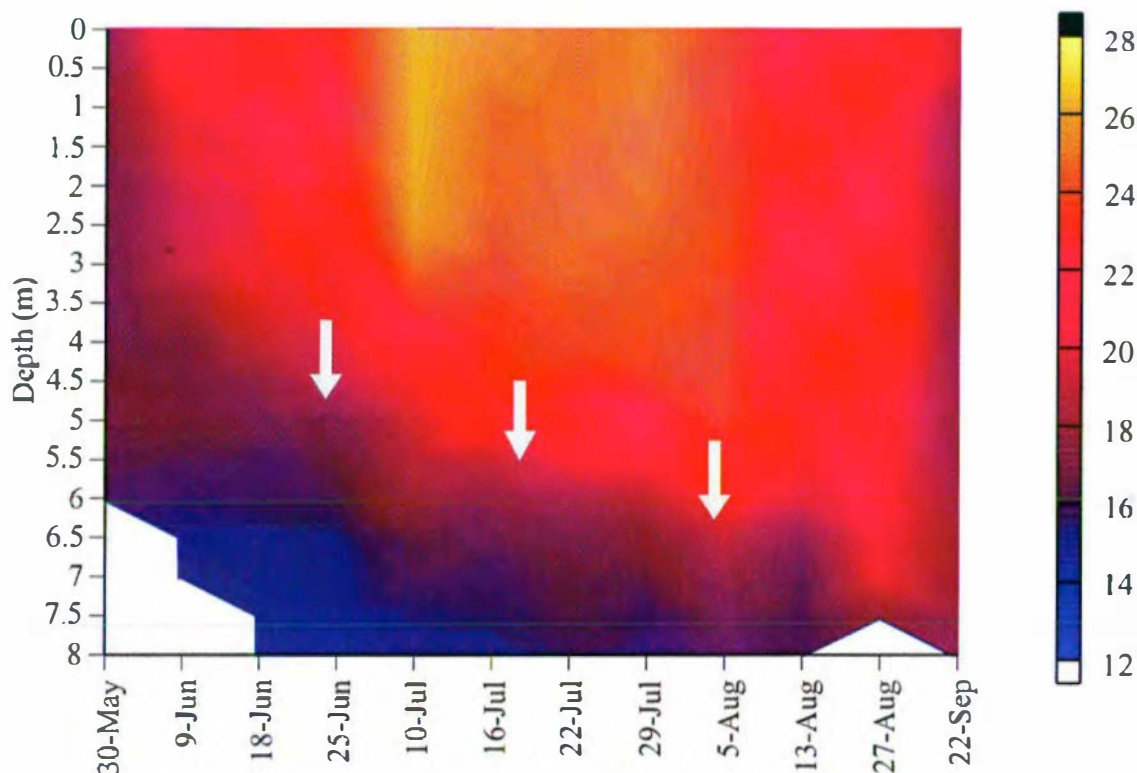
**Figure 44. Temperature (degrees C) profile at Site 1 in Pattee Pond measured by CEAT from May to September 2008 (see Figure 42 for site locations). Arrow indicates a clear drop in the epilimnion as the summer progresses. White regions denote no data available.**

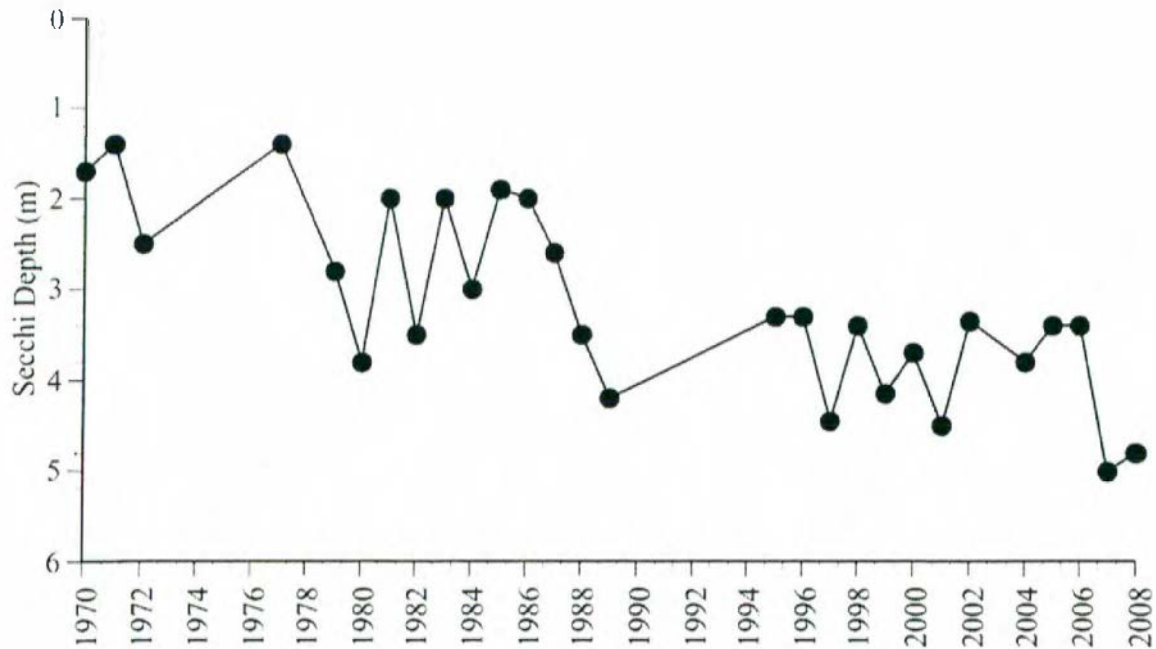
**Figure 50. Historical transparency measured by Secchi depth (m) by Maine DEP at Pattee Pond Site 1 based on readings taken between 26-Jul and 13-Aug in summers from 1970 to 2008 (See Figure 42 for site locations).**

- Water transparency in Pattee Pond, as measured using a Secchi disk, has gradually improved over the last 40 years. CEAT recorded Secchi depth of 3.5 m in early June. Depths then increased to 4.5 to 5.0 m through the summer. Secchi disk readings dropped rapidly beginning in early August as a result of an algal bloom caused by the fall turnover.

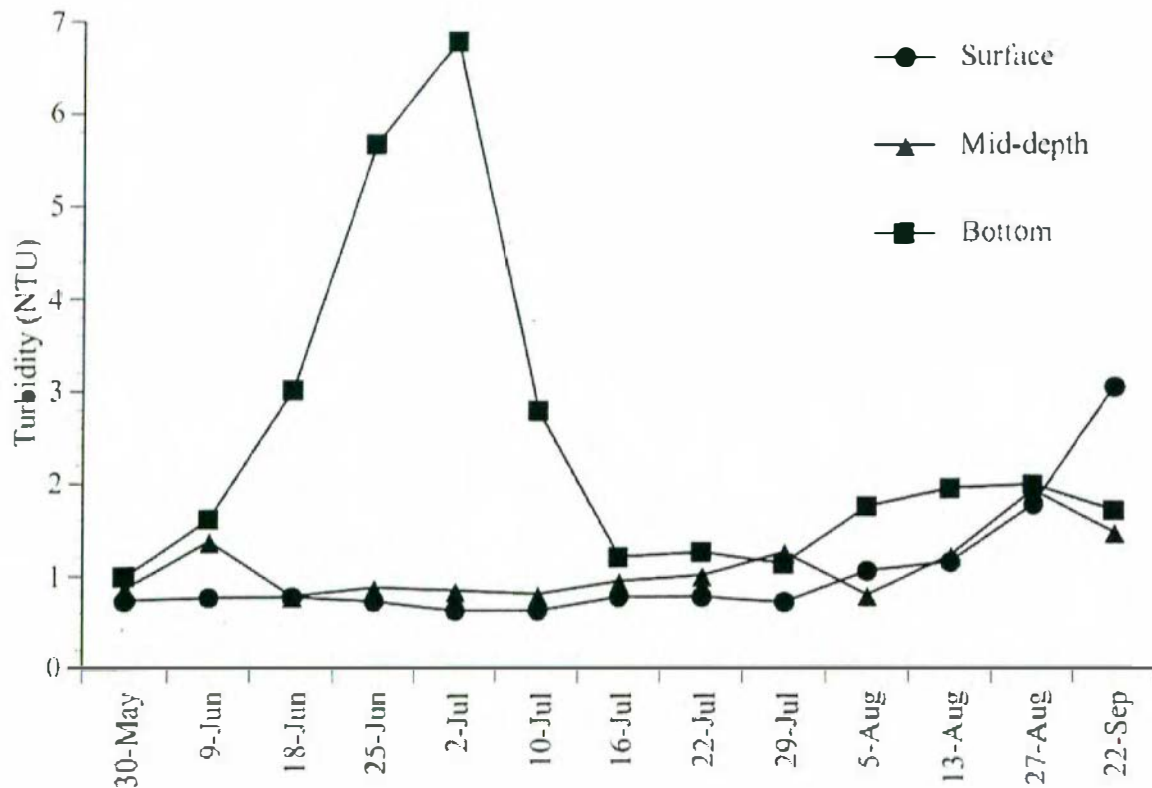
**Figure 51. Surface, mid-depth, and bottom turbidity (NTU) at Pattee Pond Site 1 measured by CEAT from May to September 2008 (See Figure 42 for site locations).**
