## A Watershed Analysis of Pattee Pond: Implications for Water Quality and Land Use Management

Problems in Environmental Science course (Biology 493), Colby College

# A WATERSHED ANALYSIS OF PATTEE POND

IMPLICATIONS FOR WATER QUALITY  
AND LAND USE MANAGEMENT

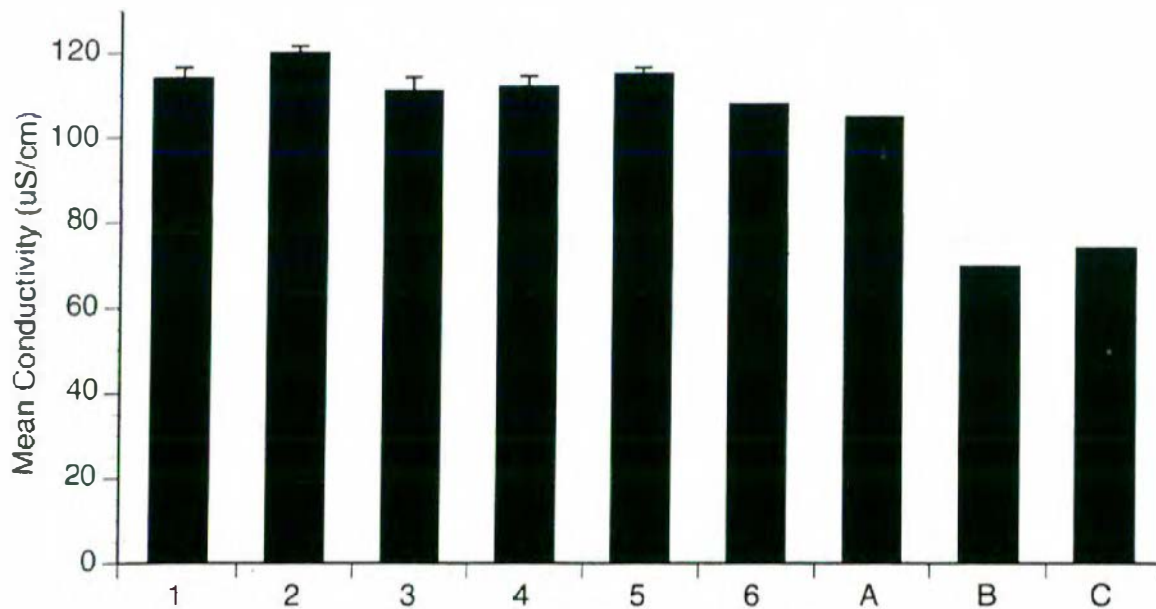
**Figure 52. Mean surface conductivity ( $\mu\text{S}/\text{cm}$ ) at Lake Sites 1-5 on Pattee Pond was measured by CEAT using a YSI Sonde 6820 from 30-May-08 to 22-Sep-08, and at Site 6 on 22-Sep-08. At Tributary Sites A-C conductivity was measured using an Orion 140 conductivity and salinity meter on 22-Sep-08.**

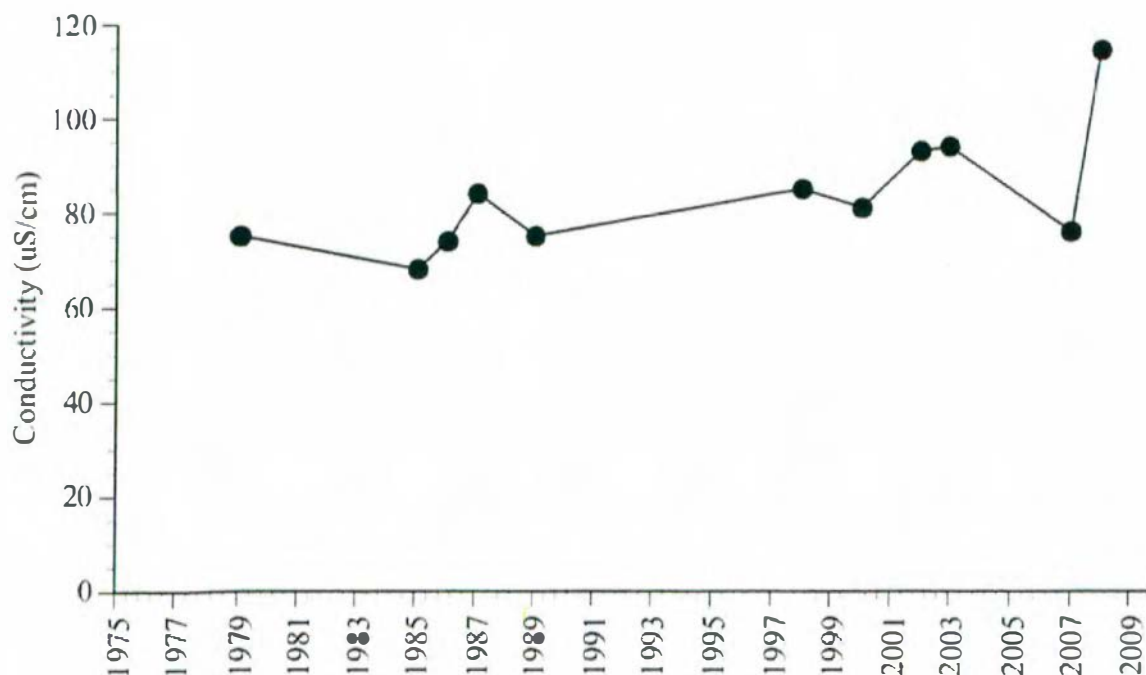
**Figure 53. Historical annual mean conductivity (µS/cm) for Pattee Pond (PEARL 2008). Data for 2008 were measured by CEAT from 20-May-08 to 22-Sep-08 using the YSI Sonde 6820 (see Appendices I, J, and K). High readings for 2008 may suggest increased sediment loading, or be the result of a very rainy summer.**

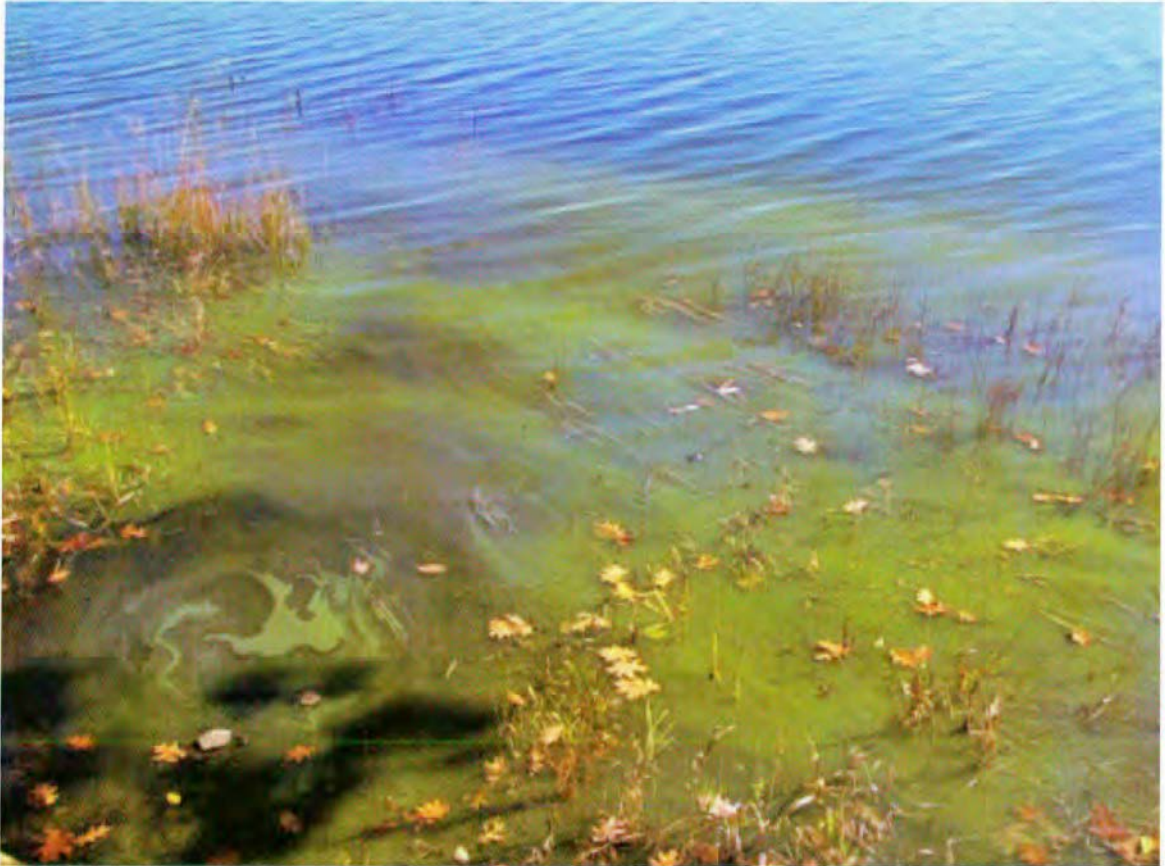
**Figure 58. A late season algal bloom on 20-Oct-08 photographed by homeowner Larry Fleury. Milder algal blooms were witnessed on 8-Oct-08 and 24-Oct-08 by CEAT members.**

Characterization Site (Site 1) went anoxic below six meters on 22-Jul-08 (see Figure 43). A week later, 29-Jul-08, water samples taken from the bottom at Site 1 reached their peak phosphorus concentration, and stayed at this concentration till 5-Aug-08 (see Figure 54). On 8-Oct-08 and 24-Oct-08 mild algal blooms were witnessed by CEAT members. On 20-Oct-08 Larry Fleury, a homeowner and pond association member, witnessed a significant bloom in which parts of the lake turned bright green (Figure 58).

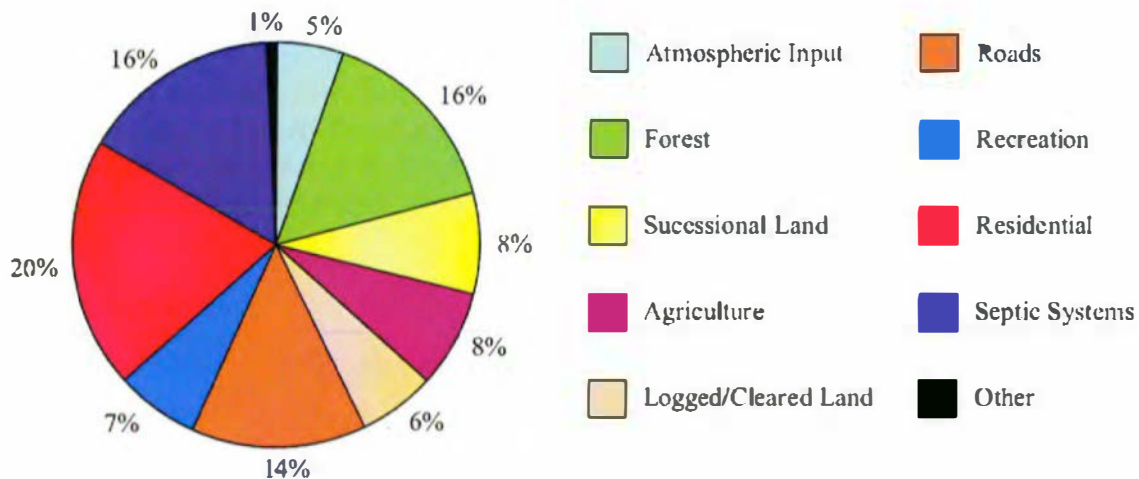
**Figure 59. Non-point sources of phosphorus from runoff loading for Pattee Pond. Percentage values reflect the amount that each source contributes to the total phosphorus budget in Pattee Pond. Some land use types were grouped: forest (deciduous, mixed, coniferous), successional land (transitional forest, regenerating forest, reverting land), agriculture (crops, pasture/grassland, tree farms), roads (camp, municipal, state), recreation (Camp Caribou, Giordano's Market and RV Camp), residential (shoreline and non-shoreline development), and septic systems**

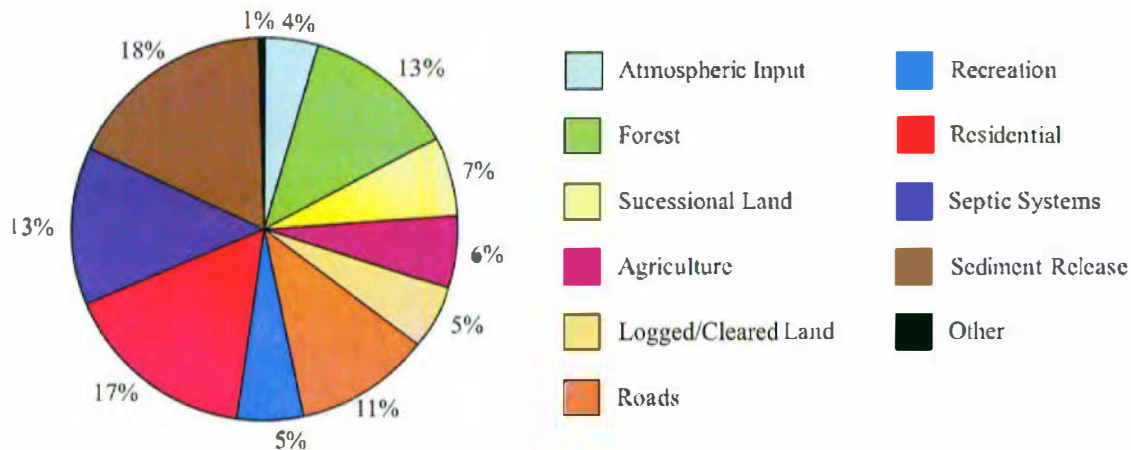
**Figure 60. Sources of internal and external phosphorus loading for Pattee Pond. Percentage values reflect the amount that each source contributes to the total phosphorus budget in Pattee Pond. Some land use types were grouped: forest (deciduous, mixed, coniferous), successional land (transitional forest, regenerating forest, reverting land), agriculture (crops, pasture/grassland, tree farms), roads (camp, municipal, state), recreation (Camp Caribou, Giordano's Market and RV Camp), residential (shoreline and non-shoreline development), and septic systems (shoreline and non-shoreline).**

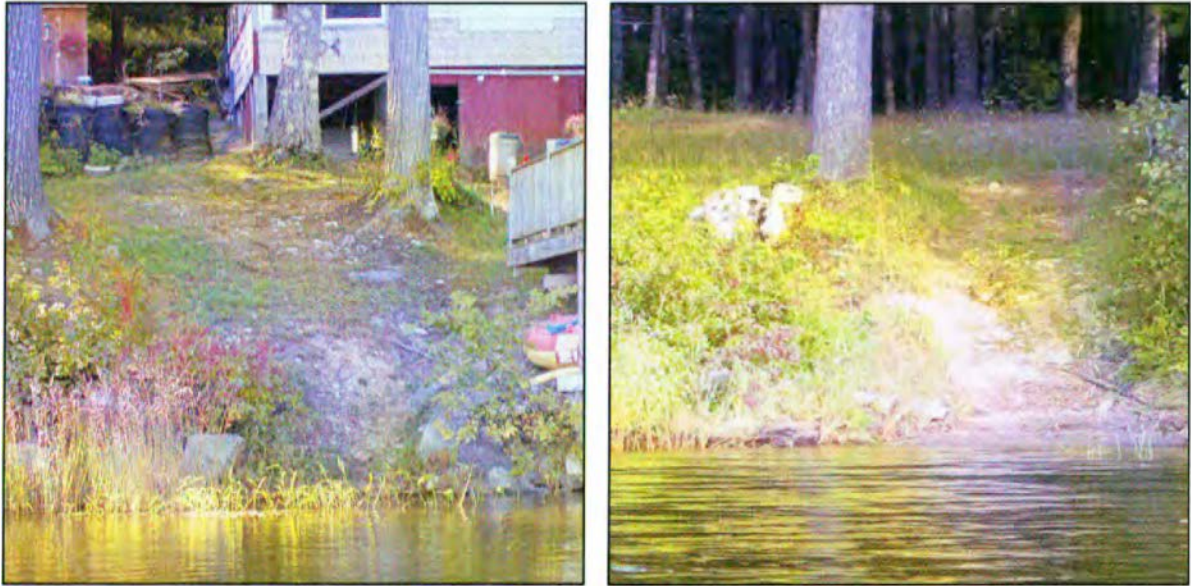
**Figure 61.** These photos illustrate erosion from steep lots on the shoreline of Pattee Pond that carry sediment and phosphorus into the lake. Lots on the west side of the lake are of particular concern because of the steep slopes on that shore. BMP techniques can help mitigate the flow of runoff across lots and reduce sediment loading into Pattee Pond.

Best management practices (BMP) are procedures designed to reduce the impacts of development on the natural ecosystem. For new construction in the Pattee Pond watershed, best management practices and low-impact designs should be utilized to mitigate negative effects on the watershed (MDEP 2003d). BMP can also be implemented on existing lots to improve water quality and reduce the environmental impacts of a residence. Runoff flowing across shoreline lots directly into the lake is an important concern for shoreline properties. Homes close to the water increase the amount of impervious surface near the lake and often have cleared lawns that do not impede the flow of runoff. Many best management practices for lakefront homeowners focus on slowing down and stopping runoff before it enters the lake. If runoff continues across shoreline lots, it can create erosion pathways that carry sediment and phosphorus directly into the lake, negatively affecting water quality (Figure 61). Rain gardens, which are plantings specially designed to be effective rainwater catchment basins, are one runoff-hindering mechanism. There are several publications available to homeowners from the Maine DEP and other sources outlining both simple steps and more complex construction techniques that improve the environmental performance of a property (see *Watershed Development Patterns: Buffer Strips*; MDEP 2003d, MDEP 2006, MDEP 2008b, MDEP 2008c). Maine is in the process of developing a certification process for contractors who work on projects in shoreline areas (Stankevitz, pers. comm.). The early stages of this program will likely be on a voluntary basis, though it may become mandatory in the future. Programs such as these are designed to promote compliance with zoning laws and the implementation of BMP during construction and renovation processes. CEAT encourages each landowner to consult BMP and low-impact design techniques to improve environmental practices on their property in order to reduce nutrient loading into the lake.
