## A Watershed Analysis Of Salmon Lake And McGrath Pond: Implications For Water Quality And Land Use Management

Colby Environmental Assessment Team, Colby College

Problems in Environmental Science course (Biology 493), Colby College

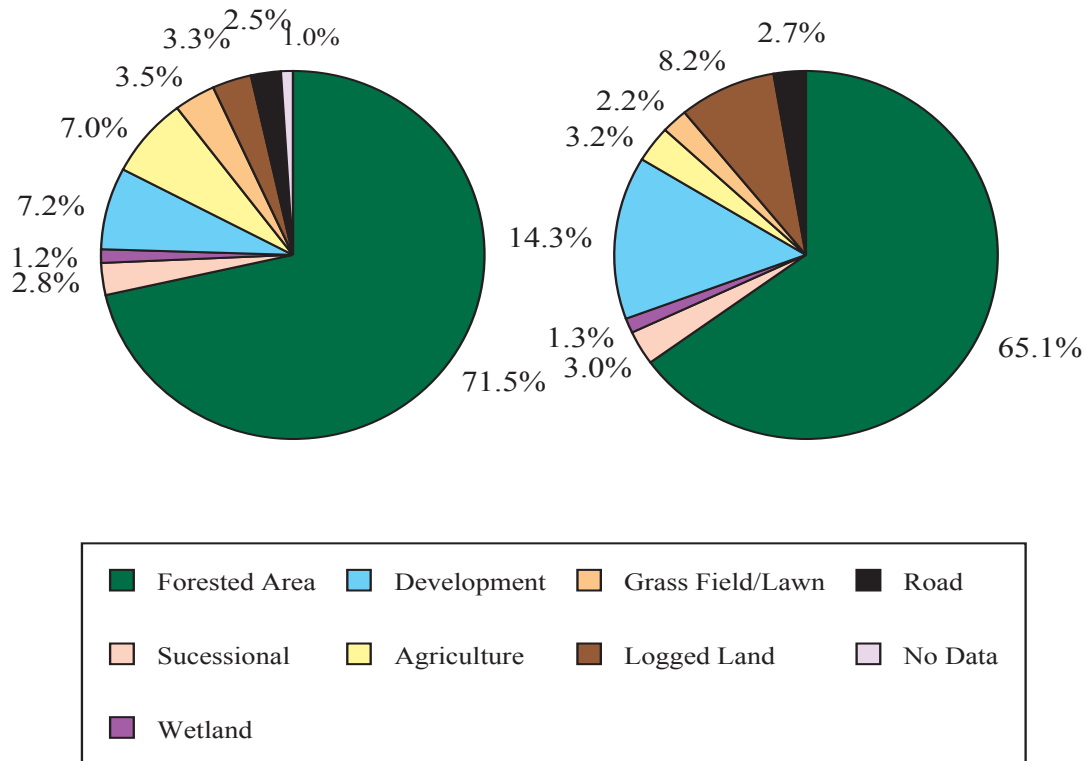
**Figure 9. Percent land cover of Salmon/McGrath watershed for 1965/66 and 2007 as determined using aerial photographs obtained from the Colby Environmental Assessment Team and the United States Department of Agriculture and Digital Orthophoto-Quadrangles obtained from the Maine Office of Geographic Information Systems, respectively.**

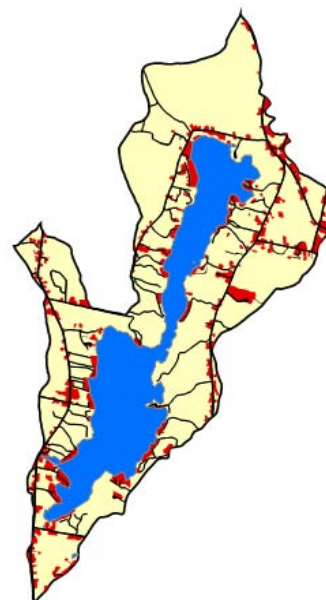
**Figure 11. Comparison of different land use types. Agricultural land refers to pasture, cropland, and livestock and decreased from 111 ha to 44 ha. Developed land refers to residential, commercial, municipal and industrial areas and increased from 103 ha to 210 ha.**

Developed land includes areas used for commercial, municipal and residential purposes. In general, developed land is dominated by human-made structures, roads, parking areas, landscaped areas or other characteristics that indicate a significant human impact. There are a variety of nutrient loading opportunities associated with developed land, including the presence of household, industrial and landscaping chemicals, which often contribute to the nutrient load of nearby water bodies. Additionally, the high levels of impervious surfaces contribute to increased erosion and runoff. The change in area from 1965/66 to 2007 of developed land including commercial, municipal, and residential land is represented in Figure 11.

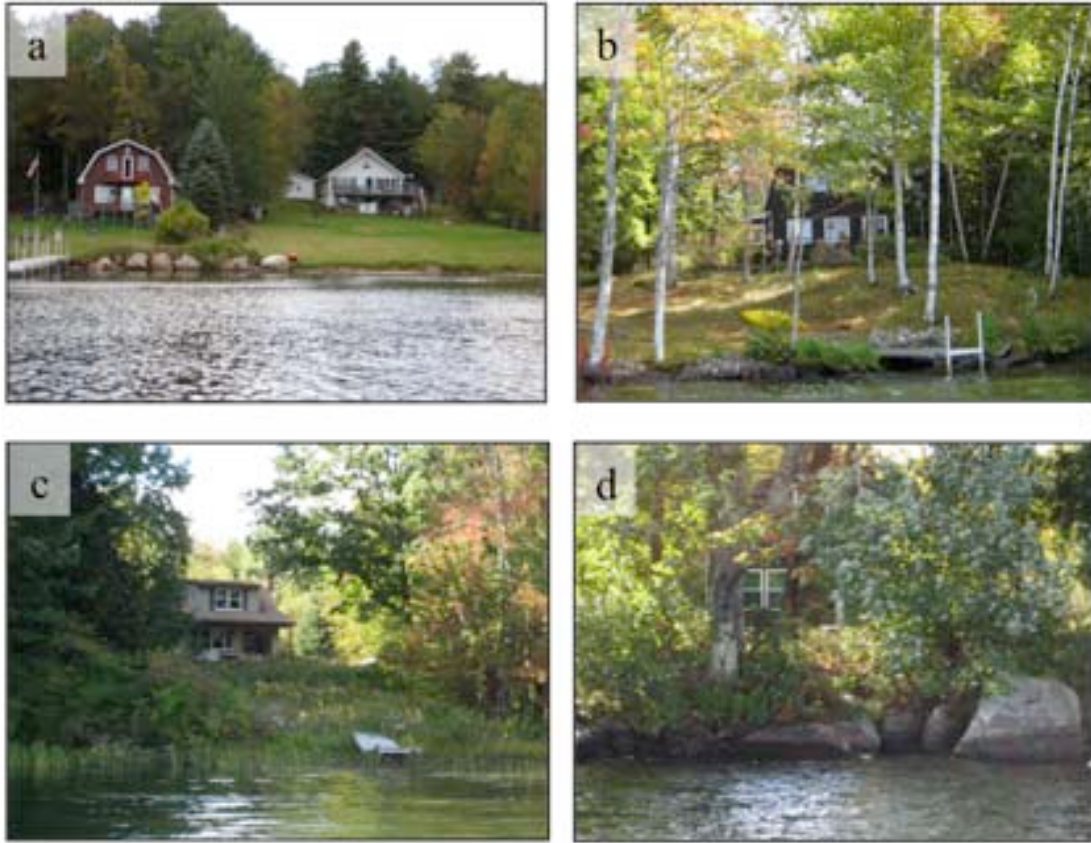
**Figure 13. Examples of a lot from each of four buffer quality categories on Salmon Lake and McGrath Pond. (a) Poor - sloping lawn stretches all the way to the shore. (b) Fair - lacks a shrub layer and has low vegetation density. (c) Adequate - dense, uninterrupted layer of herbaceous vegetation. (d) Excellent - dense layer of trees, shrubs and herbaceous plants between the building and the lake. Photos from CEAT shoreline survey conducted on 24-September-09 (see Appendix D).**

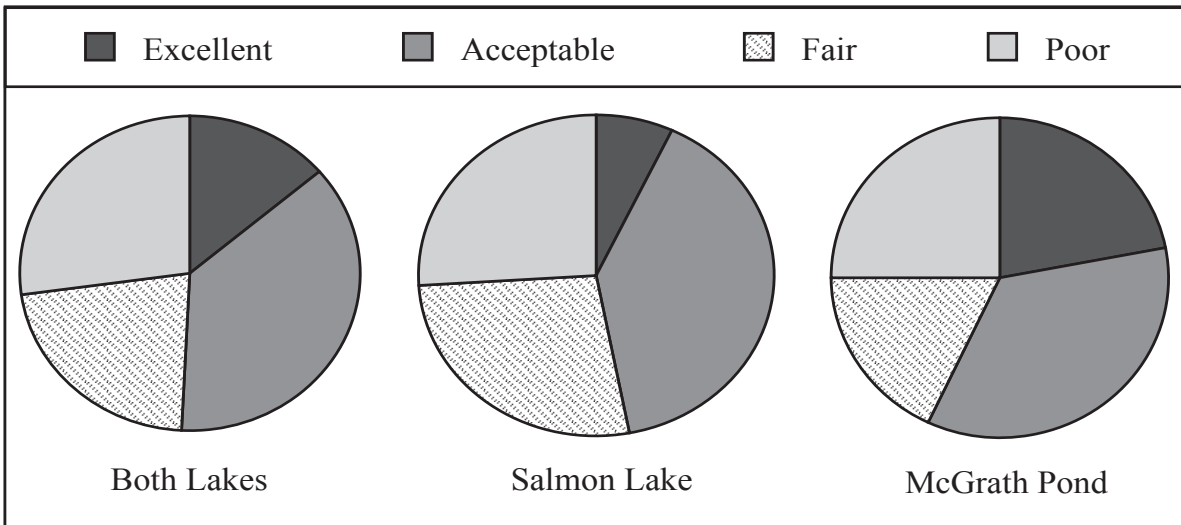
**Figure 14. Percent of lots in each buffer quality category for both Salmon Lake and McGrath Pond combined and for each lake individually. Data were collected in the shoreline survey conducted by CEAT on 24-September-09 (see Appendix D).**

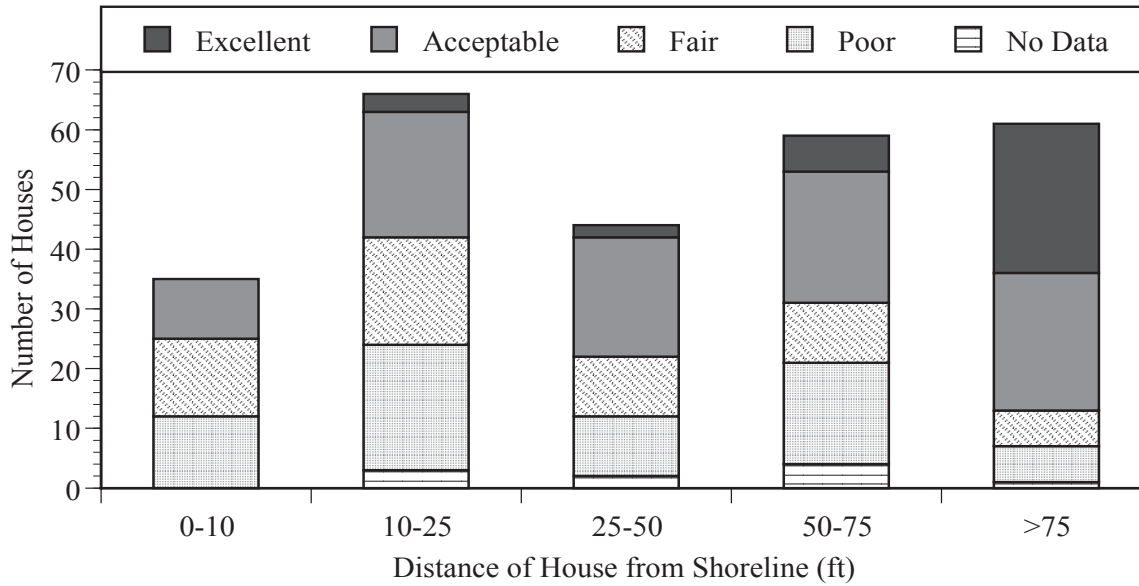
**Figure 17.** The distribution of house distances from the shoreline along Salmon Lake and McGrath Pond, as estimated during the CEAT shoreline survey conducted on 24-September-09 (see Appendix D). The proportion of houses in each distance category assigned a specific buffer quality rating is shown.

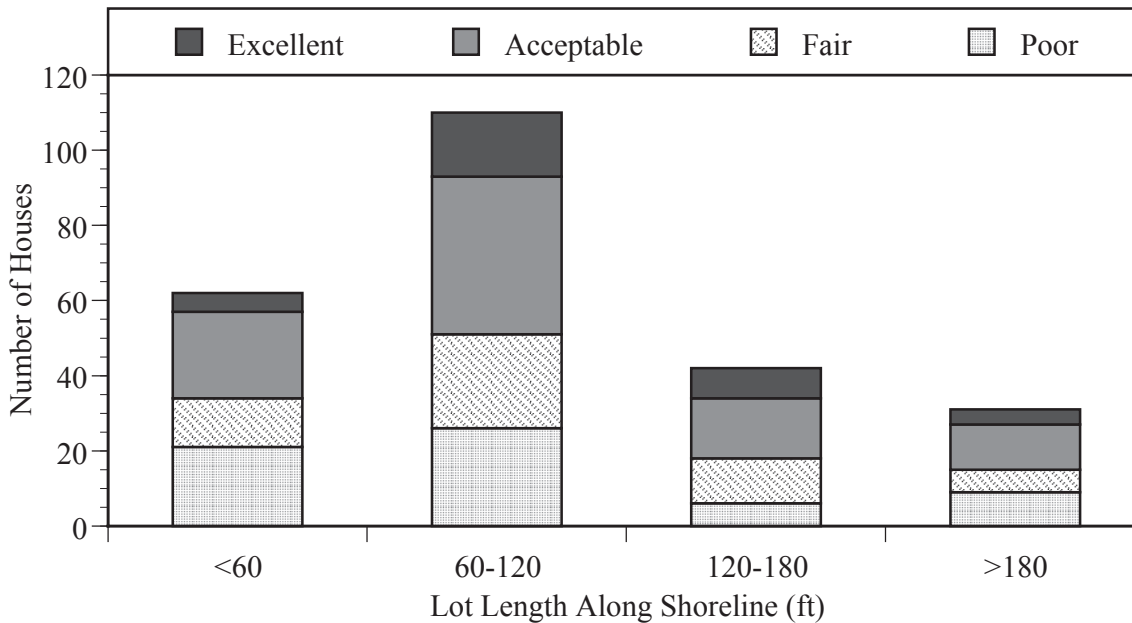
**Figure 18.** The distribution of lot length along the shoreline for Salmon Lake and McGrath Pond, as estimated during the CEAT shoreline survey conducted on 24-September-09 (see Appendix D). The proportion of houses in each lot length category assigned a specific buffer quality rating is shown.

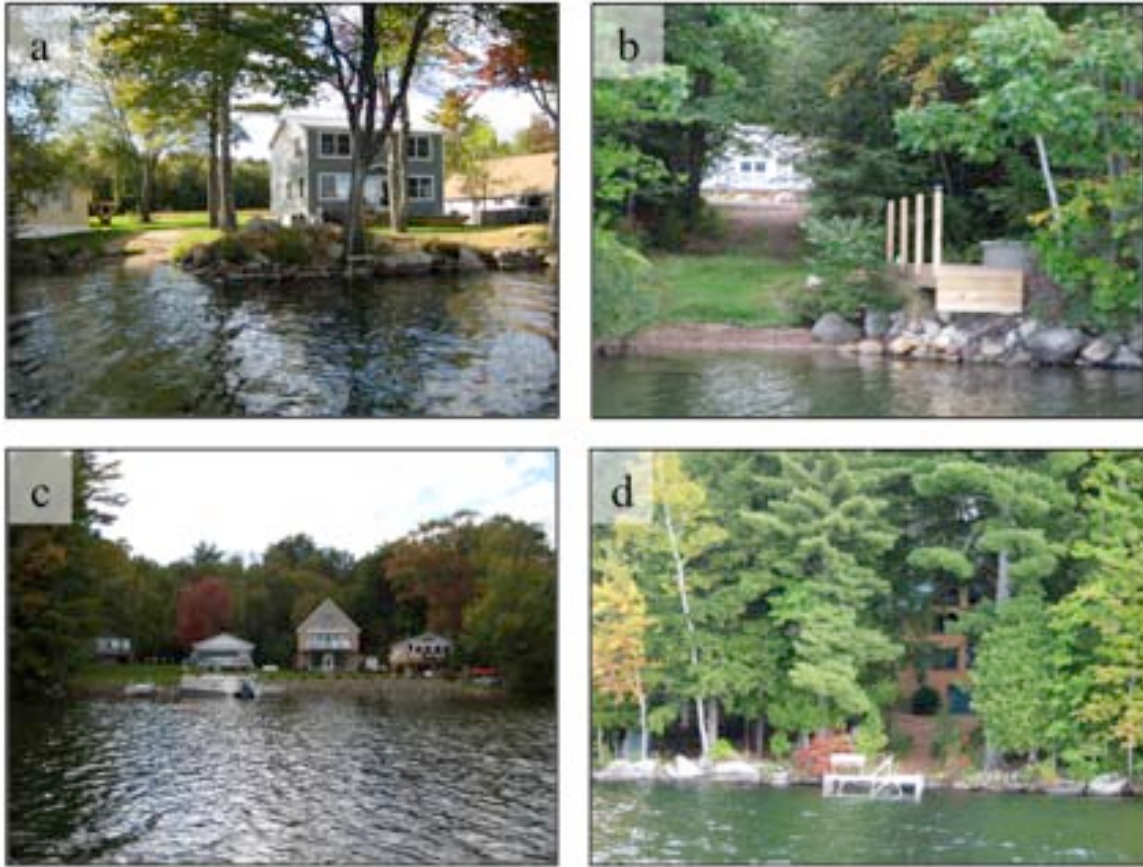
**Figure 19. Examples of potential problem areas along the shorelines of Salmon Lake and McGrath Pond. (a) Private boat launch, which can provide a conduit for runoff to enter the lake. (b) Private boat launch connected to a steep uphill road where runoff can flow from the house directly in the water with no impediments. (c) Short lot lengths with houses close together, which may result in concentrated nutrient loading. (d) Straight path from the house to the shore. Photos from the CEAT shoreline survey conducted on 24-September-09 (see appendix D).**

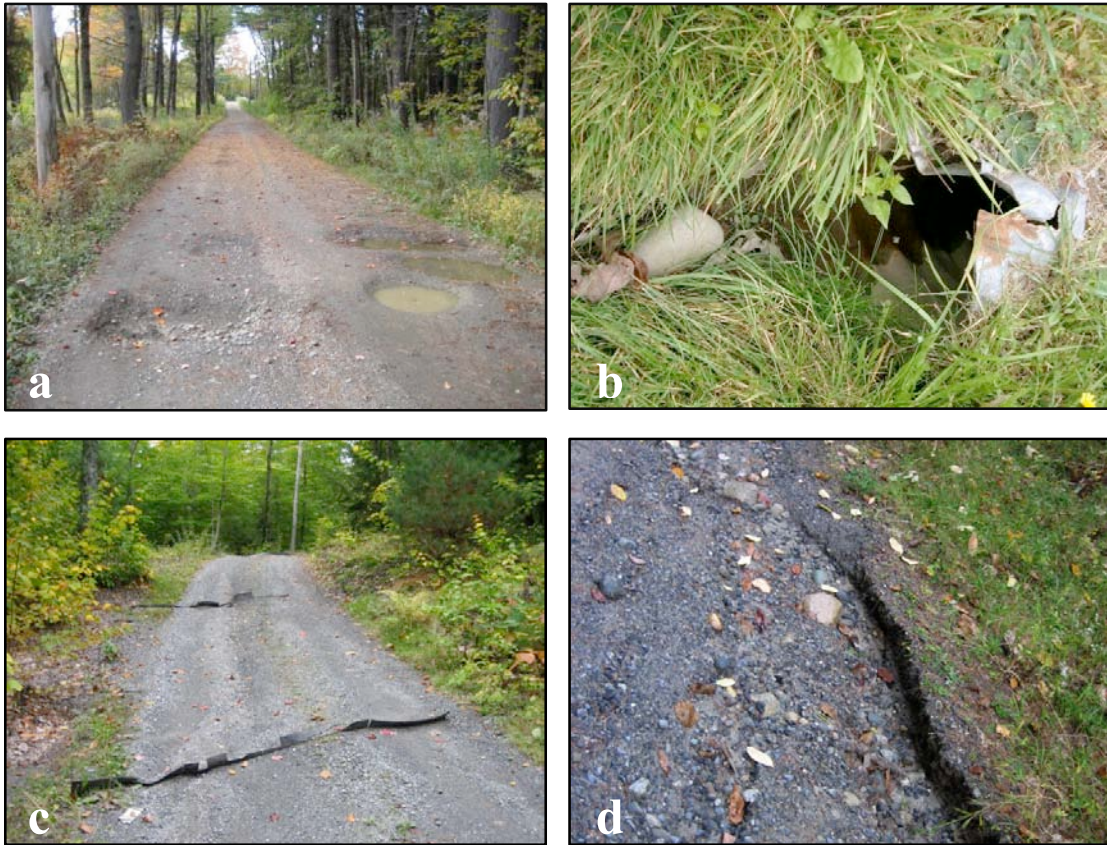
**Figure 23. Examples of road problems in the Salmon/McGrath watershed. (a) A road with deep potholes. The road should be regraded to eliminate the potholes and improve crowning. (b) A culvert that is crushed and overtaken by grass. The culvert is also rusting. This culvert needs maintenance or replacement. (c) Rubber bars in disrepair. These rubber bars will not divert water properly and should be replaced. (d) A road with extensive erosion. Structures should be added to improve the removal of runoff from the road surface, such as rubber bars or ditches.**

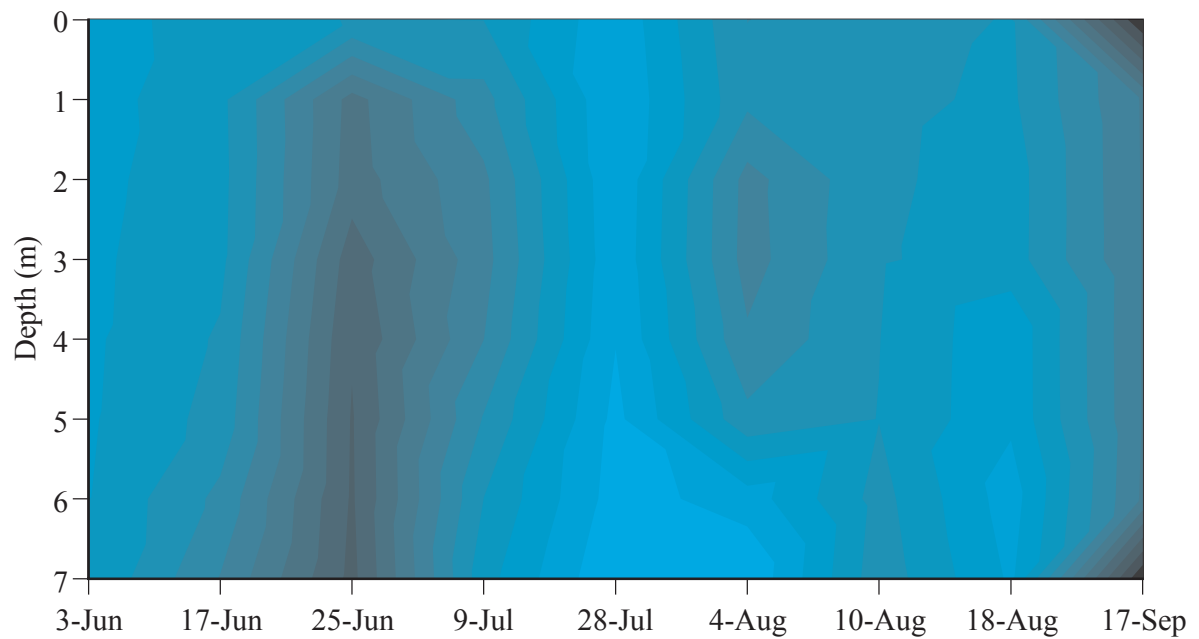
**Figure 30. Dissolved oxygen profile (mg/L) of Site 1 in Salmon Lake (top) and Site 3 in McGrath Pond (bottom) for summer 2009. Data collected by CEAT from June to September. See Figure 29 for site locations.**

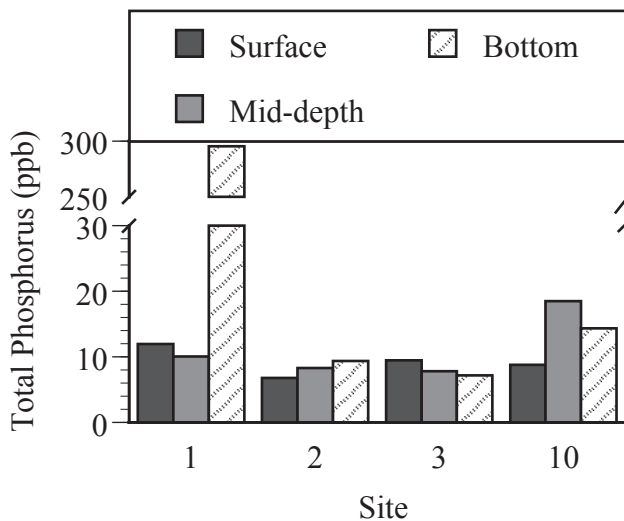
**Figure 46. Surface, mid-depth and bottom phosphorus concentrations (ppb) sampled on 17-September-09 for Sites 1 and 10 in Salmon Lake and Sites 2 and 3 in McGrath Pond. See Figure 29 for site locations.**

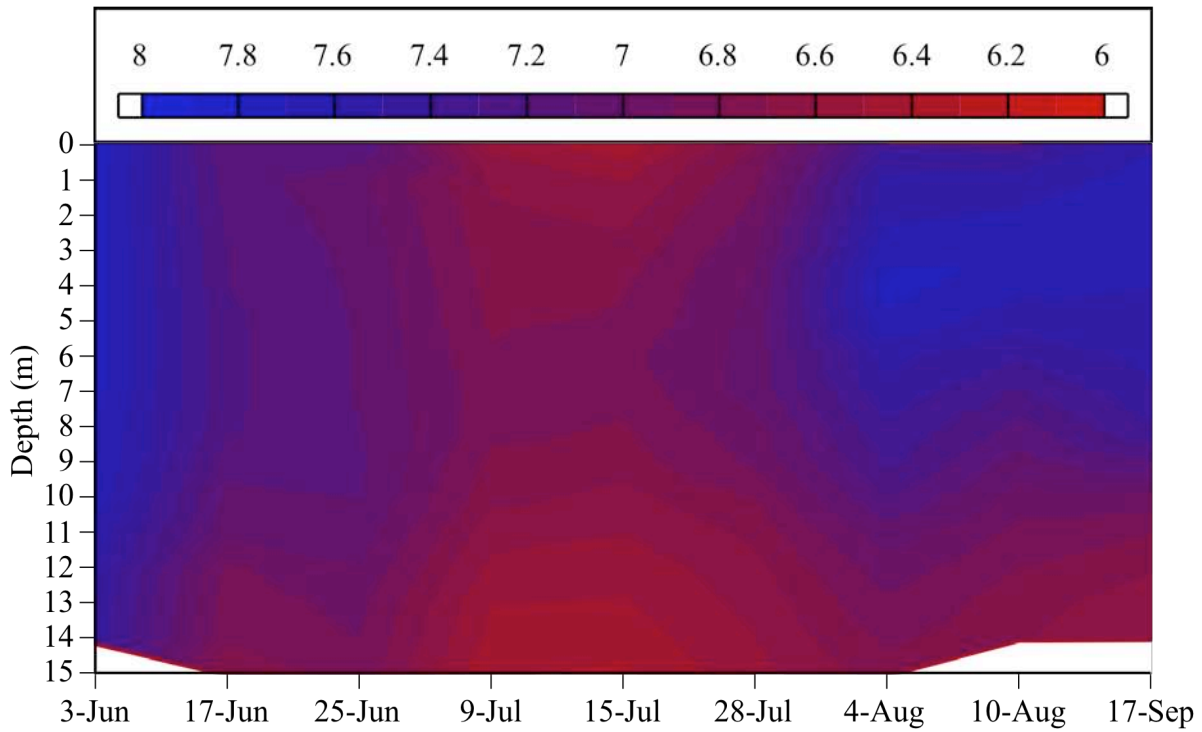
**Figure 50. pH depth profile for Site 1 (top) in Salmon Lake and Site 2 (bottom) in McGrath Pond from June-September 2009. See Figure 29 for site locations.**

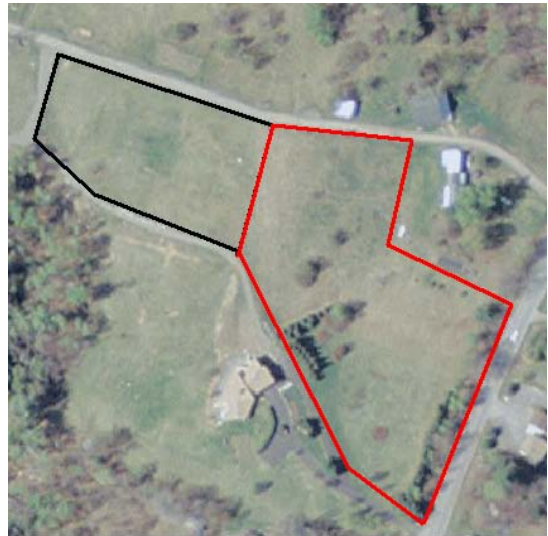
Current Fields (2007)  
Black = Grass Field  
Grey = Open Field

These two images depict the same location in the Salmon/McGrath watershed.
