## A Watershed Analysis of Threemile Pond: Implications for Water Quality and Land Use Management

Colby Environmental Assessment Team, Colby College

Problems in Environmental Science course (Biology 493), Colby College

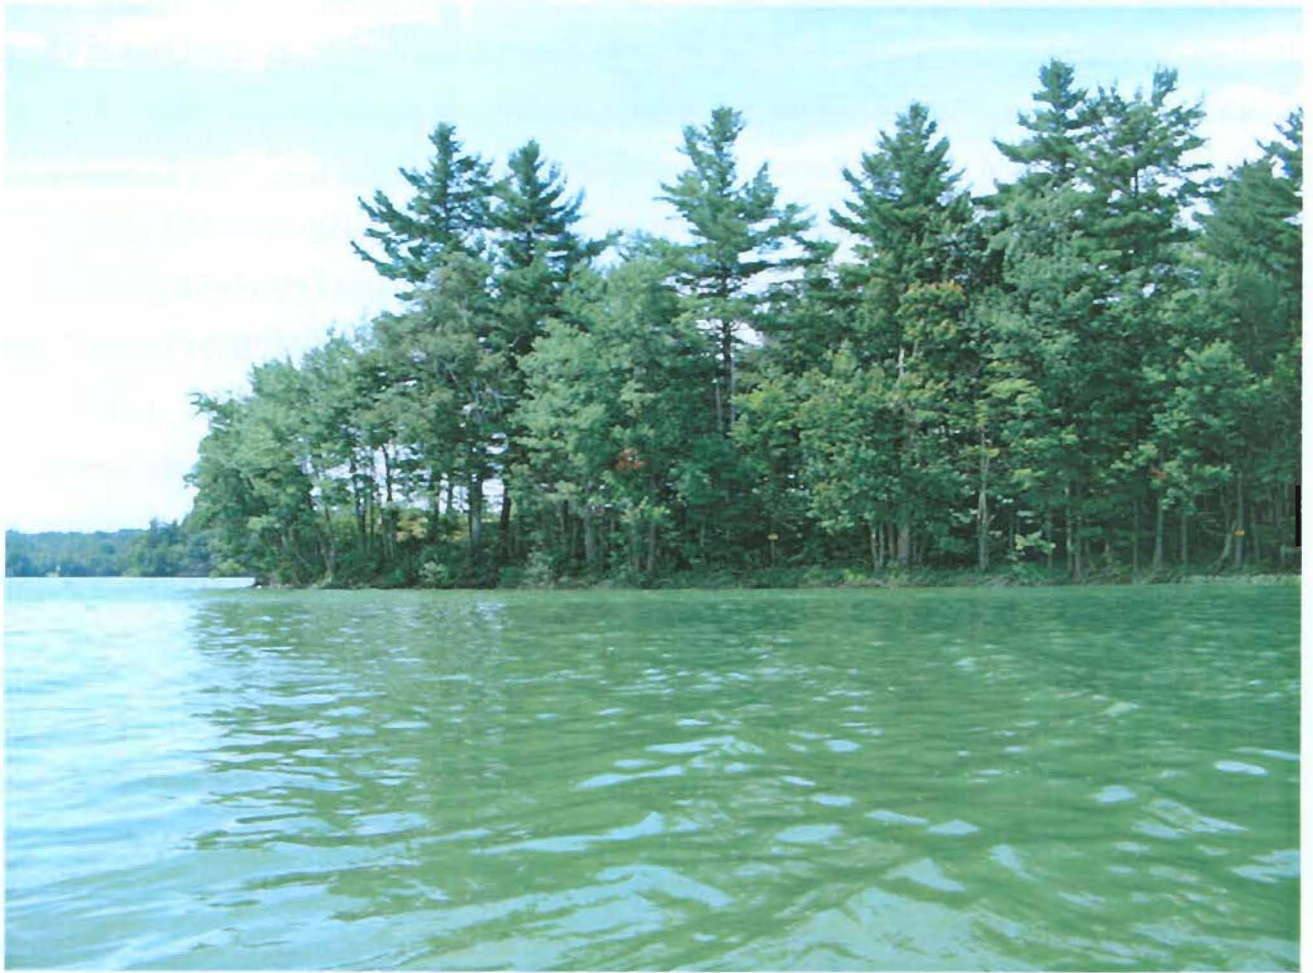
**Figure 18b. Threemile Pond 15-Aug-03 in full algal bloom.**

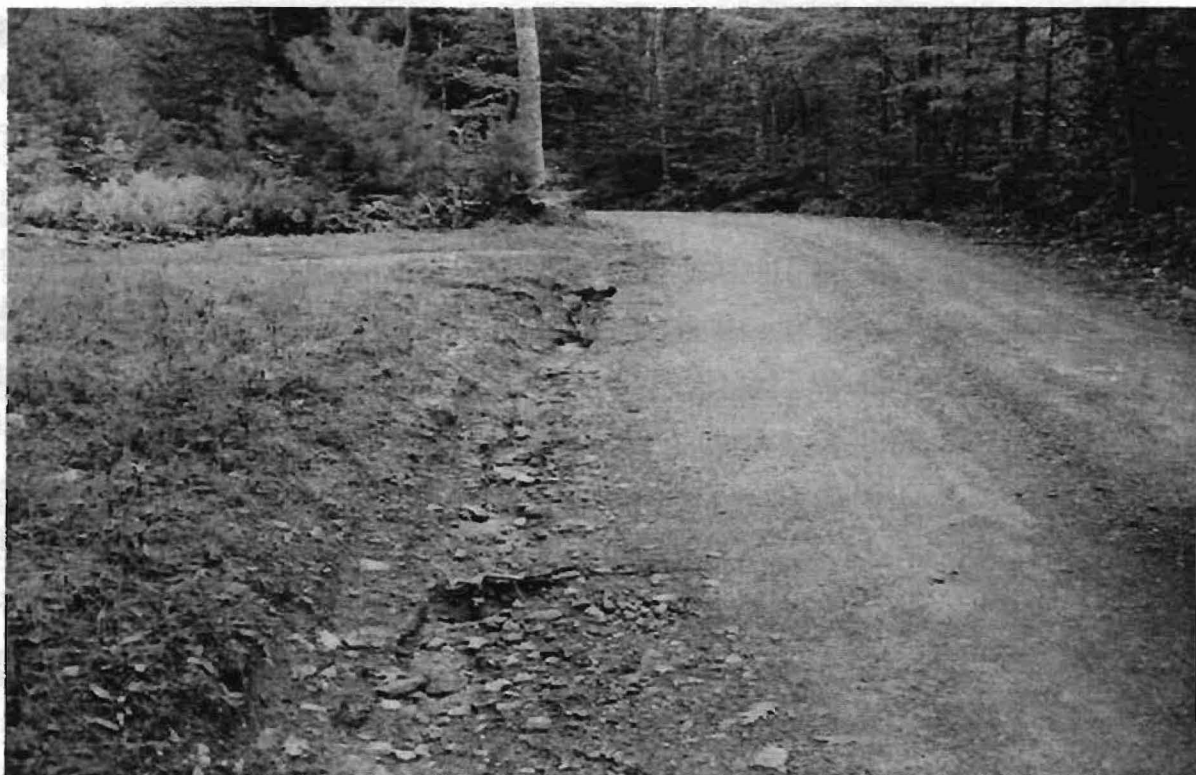
**Figure 35. This photograph illustrates the erosion that can result from runoff that is not properly diverted off the roadbed. Notice the berm that prevents water from flowing into the buffer area, and the lack of vegetation in the ditch to facilitate runoff absorption (BI 493 2003).**
