## A Watershed Analysis of Togus Pond: Implications for Water Quality and Land Use Management

Colby Environmental Assessment Team, Colby College

Problems in Environmental Science course (Biology 493), Colby College

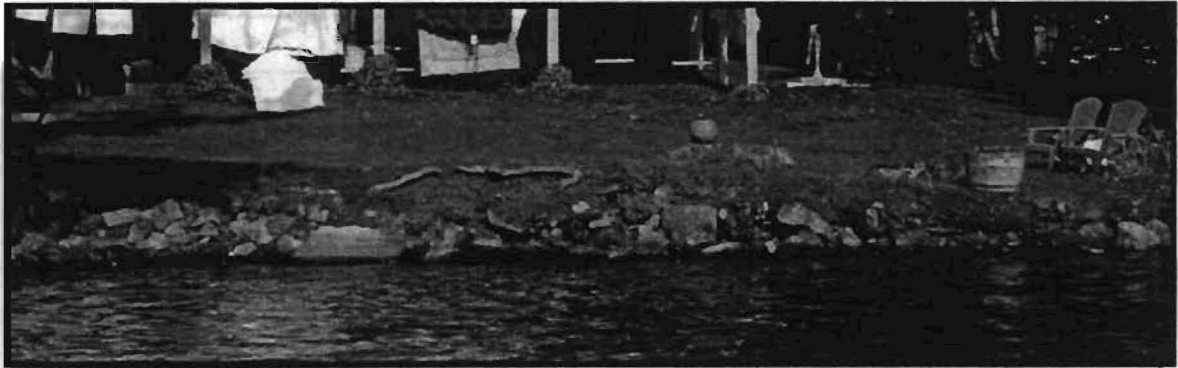
**Figure 47. Photo of a poorly buffered home receiving a failing score on the buffer strip survey. The buffer strip has been cut down, exposing bare dirt to the elements. There is no buffer depth or coverage along the shoreline, in addition, there is no plant life along the shore. There is also very little rip rap. Overall, this shoreline is very susceptible to erosion.**

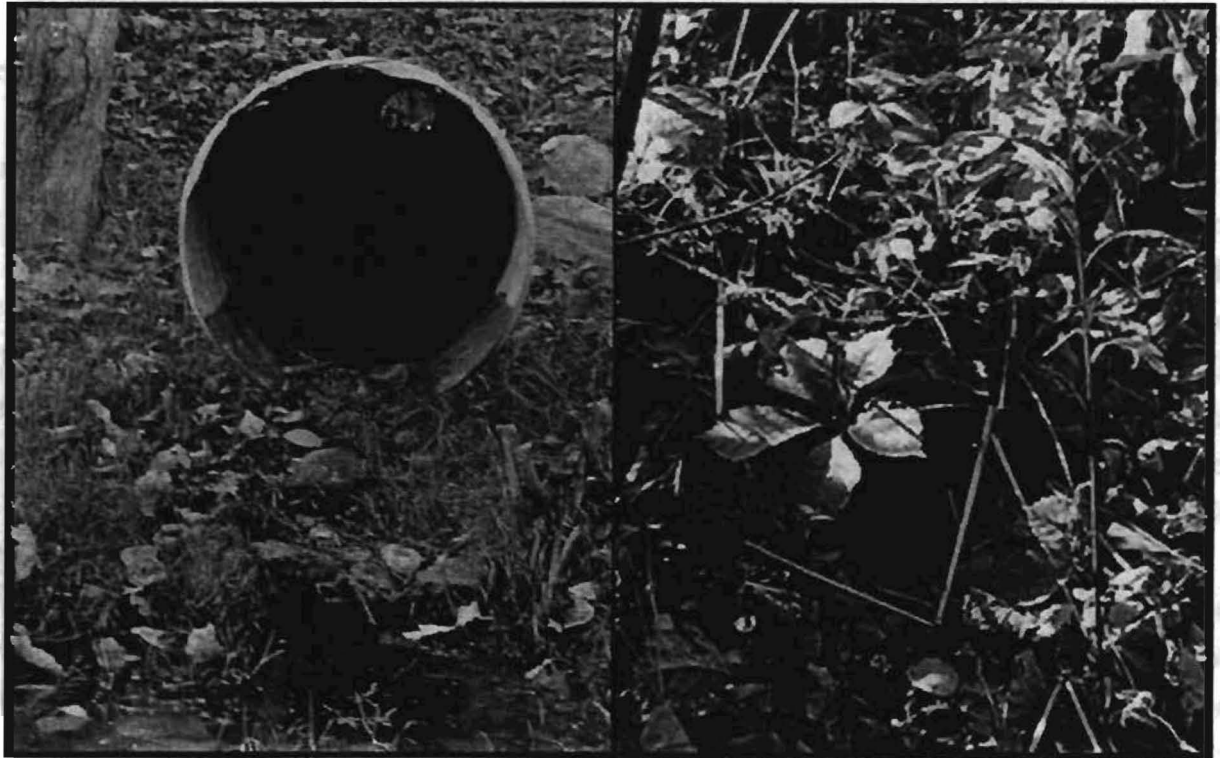
**Figure 50.** On the left, a properly maintained culvert. The culvert is free of debris and is large enough to accommodate excess volumes of water during storms. On the right, an improperly maintained culvert. This culvert is completely overgrown and filled with debris. There is no way for water to move in or out, which can cause water to back up and flood over roads into lawns.
