## An Analysis of East Pond and the Serpentine Watersheds in Relation to Water Quality

Problems in Environmental Science course (Biology 493), Colby College

# **AN ANALYSIS OF EAST POND AND THE SERPENTINE WATERSHEDS IN RELATION TO WATER QUALITY**

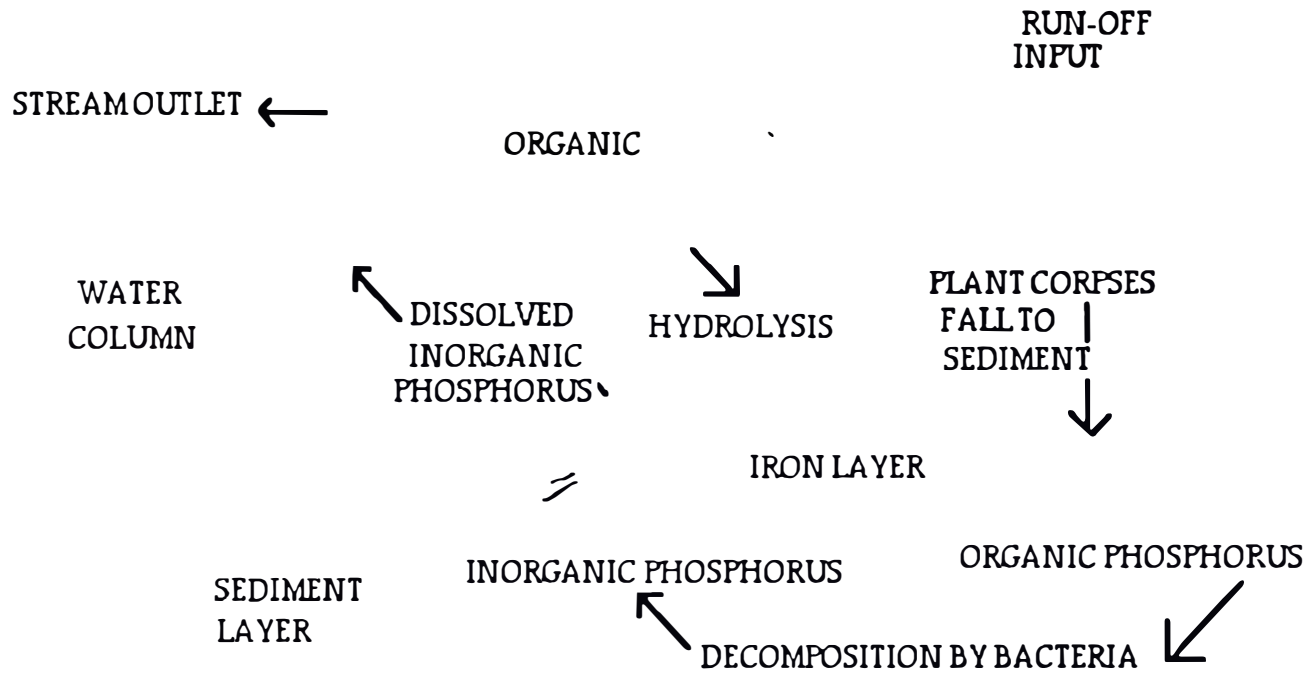
Figure 5. The total phosphorus cycle in a lake ecosystem: phosphorus inputs, internal recycling of phosphorus between the sediments and the water column, and phosphorus outputs.

Phosphorus found in the sediments and water column of a lake interact in a natural cycle which maintains the water quality of a lake ecosystem (Figure 5). Phosphorus in a lake exists in a biologically unavailable organic form and a transitory, available inorganic form. The sum of the two forms of phosphorus is termed the total phosphorus concentration. Phosphorus is recycled from the sediment back into the water column where it is available for organismal metabolism. Phosphorus returns to the sediment when organisms decompose. The cycle is fed by concentrations of phosphorus from precipitation, springs, groundwater seepage, human or industrial impact, and streams. Outlet streams carry phosphorus out of the lake ecosystem.

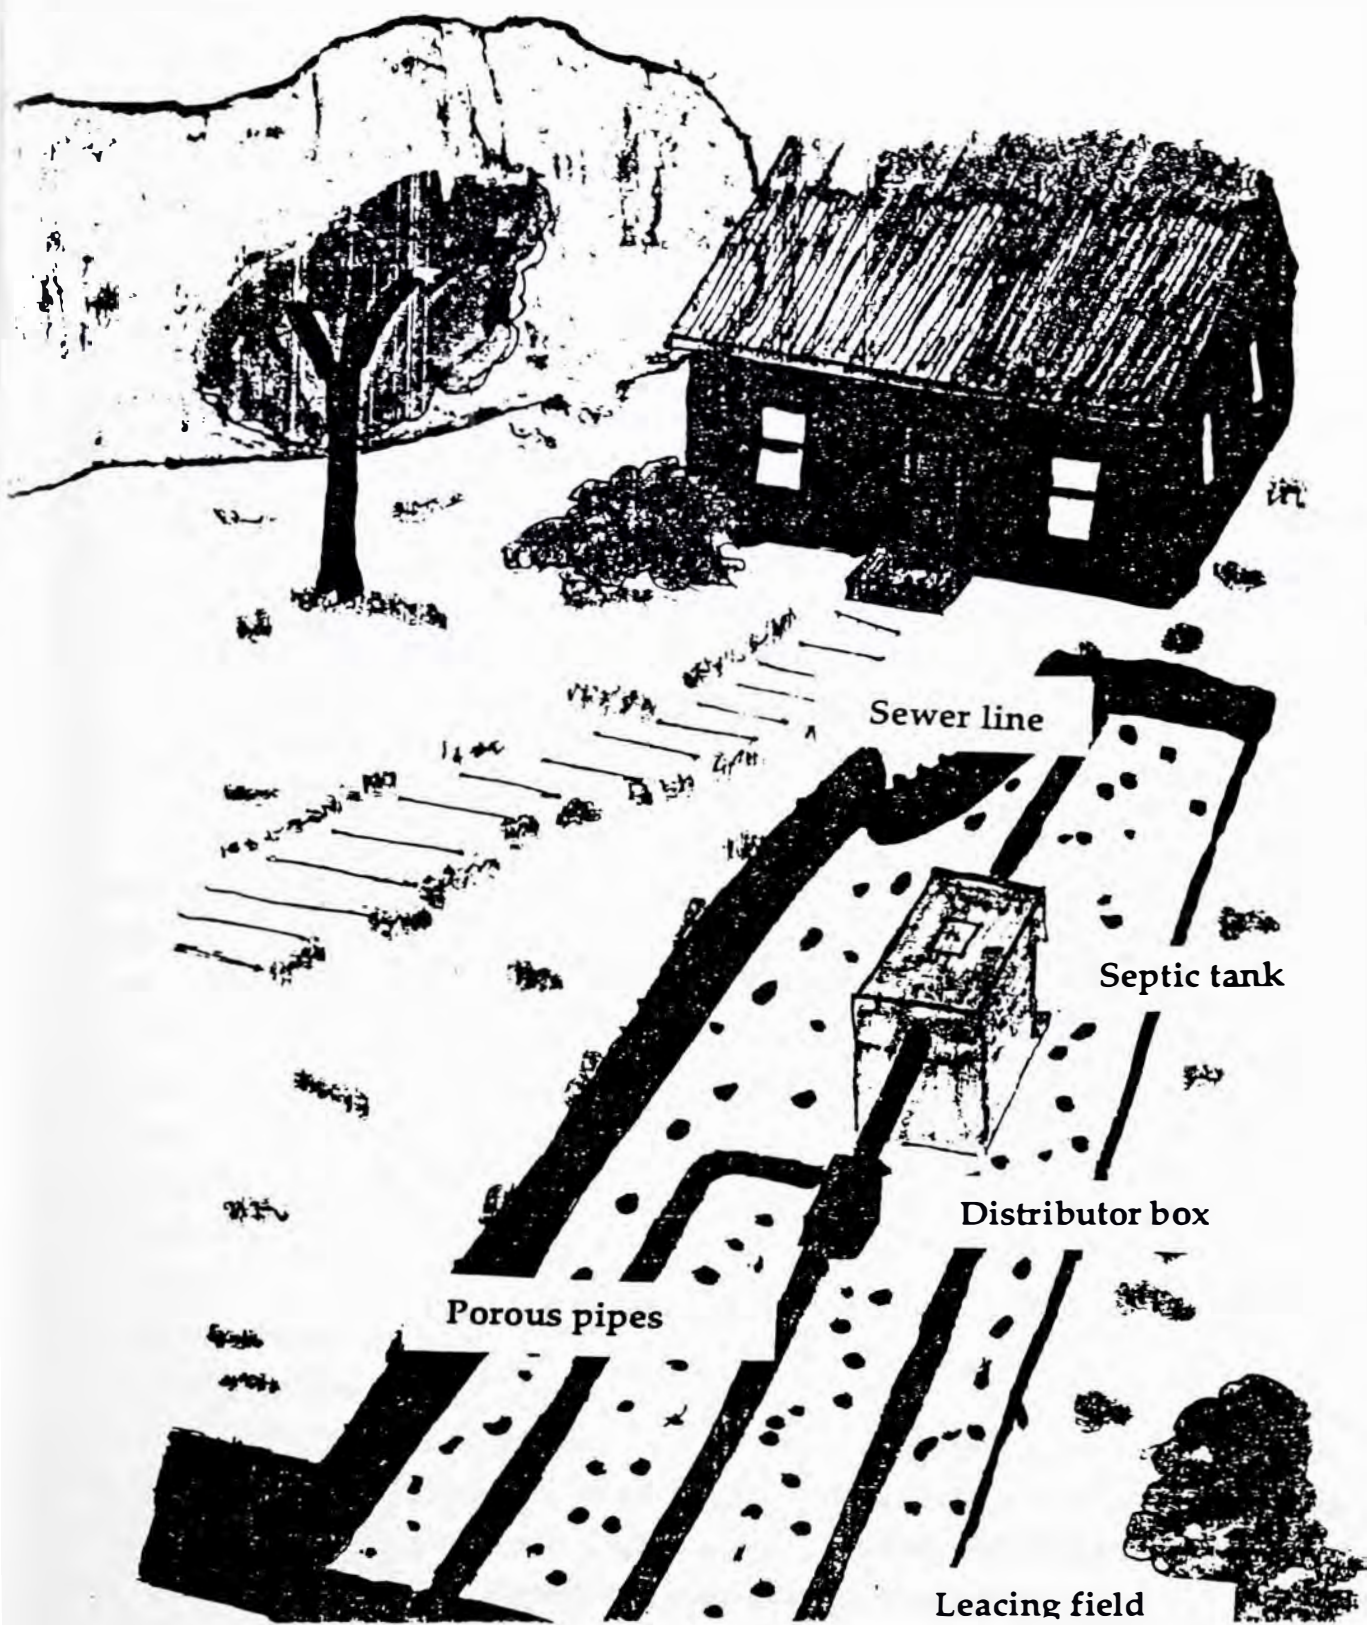
Figure 12. Diagram of Septic System

Three major types of waste components comprise the septic tank and holding tank receiving water: garbage disposal wastes, black water, and grey water (Mitchell, 1974). Each type of waste contributes various amounts of nutrients and microorganisms to the system. Garbage disposal wastes (ground up garbage from a disposal system) are deposited in septic and holding tanks. This type of waste tends to put an unnecessary strain on septic systems (COLA, 1991). A second type of waste is black water which consists of toilet wastes contributing nitrogen, phosphorus, and microorganisms from human excreta. The third major

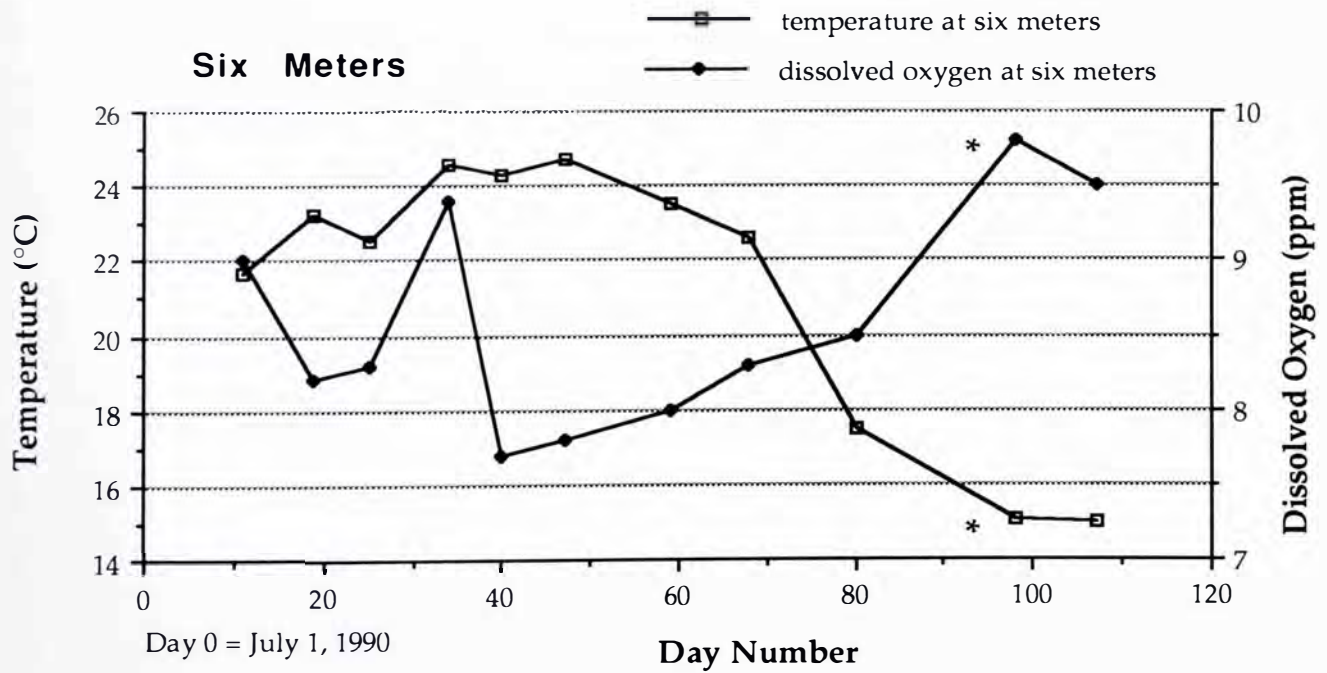
Figure 17. Temperature and dissolved oxygen levels taken in 1990 by the East Pond Lake Association at the surface and at a depth of six m. Data points from the present study, taken Oct. 3, 1991, are indicated by an asterisk.

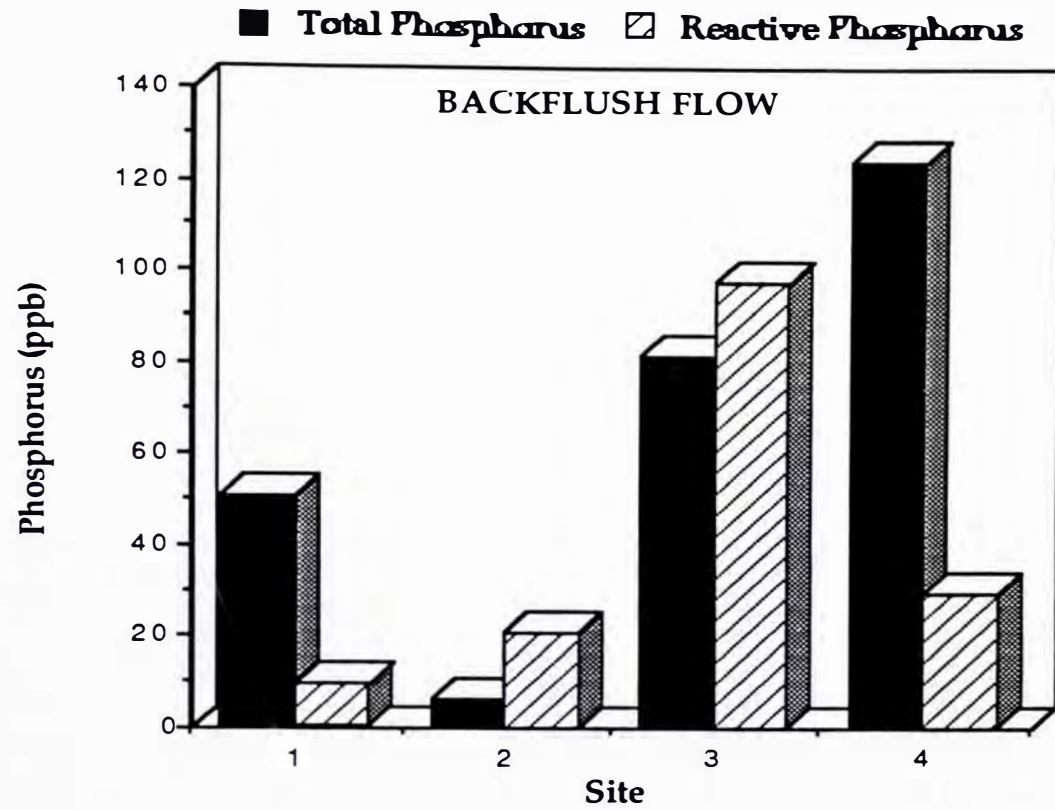
Figure 27. Backflush flow (Sept. 26) and normal flow (Oct. 10) sampling of the Serpentine Marsh study sites. Data expressed as total or reactive phosphorus.

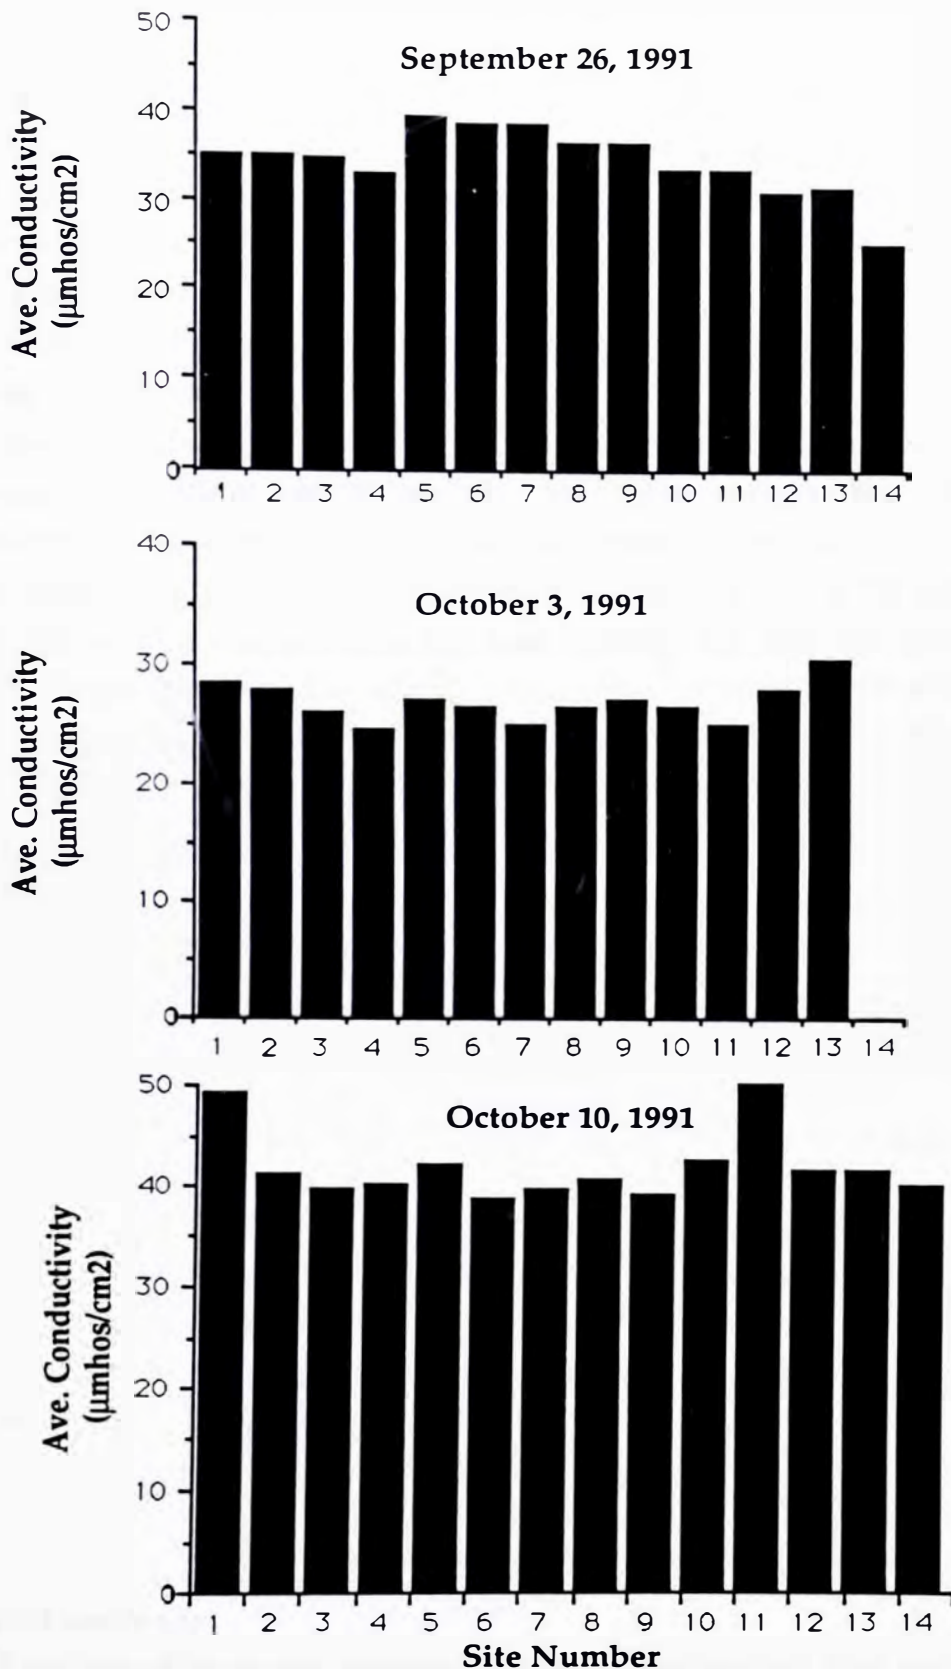
**Figure 33. Conductivity of the Serpentine Bog transect on Sept. 26, Oct. 3, and Oct. 10, 1991. The Sept. 26 graph represents average conductivity of the water flowing into East Pond at sites B-1 (marsh) through B-14 (mouth of the Serpentine), and the Oct. 3 and Oct. 10 graphs represent the average conductivity (of the surface & sediment readings) of the water flowing into and out of East Pond. No samples were taken from site B-14 on Oct. 3, 1991.**

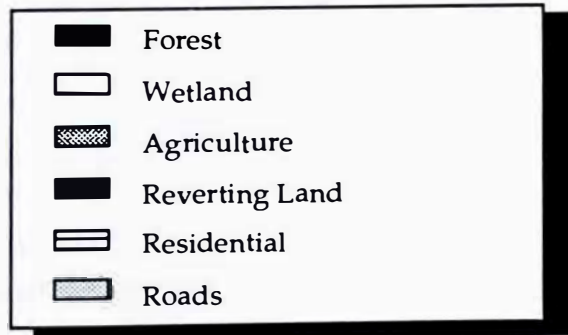
Figure 36. Comparison of general land use patterns for both East Pond and Serpentine Watersheds between 1965 and 1991.

The land use patterns for the East Pond and Serpentine watersheds in 1965 and 1991 enable comparison between years and watersheds. The area of the East Pond watershed (1,087.8 ha) is smaller than the Serpentine watershed (1,596.1 ha). The percent of wetlands remained stable over time in both watersheds (Figure 36). Residential land use increased over

Each of the six land use categories affect the water quality of East Pond to a varying degree (Figure 36). Wetlands provide a sink for nutrients which, if flooded may release nutrients into East Pond. It is crucial to understand this phenomenon because 14% of the Serpentine watershed consists of wetlands whereas only 3% of East Pond watershed is wetlands. During heavy rains on Sept. 25-26, as discussed previously, flow in the Serpentine Bog reversed causing the Serpentine to possibly feed East Pond with nutrients stored in the wetlands. The area of wetlands did not change significantly in either watershed from 1965 to 1991.

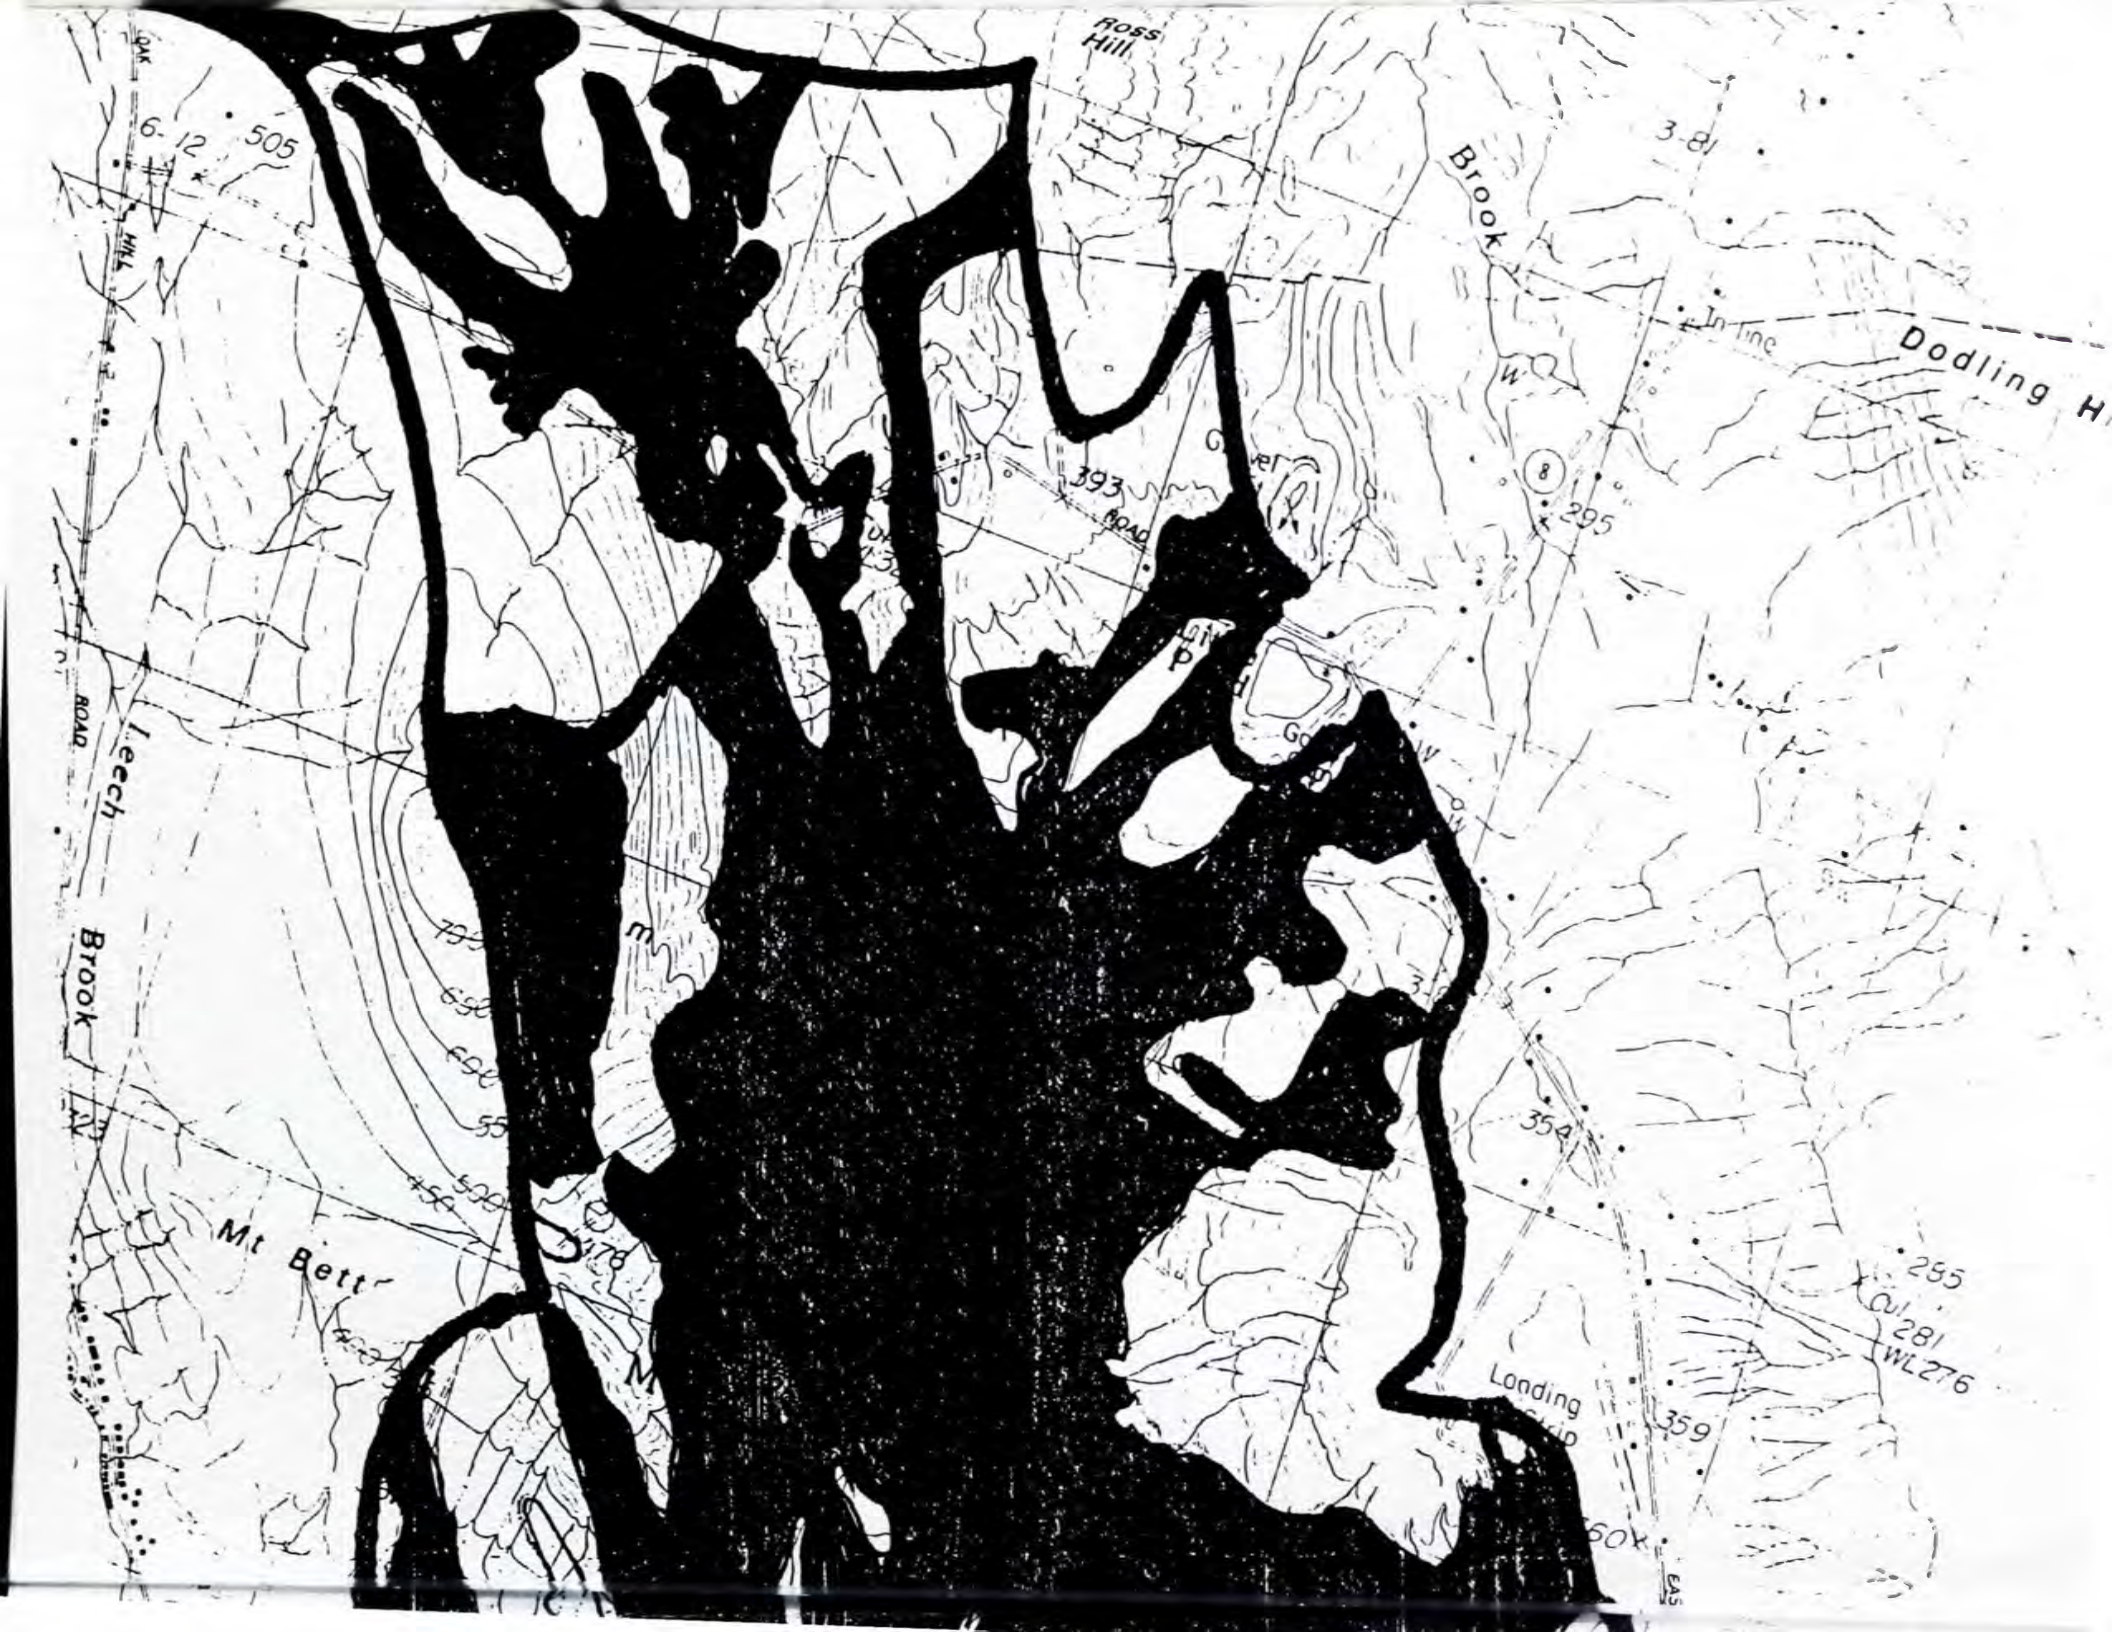
Figure 42. The shaded areas indicate soils located in the East Pond watershed with severe limitations to sewage effluent. 1982 USGS map, scale (1:16,000).

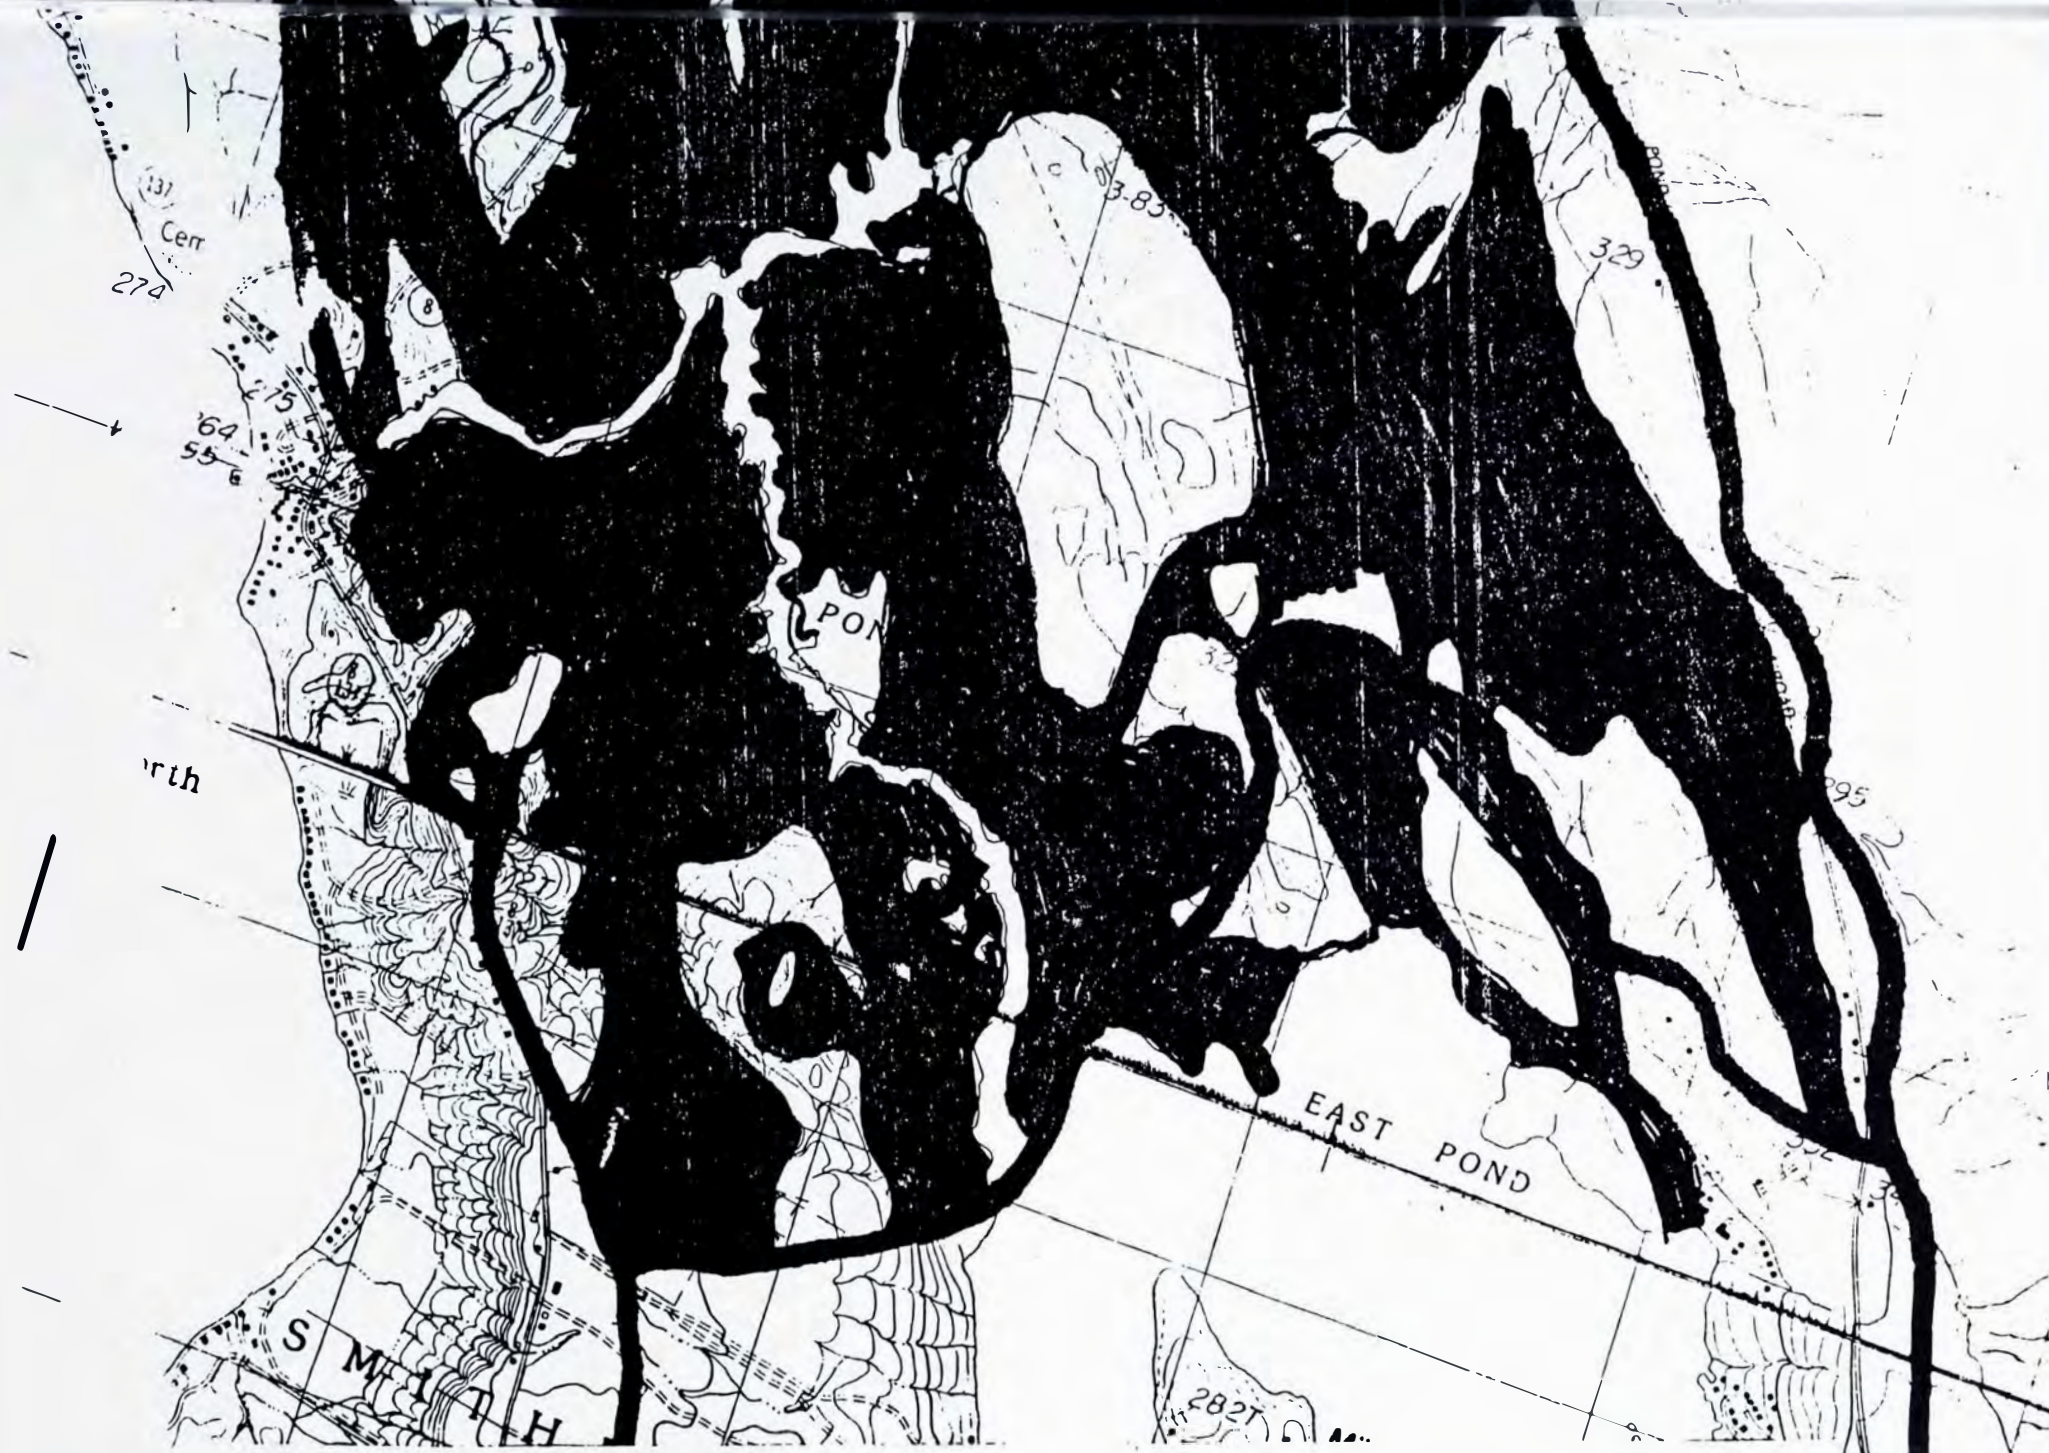
Figure 43. The shaded areas indicate soils located in the Serpentine watershed with severe limitations to sewage effluent. 1982 USGS map, scale (1:16,000).
