A Watershed Analysis of Long Pond South: Implications for Water Quality and Land-Use Management [Presentation]

A Watershed Analysis of Long Pond South

Implications for Water Quality
and Land-Use Management

Colby Environmental Assessment Team
December 6th, 2007

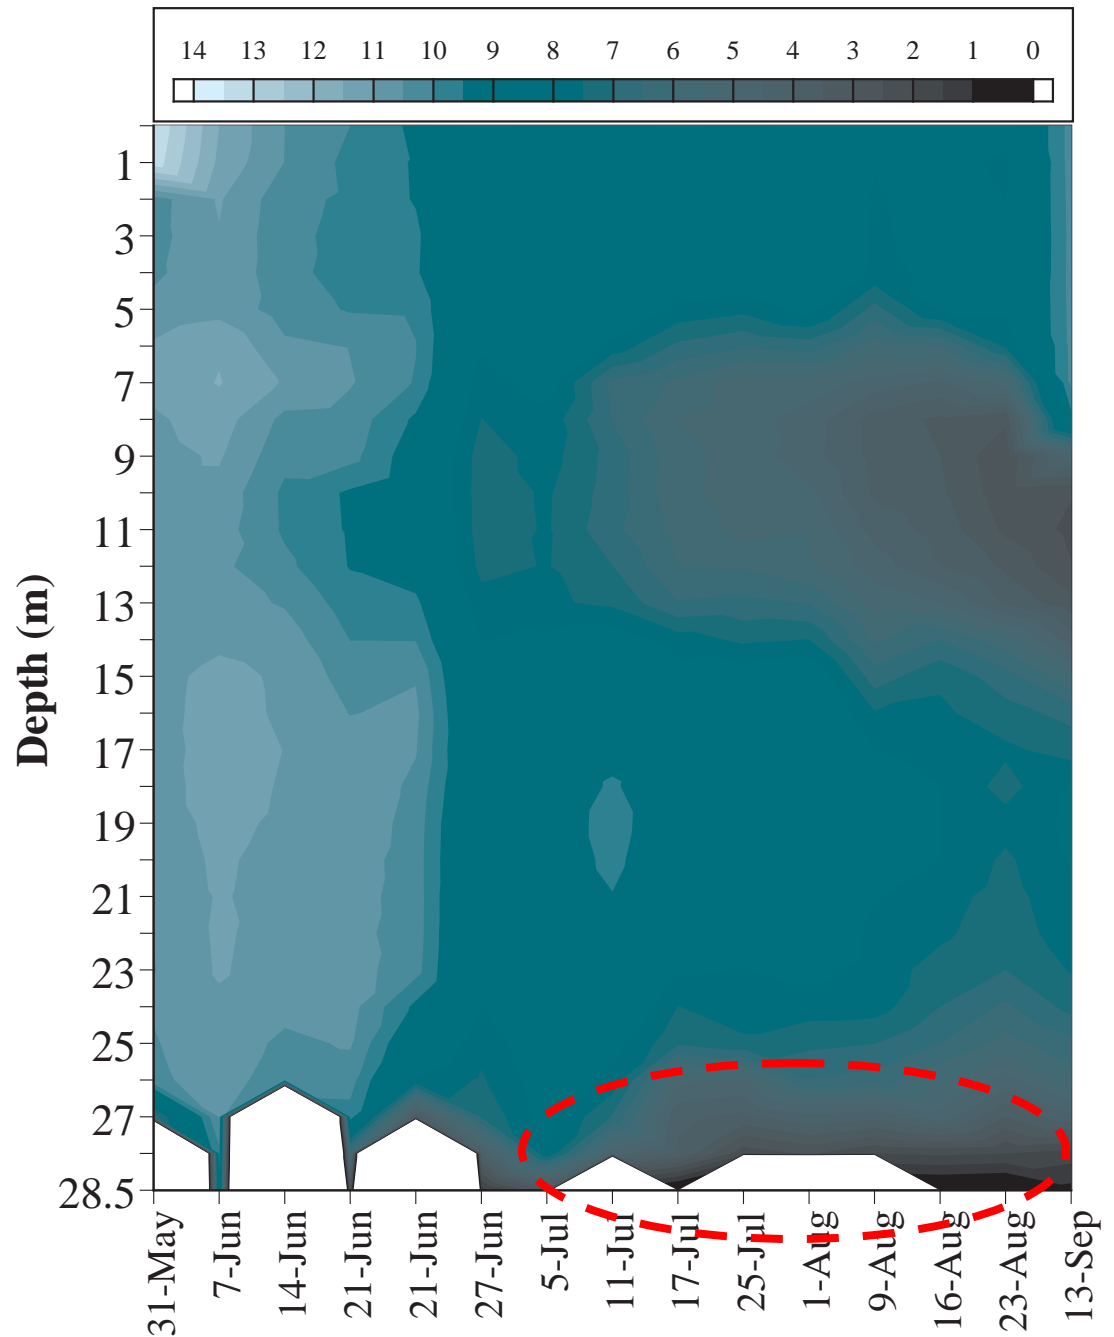
DO (ppm)

DO and Temperature

- Biological importance of DO
- DO: 1 ppm and 5 ppm
- As temp

- Profile at Site 1
- May to September 2007

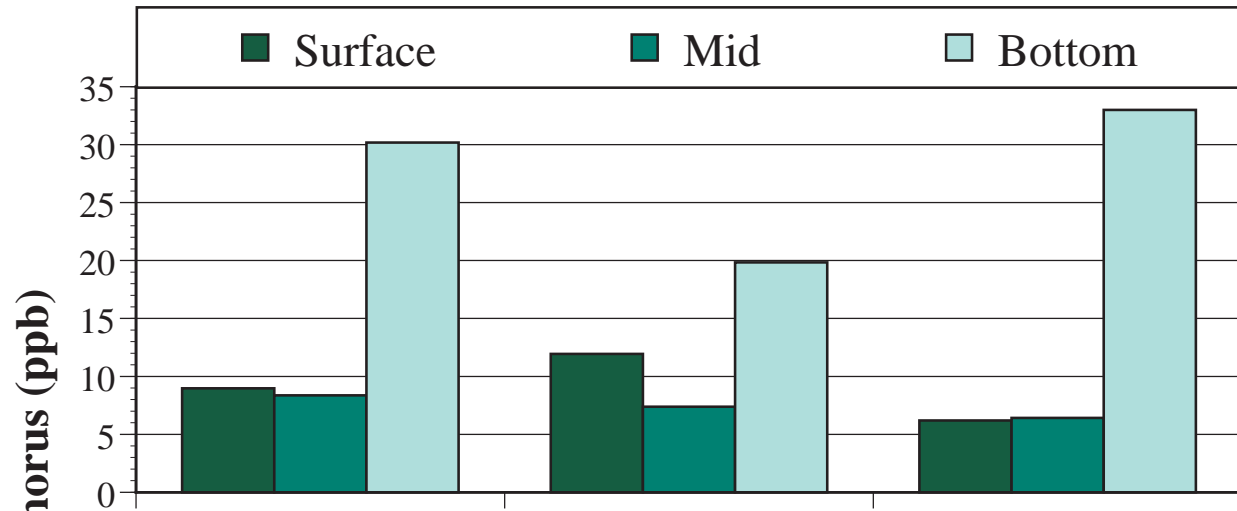
Site 1

Total Phosphorus

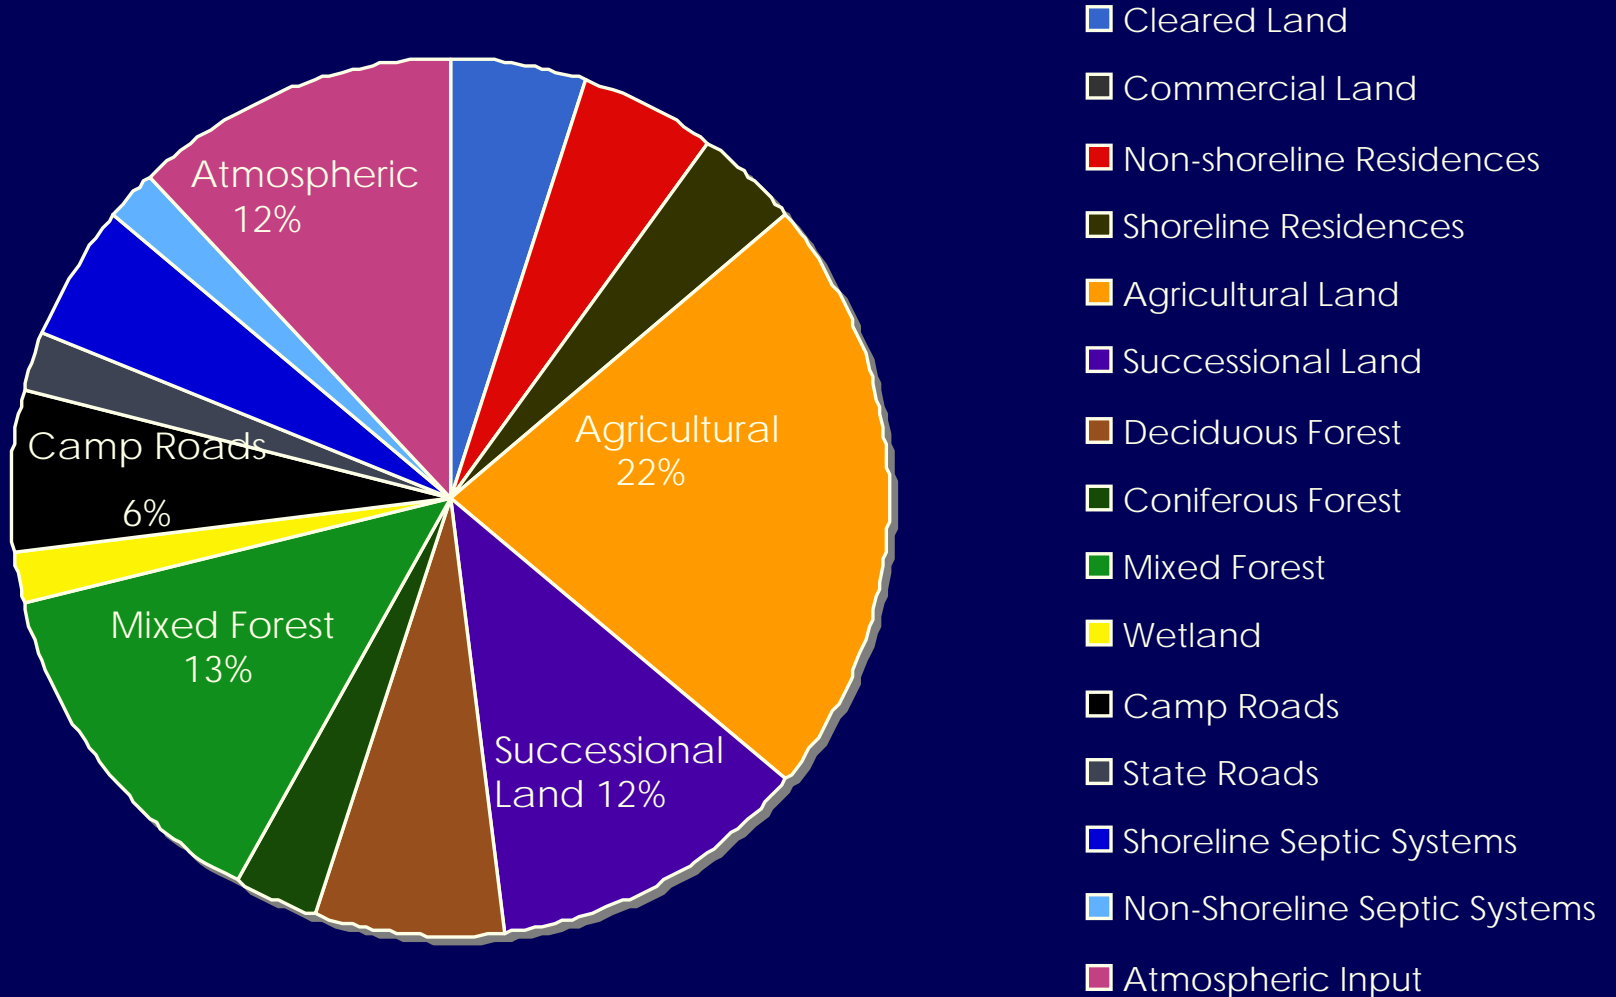
Runoff from Land-Use Types

Non-Point Source Input Within the Watershed

- 15 Land-Use Types
- Export Coefficients
- Percent contribution

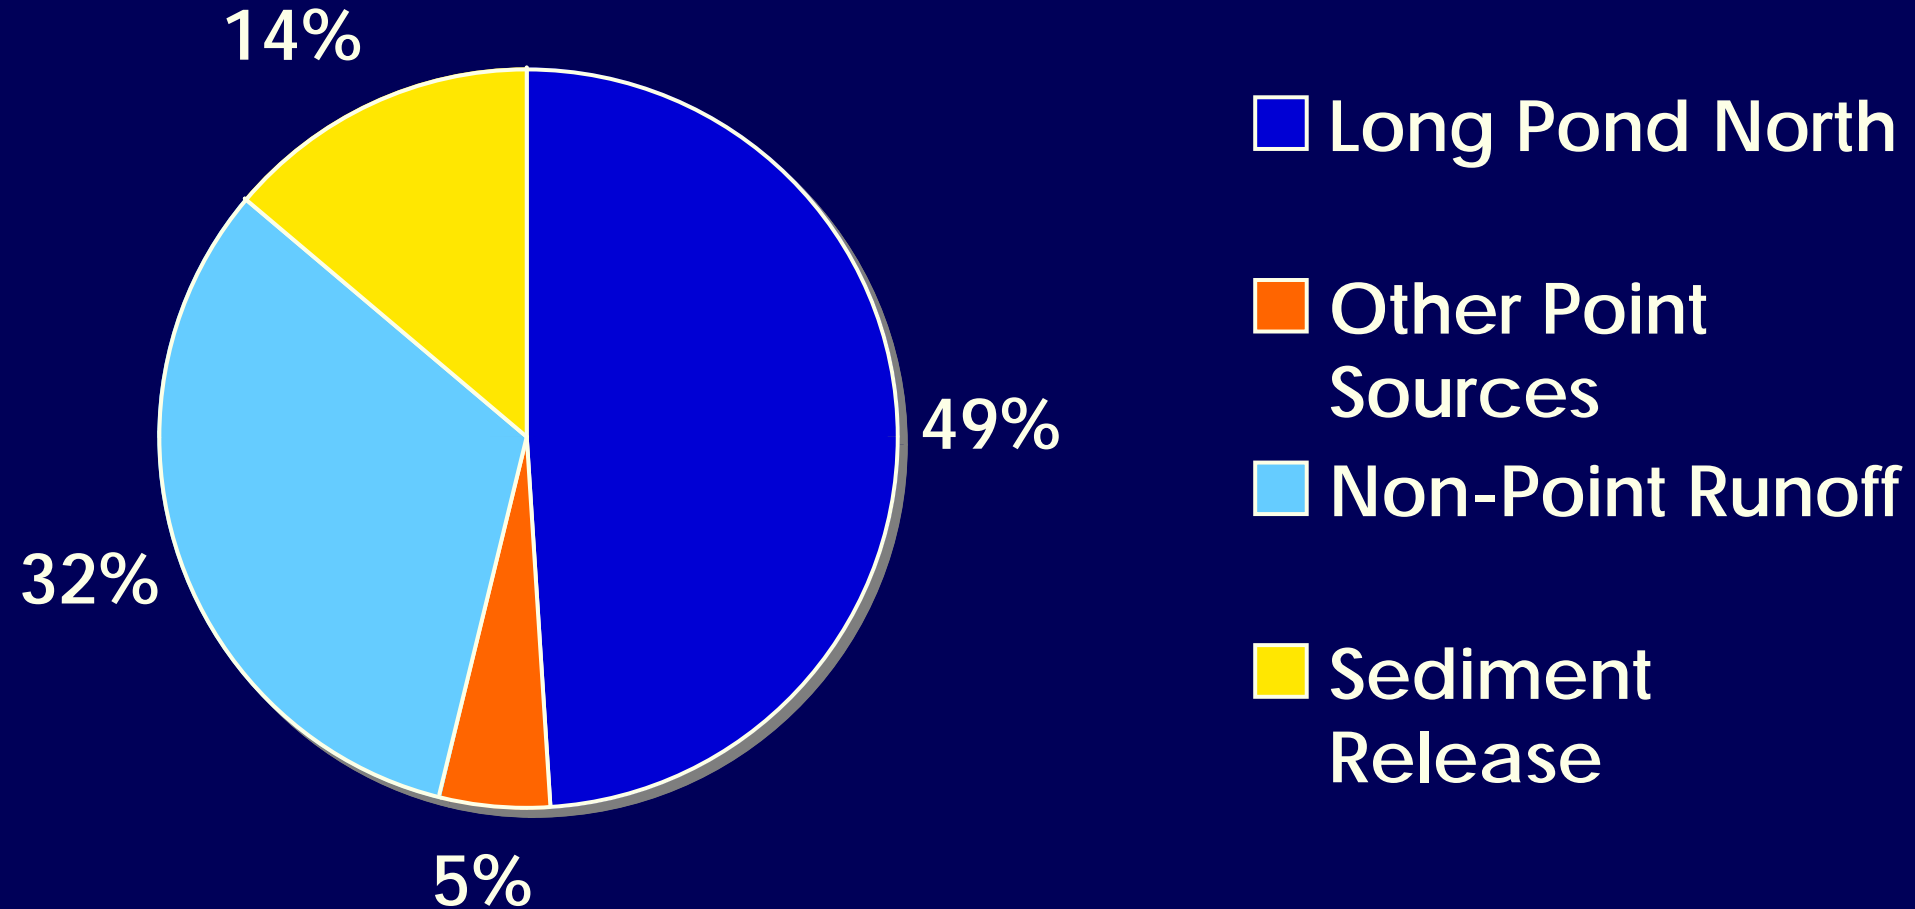
- Runoff 759 kg
- Point Sources 1,280 kg
- Sediment Release 324 kg
- Total Phosphorus Loading 2,363 kg

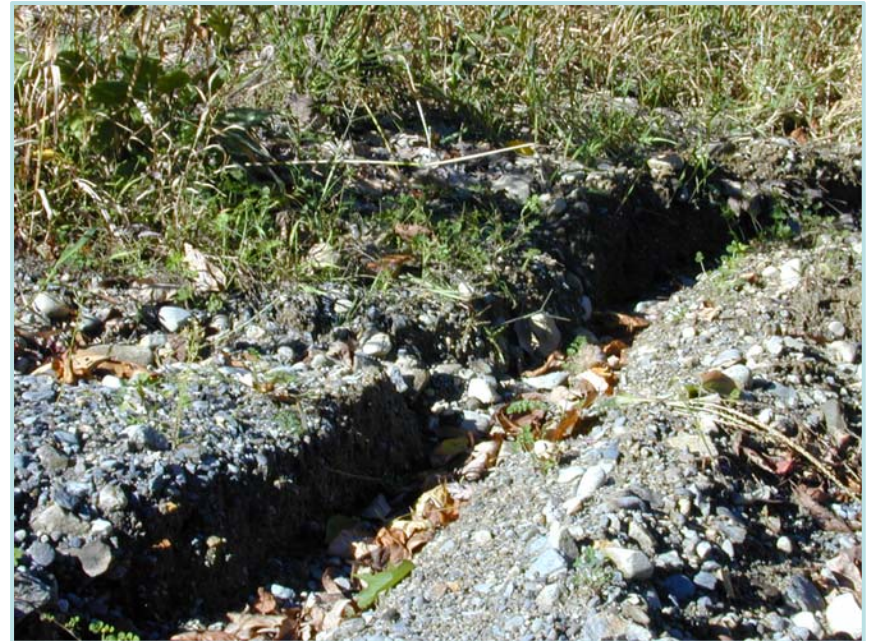
Example of erosion

- Erosion
 - Displacement of soil and organic matter
- Causes
 - Soil type, slope, and land-use
- Effects
 - Algal blooms, harmful to organisms

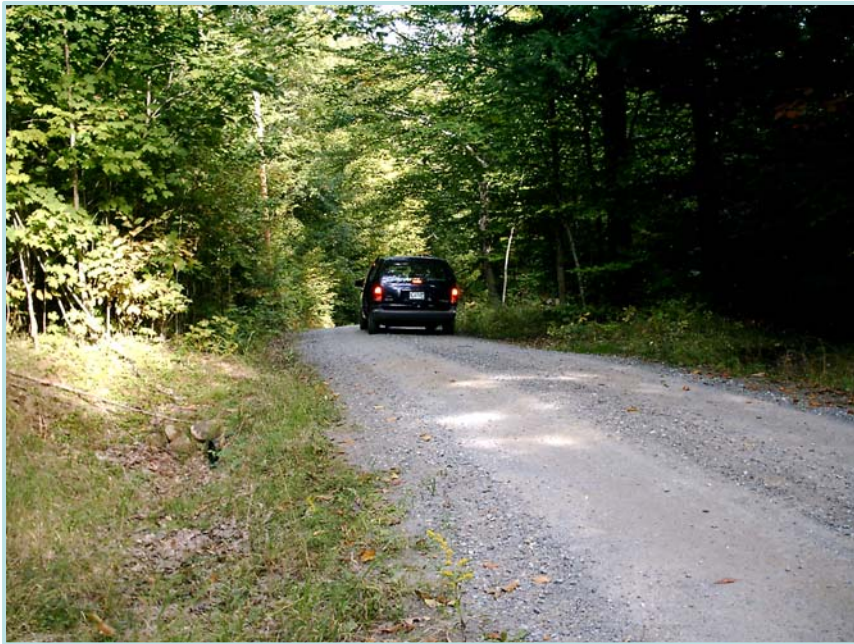
Proper Drainage: Essential in Preventing Pollution

Crowning, grading,
and ditching

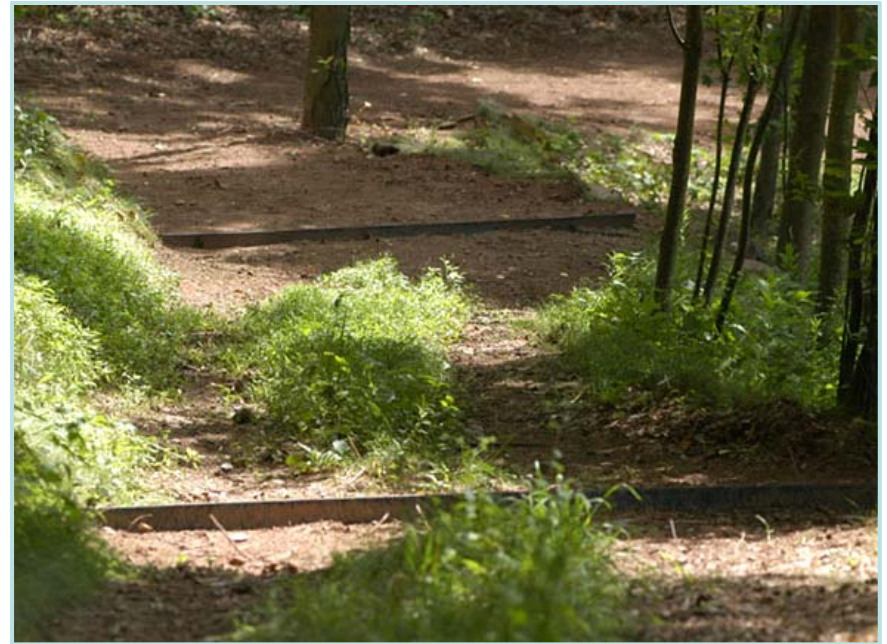
Rubber bar

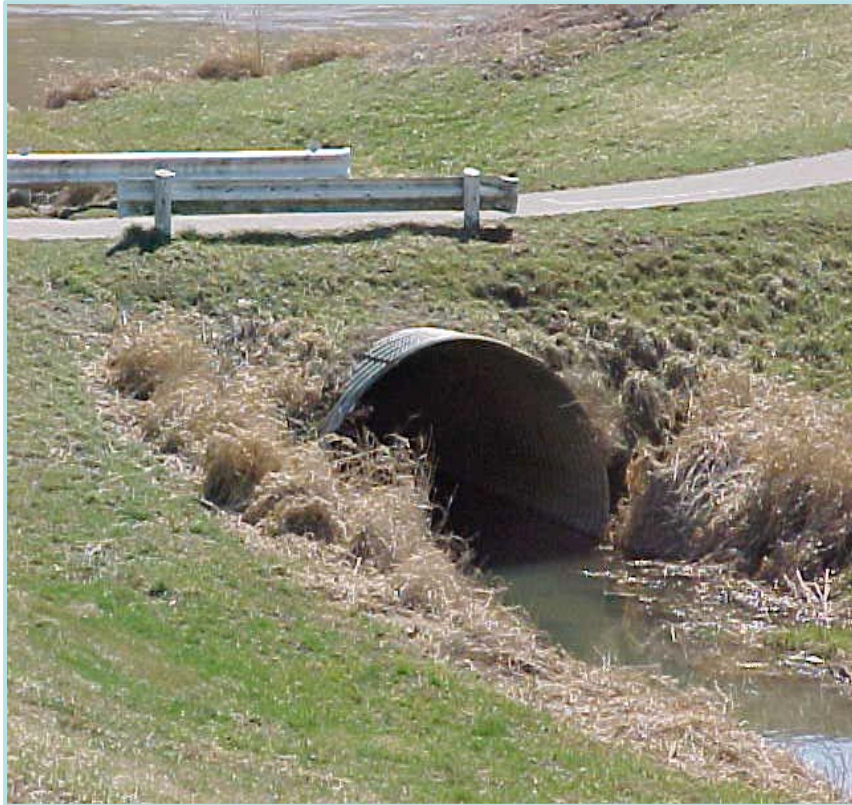
Good culvert

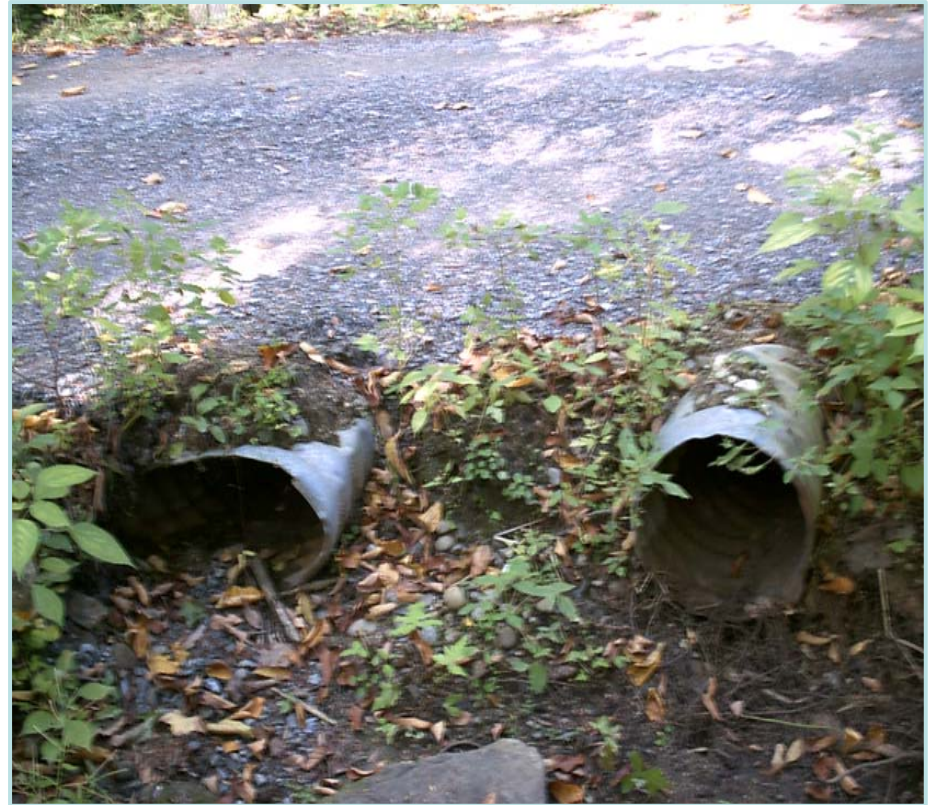
Poor culvert

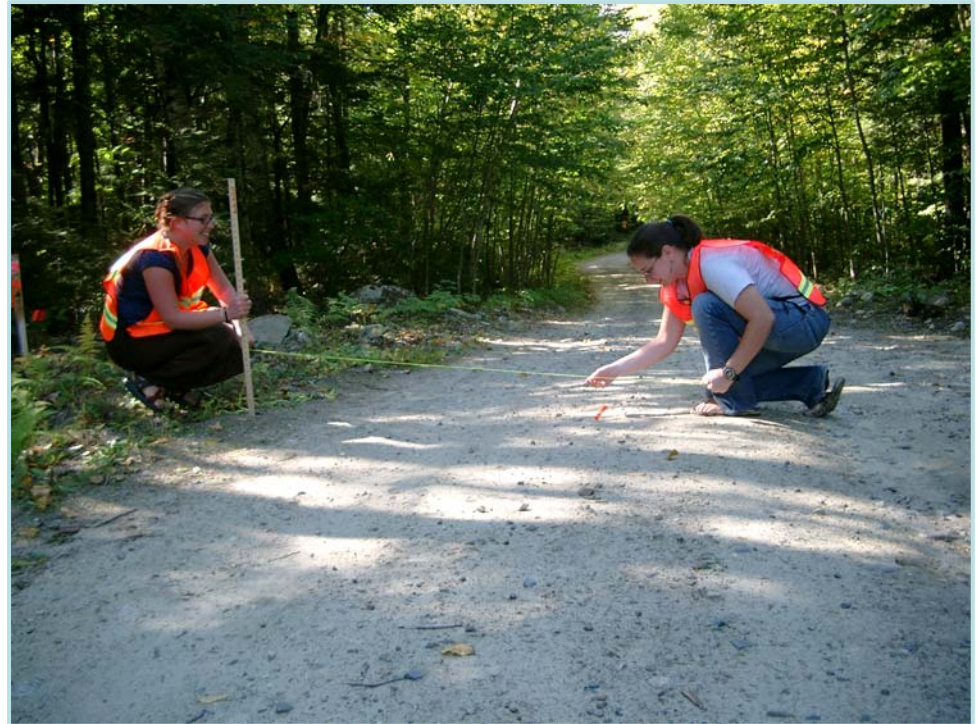
CEAT surveyors measuring crowning

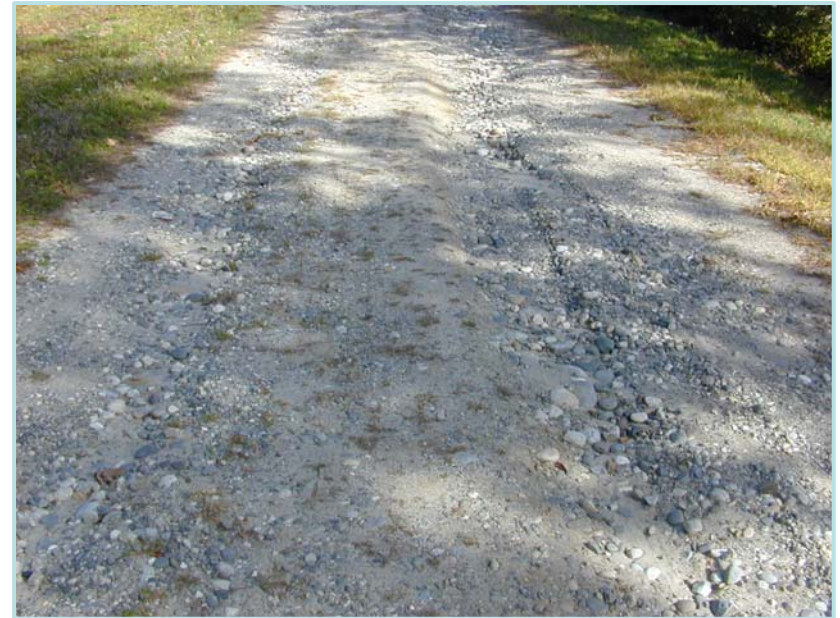
- 52 roads in LPS watershed
 - 2 state roads
 - 8 town
 - 42 camp roads
- 90.3 acres of road area
 - 9.1 acres state
 - 42.7 acres town
 - 38.4 acres camp roads
 - Camp roads make up over 40%

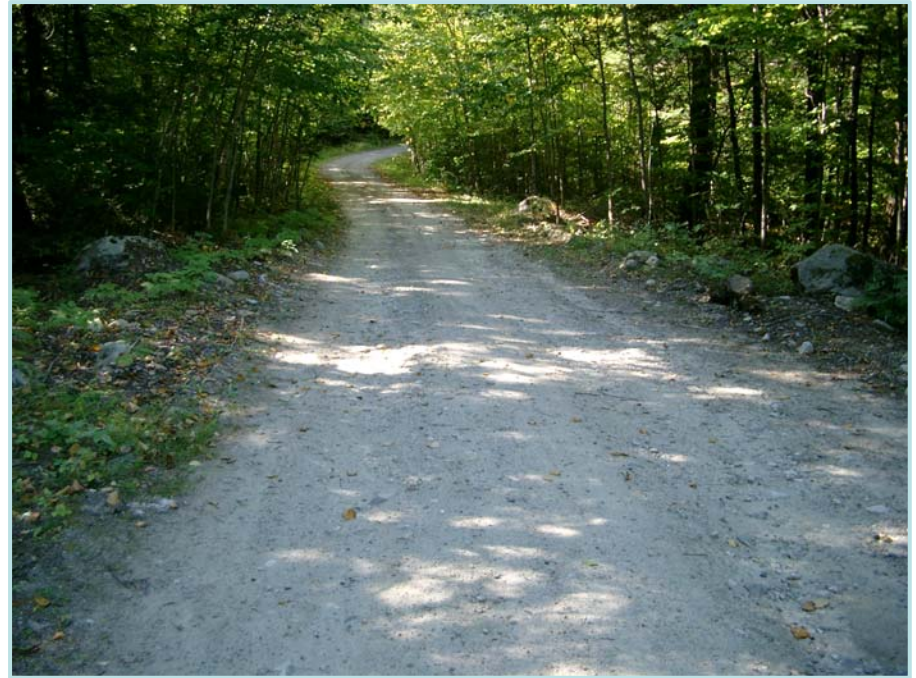
- Camp Roads:
 - 16.7% Good (7 roads)
 - 35.7% Acceptable (15)
 - 16.7% Fair (7)
 - 31.0% Poor (13)
