Land Use Patterns in Relation to Lake Water Quality in the Messalonskee Lake Watershed

Problems in Environmental Science course (Biology 493), Colby College

LAND USE PATTERNS IN RELATION TO LAKE WATER QUALITY IN THE MESSALONSKEE LAKE WATERSHED

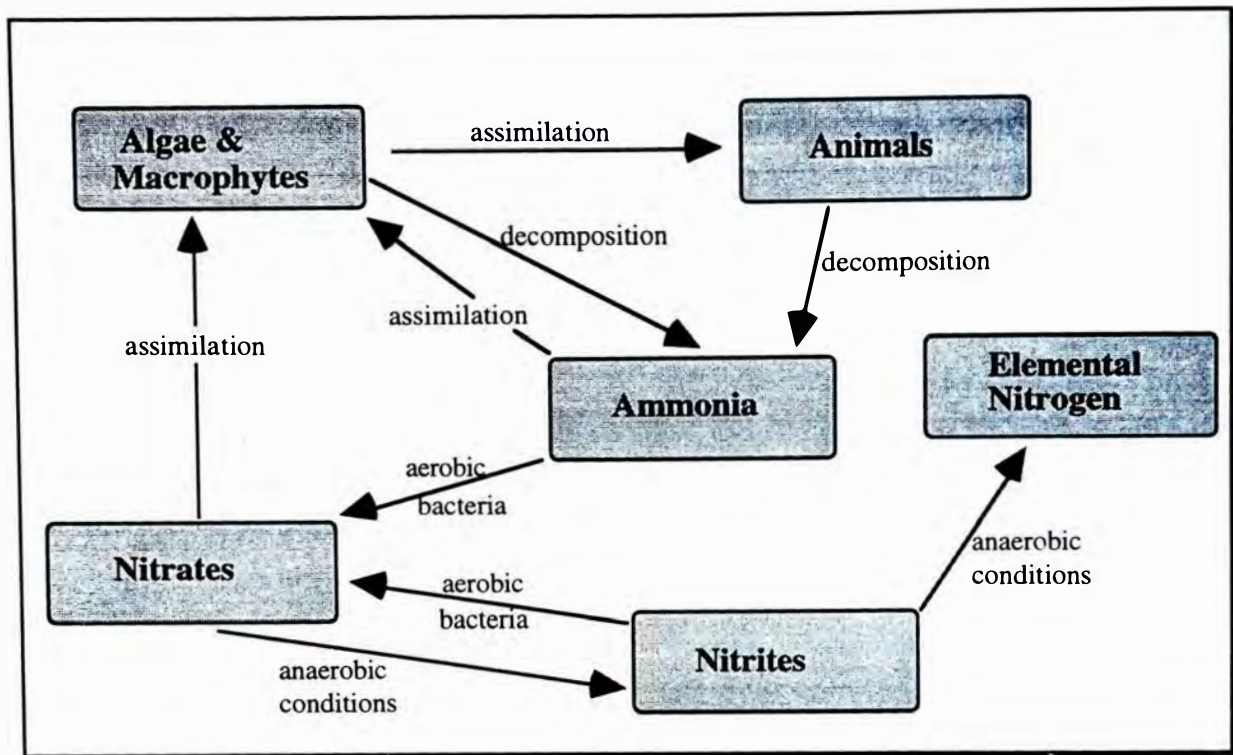
Figure 3. A diagram of the various forms of nitrogen that occur in the nitrogen cycle within a lake ecosystem. It is important to note that in aerobic conditions both ammonia and nitrites are converted to nitrates which are available for use by plants.

The other major plant nutrient, nitrogen, is not usually the limiting factor for plant growth in a lake (Chapman 1996). However, it is still important to understand its cycle because high concentrations can lead to algal blooms in the presence of phosphorus. Also, levels greater than 10 ppm can lead to the development of the condition in infants known as methemoglobinemia, if the water is used as a source of drinking water (Greenberg, Clesceri, and Eaton 1992). Available nitrogen exists in lakes in three major chemical forms: nitrates (NO_3^-), nitrites (NO_2^-), and ammonia (NH_3). Their relative positions in the nitrogen cycle are summarized in Figure 3.

The majority of free nitrogen in a lake exists in the form of nitrates (Maitland 1990). This form of nitrogen is directly available for assimilation by algae and macrophytes (Figure 3). In eutrophic lakes, there may be so much algae and macrophyte growth that most of the nitrates of the lake are incorporated into their tissues (Maitland 1990). Nitrites, however, cannot be used by plants. Nitrate-forming bacteria in aerobic conditions convert nitrites to nitrates. Ammonia enters the lake ecosystem as a product of the decomposition of plant and animal tissues and their waste products. It can follow

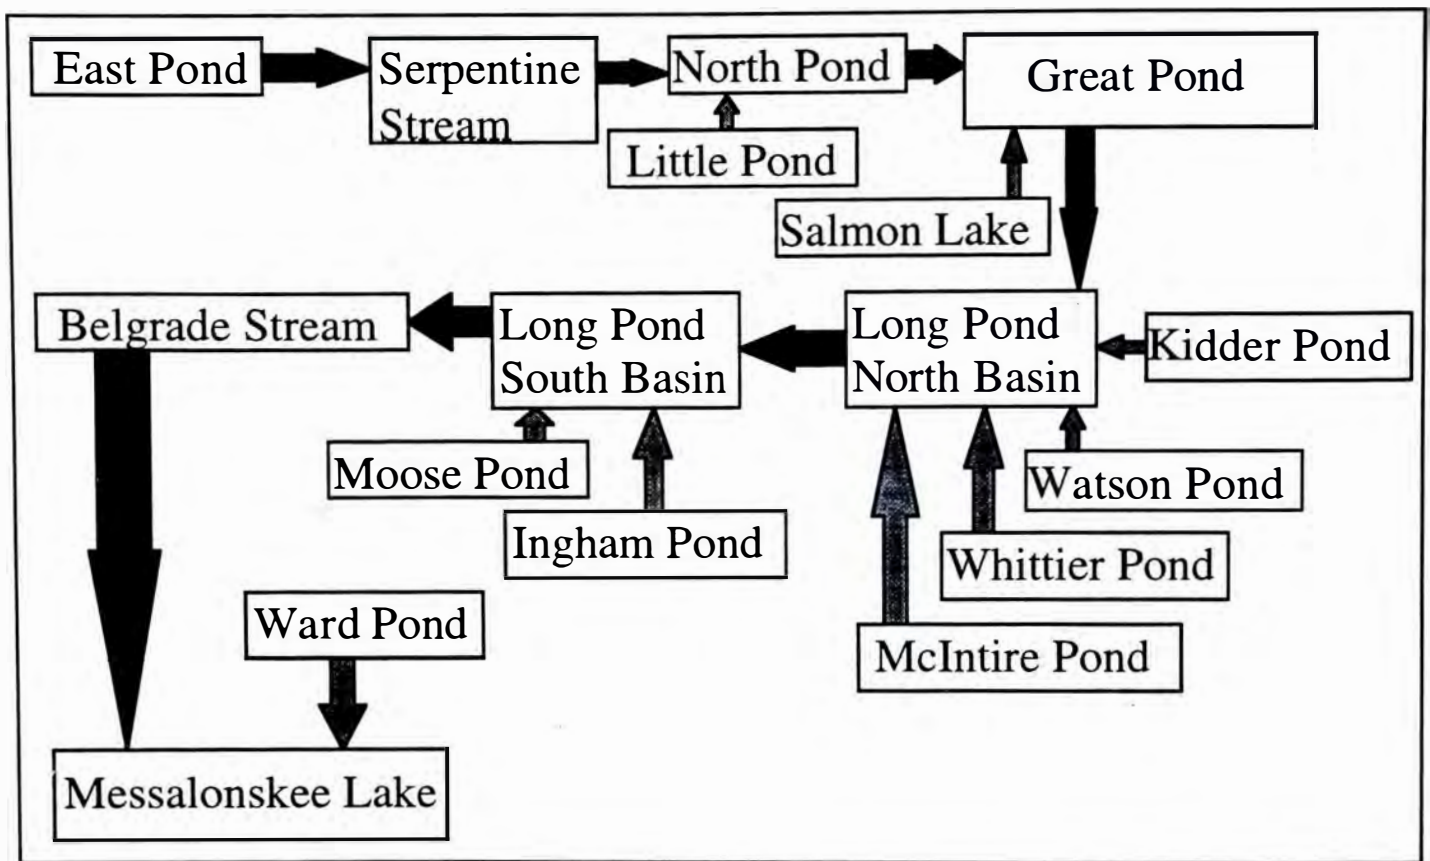
Figure 10. Diagrammatic representation of the flow of water from East Pond to Messalonskee Lake. Box sizes do not correlate with lake size. Beginning at East Pond, water flows through to Messalonskee Lake, and continues through other rivers and streams to the ocean. Darker arrows indicate direct flow of the Belgrade chain, lighter arrows are smaller inputs into the larger ponds and lakes.

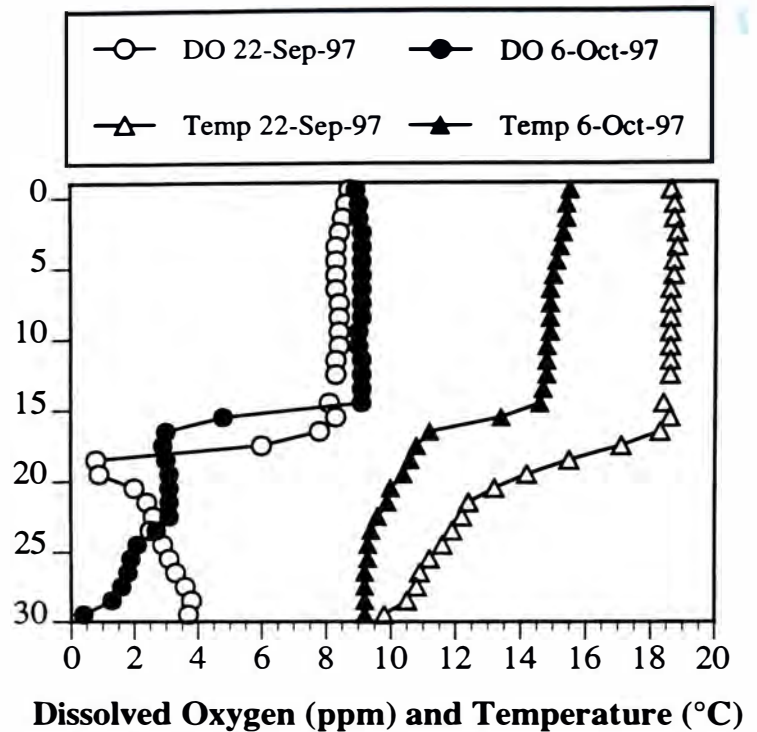
Figure 15. The dissolved oxygen (DO) and temperature profiles recorded at Messalonskee Lake Site 1 during the fall of 1997. See Figure 13 for site location.

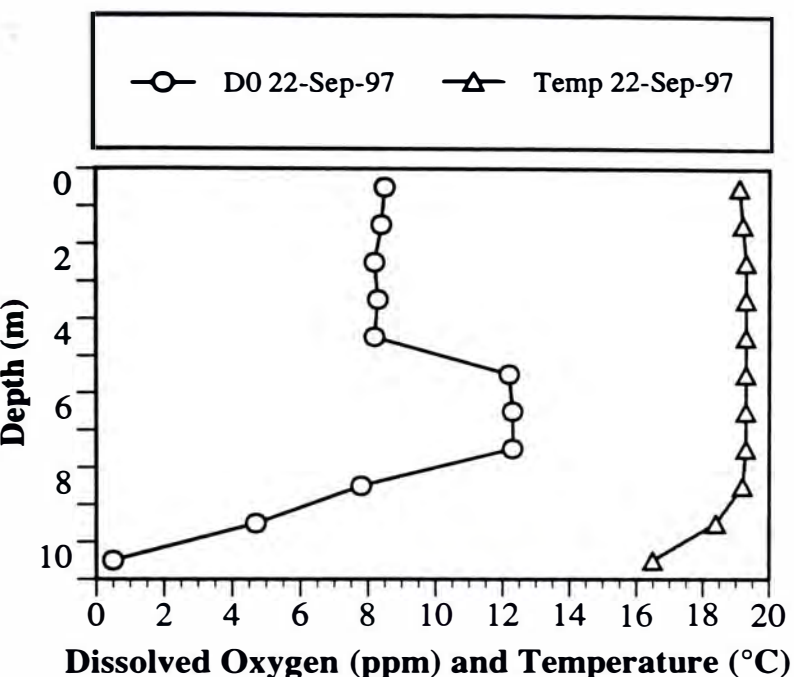
Figure 17. The dissolved oxygen (DO) and temperature profiles on 22-Sep-97 recorded at Messalonskee Lake Site 2 during the fall of 1997. See Figure 13 for site location.

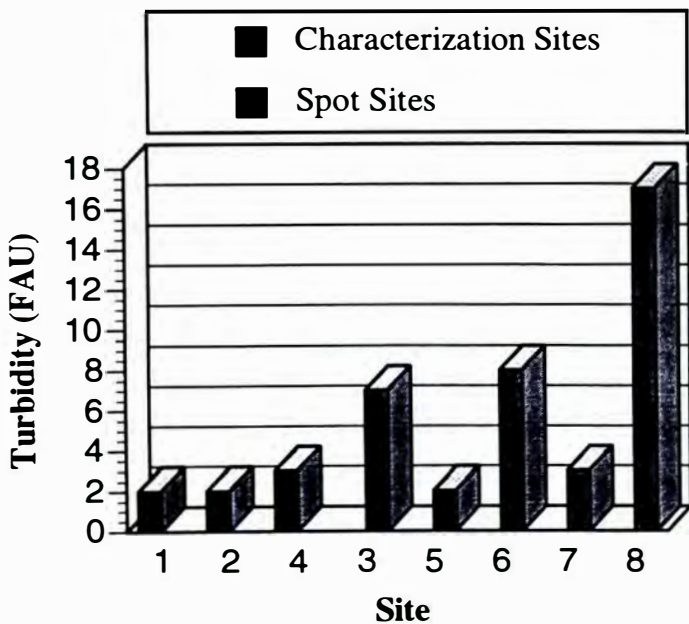
Figure 20. Turbidity measurements for surface samples taken from Characterization Sites 1, 2 and 4 and Spot Sites 3, 5, 6, 7, and 8 on 22-Sep-97.

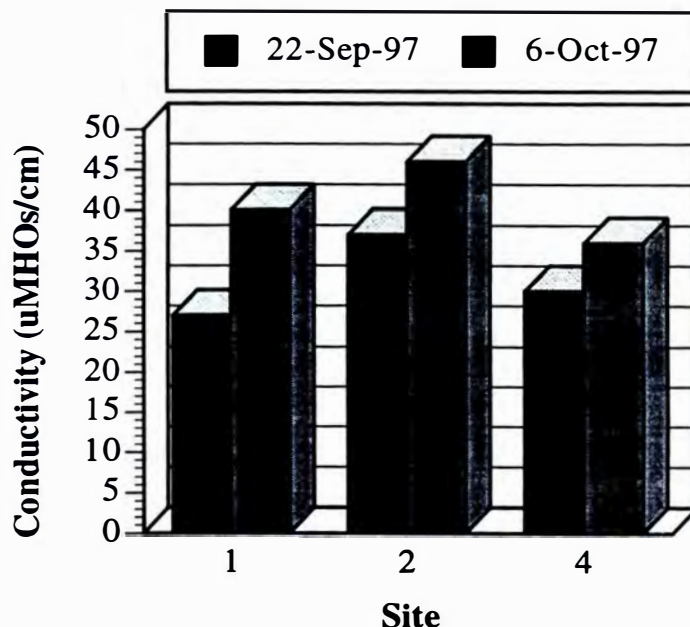
Figure 21. Mean conductivity measurements for epicore samples taken from Messalonskee Lake Characterization Sites 1, 2 and 4 on 22-Sep-97 and 6-Oct-97.

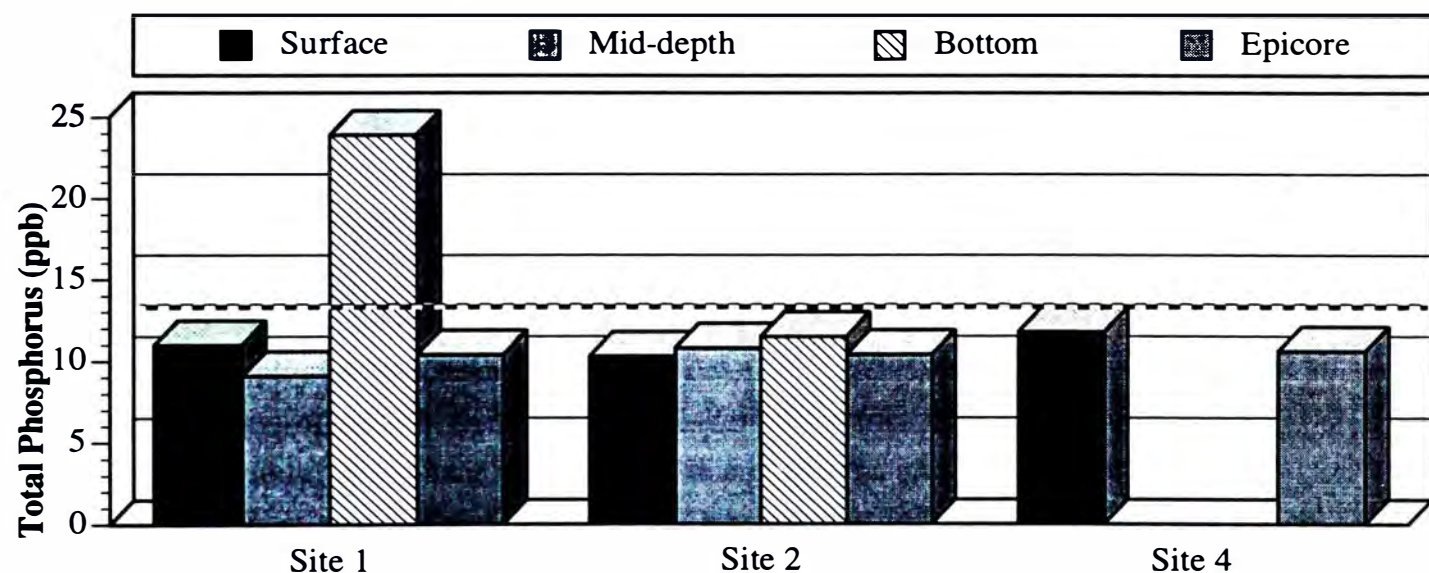
Figure 23. Mean total phosphorus concentration at Characterization Sites 1, 2, and 4, on Messalonskee Lake, for surface, mid-depth, bottom and epicore samples from 1-Jul-97 to 10-Oct-97 (see Appendix C; Table 4). Dotted line indicates 12 ppb is the critical phosphorus limit: The concentration of total phosphorus, that when sustained, may cause algal blooms occur (Bouchard, pers. comm.). Site 4 has no mid-depth or bottom samples because it was too shallow (2 m to 3 m). See Figure 13 for site location.

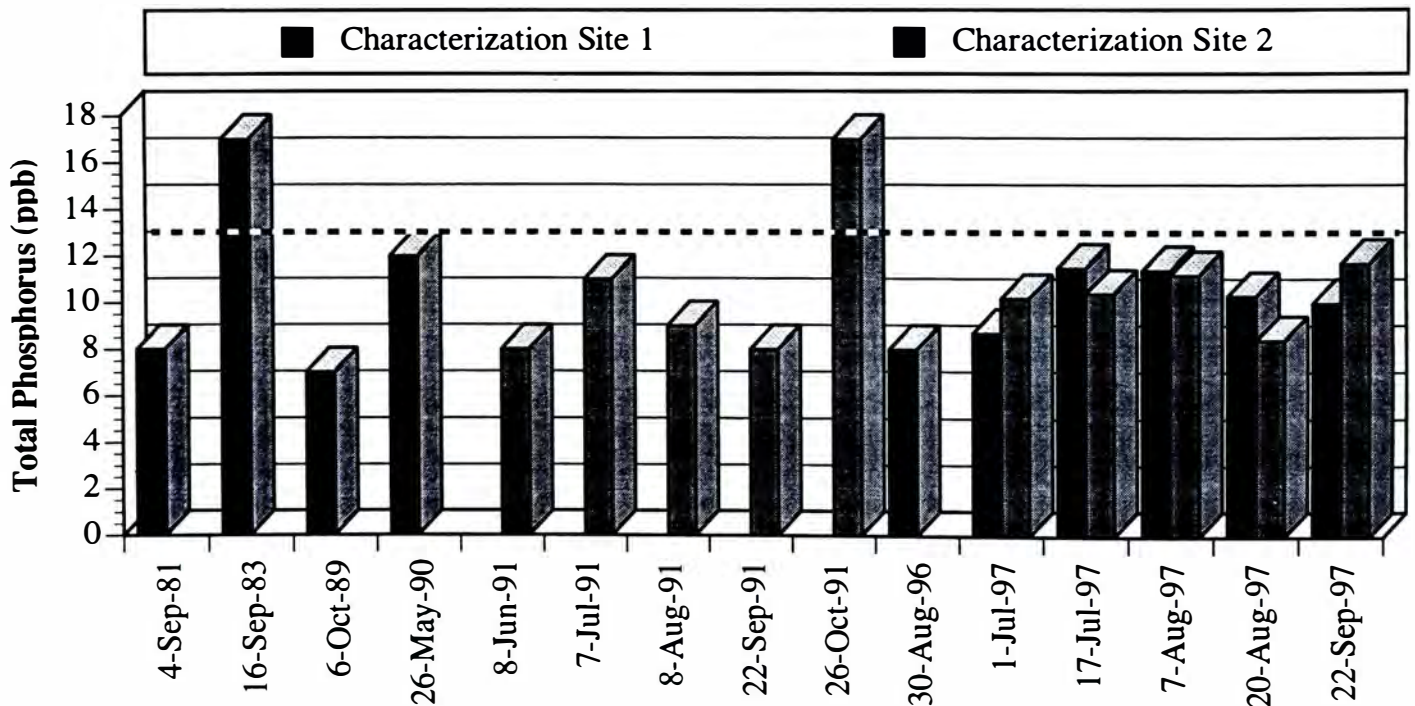
Figure 25. Total phosphorus concentration for epicore samples at Characterization Sites 1 and 2, on Messalonskee Lake, from 4-Sep-81 to 22-Sep-97. Samples taken prior to 1-Jul-97 were analyzed by MDEP; all other samples were analyzed by Colby Environmental Assessment Team (MDEP 1997; see Appendix C, Table 4). Dotted line indicates 12 ppb is the critical limit for total phosphorus: The concentration of total phosphorus, that when sustained, algal blooms occur (Bouchard, pers. comm.). See Figure 13 for site location.
