## Land Use Patterns in Relation to Lake Water Quality in the North Pond Watershed

Problems in Environmental Science course (Biology 493), Colby College

Colby Environmental Assessment Team, Colby College

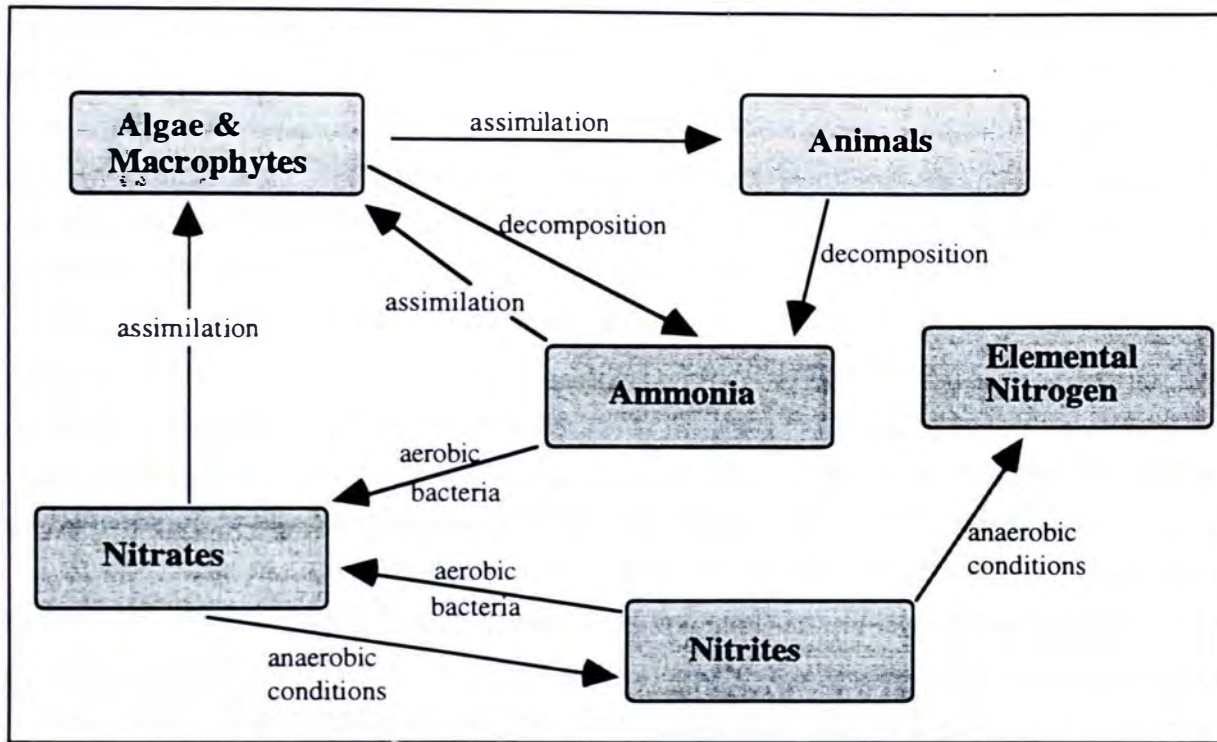
**Figure 3. A diagram of the various forms of nitrogen that occur in the nitrogen cycle within a lake ecosystem. It is important to note that in aerobic conditions both ammonia and nitrites are converted to nitrates which are available for use by plants.**

The other major plant nutrient, nitrogen, is not usually the limiting factor for plant growth in a lake (Chapman 1992). However, it is still important to understand its cycle because high concentrations can lead to algal blooms in the presence of phosphorus. Also, levels greater than 10 ppm can lead to the development of the condition in infants known as methemoglobinemia, if the water is used as a source of drinking water (Greenberg et al. 1992). Available nitrogen exists in lakes in three major chemical forms: nitrates ( $\text{NO}_3^-$ ), nitrites ( $\text{NO}_2^-$ ), and ammonia ( $\text{NH}_3$ ). Their relative positions in the nitrogen cycle are summarized in Figure 3.

The majority of free nitrogen in a lake exists in the form of nitrates (Maitland 1990). This form of nitrogen is directly available for assimilation by algae and macrophytes (Figure 3). In eutrophic lakes, there may be so much algae and macrophyte growth that most of the nitrates of the lake are incorporated into their tissues (Maitland 1990). Nitrites, however, cannot be used by plants. Nitrate-forming bacteria in aerobic conditions, convert nitrites to nitrates. Ammonia enters the lake ecosystem as a product of the decomposition of plant and animal tissues and their waste products. It can follow one of three paths. First, many macrophytes can assimilate ammonia directly into their tissues. Alternatively, in aerobic conditions, certain bacteria will convert the ammonia directly to the more usable form of nitrogen, nitrates. Finally, in the case of anaerobic decomposition, which commonly occurs in the sediments of stratified lakes, nitrates can be reduced to nitrites. If these anaerobic conditions persist, the nitrites can be entirely broken down to elemental nitrogen ( $\text{N}_2$ ). This form is not available to any plants without the aid of nitrogen-fixing bacteria, as only bacteria have the capability to convert nitrogen to nitrates through nitrogen fixation (Overcash and Davidson 1980). The underlying pattern that is evident from this cycle is that whatever form of nitrogen is added to the lake

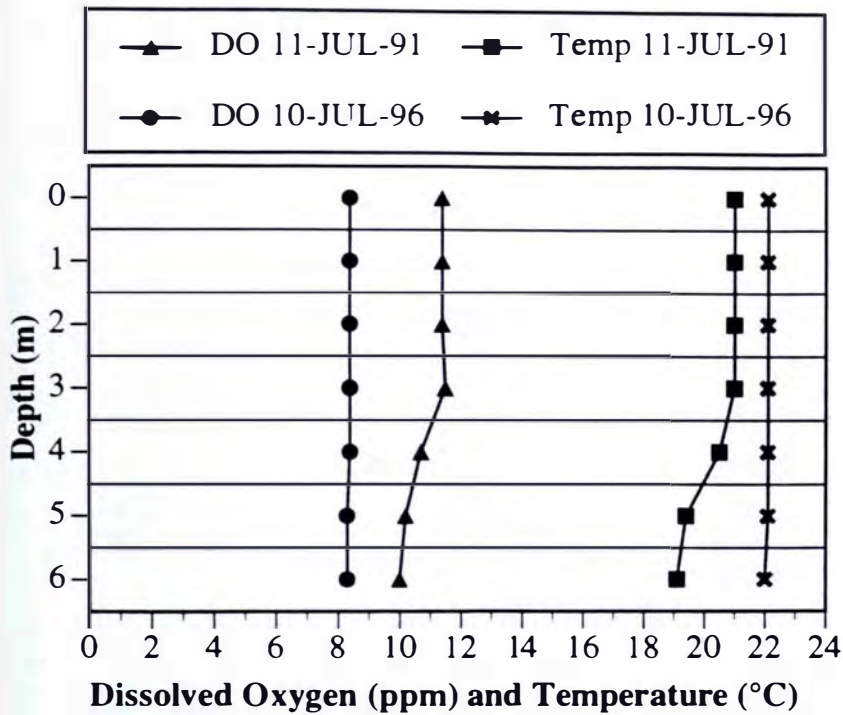
**Figure 14. Comparison of dissolved oxygen (ppm) and temperature (°C) profiles from North Pond Characterization Site 1 sampled on 10-JUL-91 (MDEP) and 11-JUL-96 (CEAT). See Figure 12 for location of the site.**

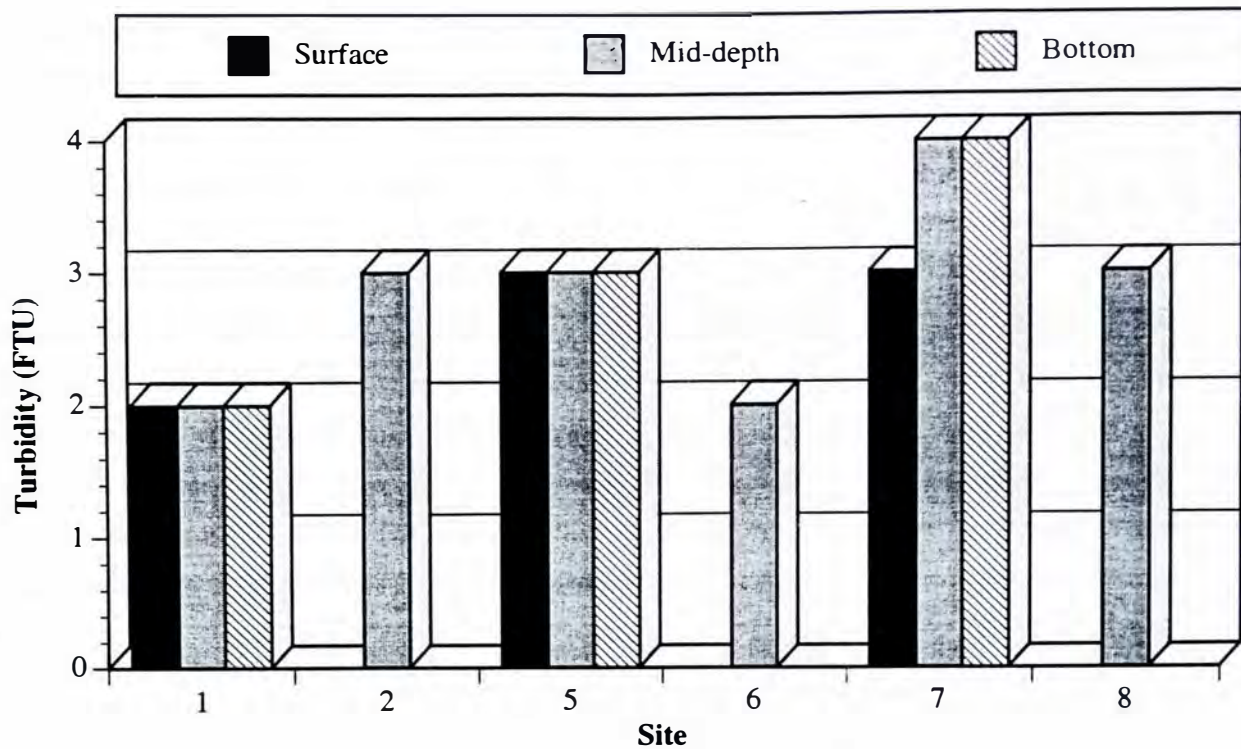
**Figure 16.** Turbidity in formazin turbidity units (FTU) of samples taken on 30-OCT-96 from surface, mid-depth and bottom samples at the North Pond (Sites 1, 2, 5 and 6) and Little Pond (Sites 7 and 8) characterization sites. See Figure 12 for location of sites.

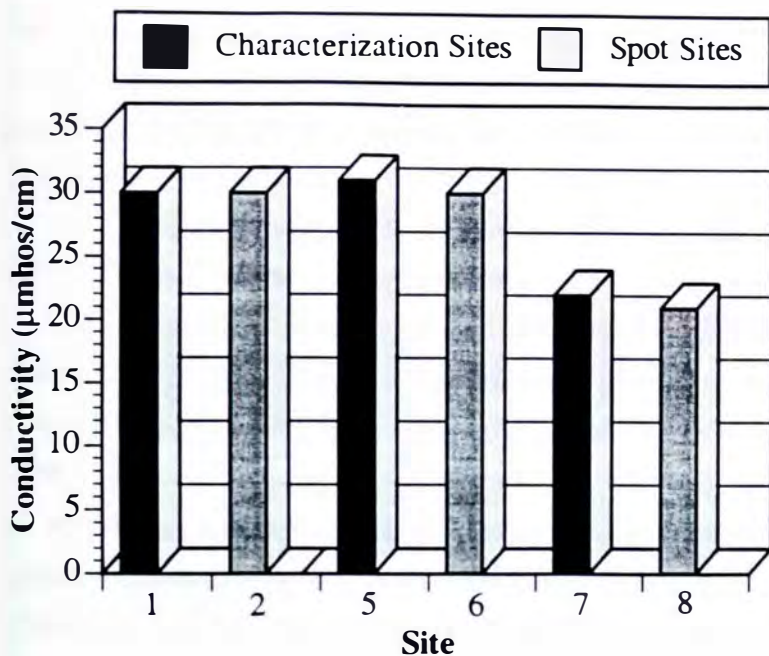
**Figure 18. Conductivity measurements ( $\mu\text{mhos/cm}$ ) for surface samples taken from North Pond (Sites 1, 2, 5 and 6) and Little Pond (Sites 7 and 8) on 30-SEP-96. See Figure 12 for location of sites.**

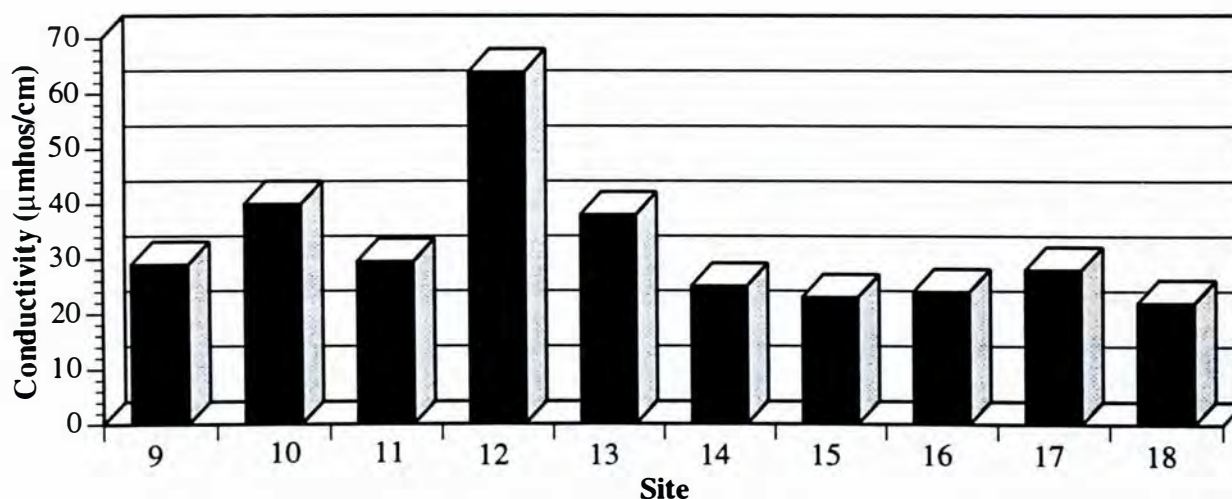
**Figure 19. Conductivity measurements (µmhos/cm) for surface samples from tributary sites flowing into North Pond except for Site 18 which flows out of North Pond. All samples were taken on 30-SEP-96 except Site 10 which was sampled on 23-SEP-96. See Figure 12 for location of sites.**

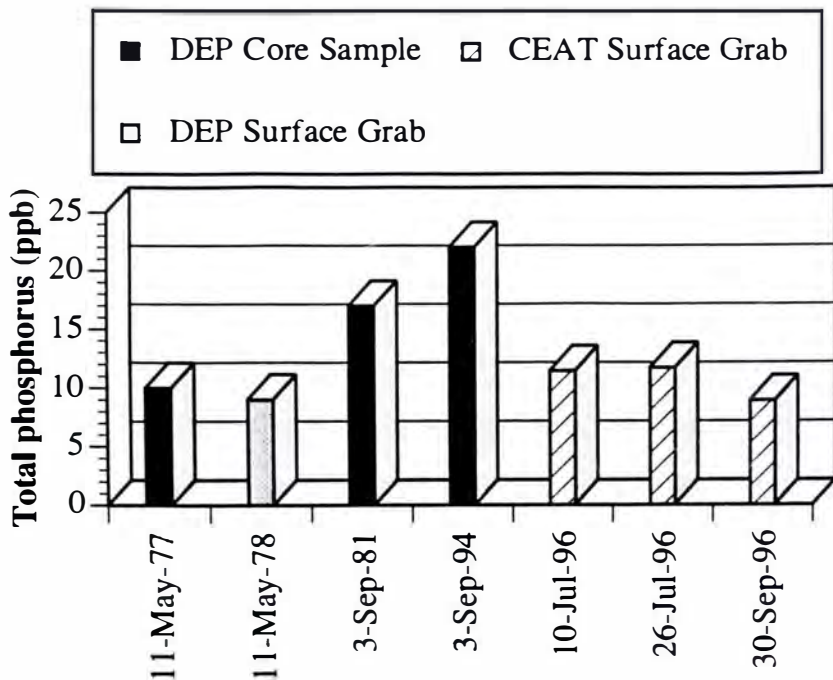
**Figure 20. Total phosphorus concentrations (ppb) from surface grabs and core samples at the North Pond DEP Characterization Site 1, during the period 1977 to 1996 (MDEP 1996, BI 493 1996). See Figure 12 for location of the site.**

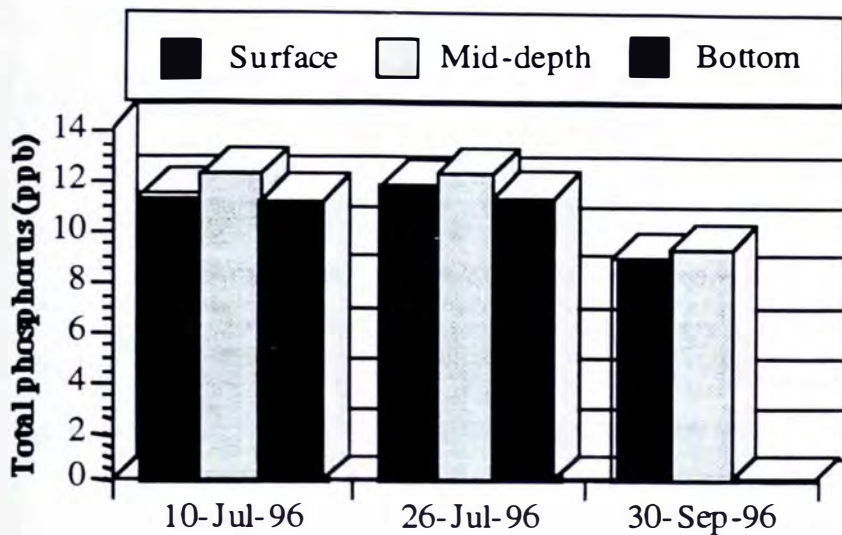
**Figure 21. Total phosphorus concentrations (ppb) for surface, mid-depth and bottom samples taken from North Pond DEP Characterization Site 1. The average of two values was taken for the middle and bottom 10-JUL-96 and the surface for 26-JUL-96. Figure 12 for location of the site.**

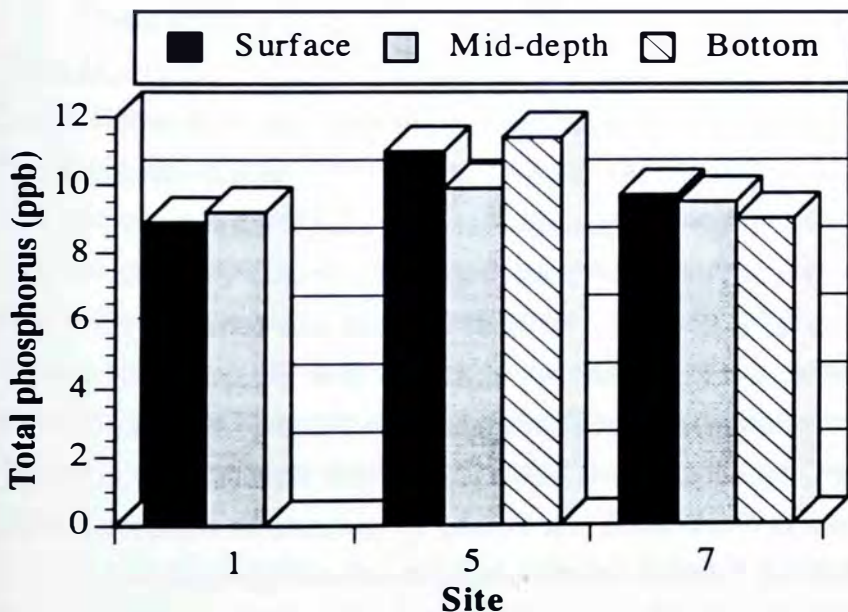
**Figure 22. Total phosphorus concentrations (ppb) for surface, mid-depth, and bottom samples. North Pond Site 5 is an average of two values. All samples taken from North and Little Ponds on 23-SEP-96 and 30-SEP-96. See Figure 12 for location of sites.**

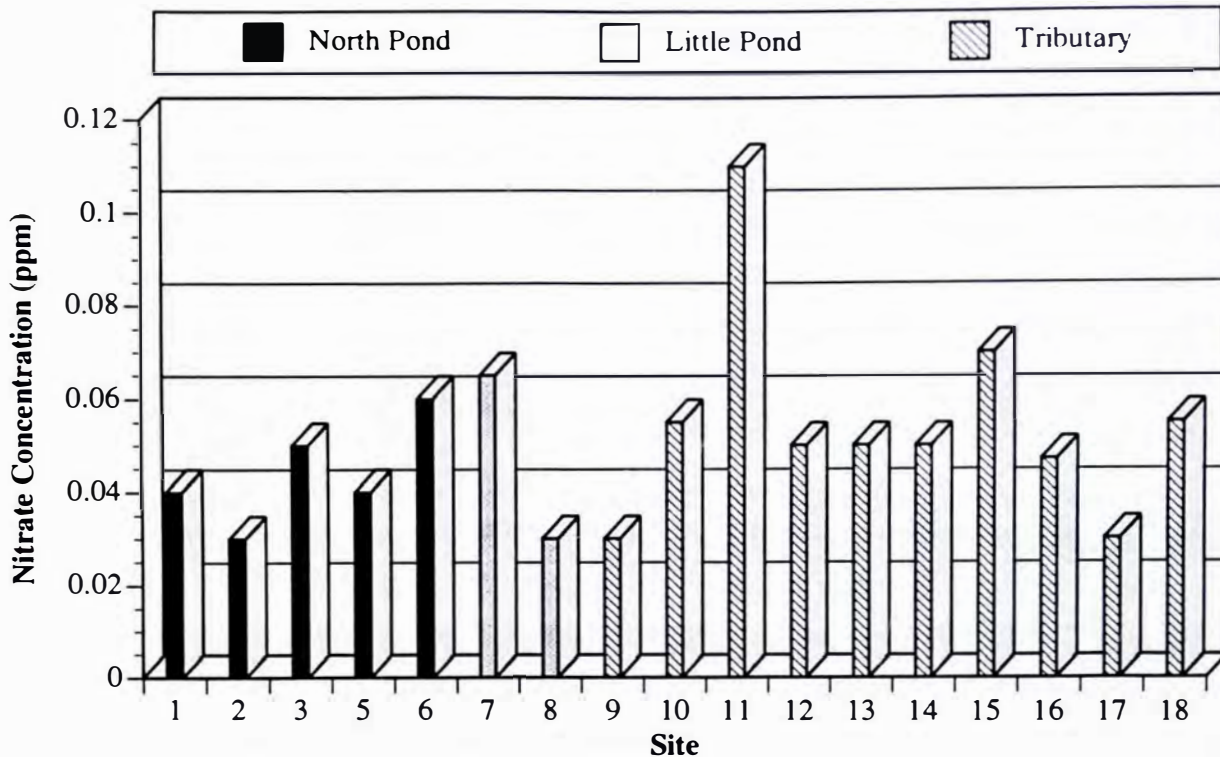
**Figure 26. Nitrate concentration (ppm) of surface samples taken on 23-SEP-96 and 07-OCT-96 at North Pond (Sites 1 to 6), Little Pond (Sites 7 and 8), and Tributaries (Sites 9 to 18). See Figure 12 for location of sites.**

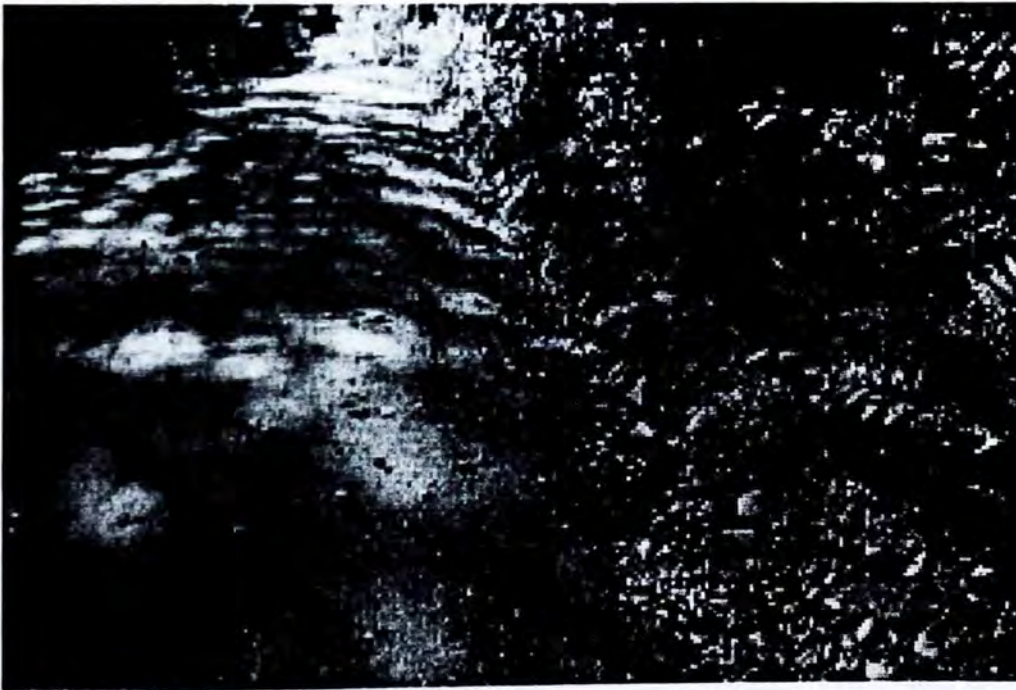
**Figure 42. A berm ridge on the side of a dirt road which prevents the drainage of water off the road.**

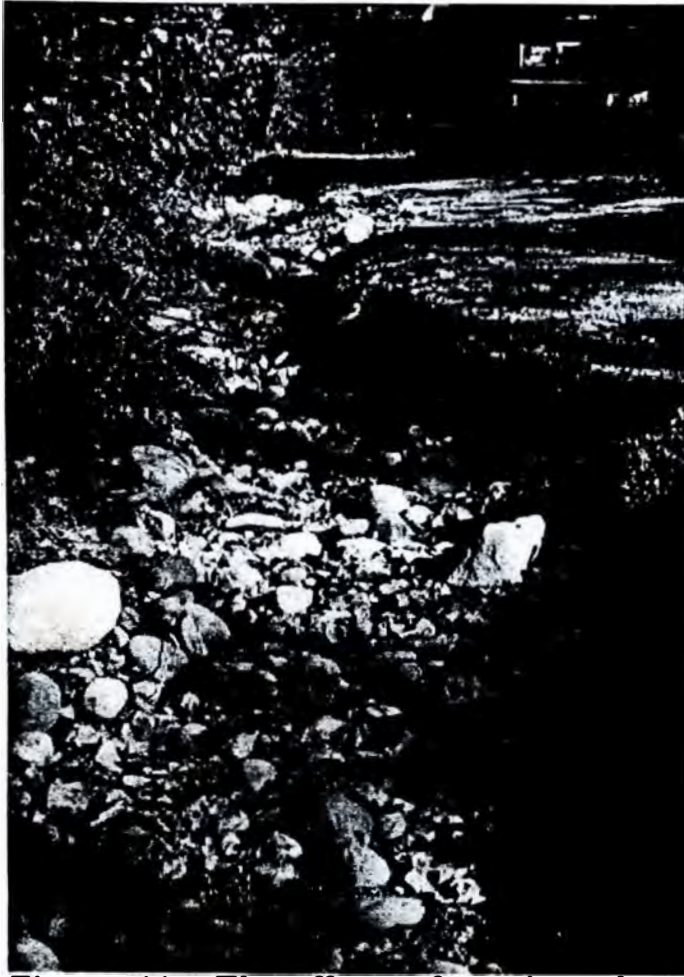
**Figure 44.** The effects of erosion where a ditch has not been properly maintained.

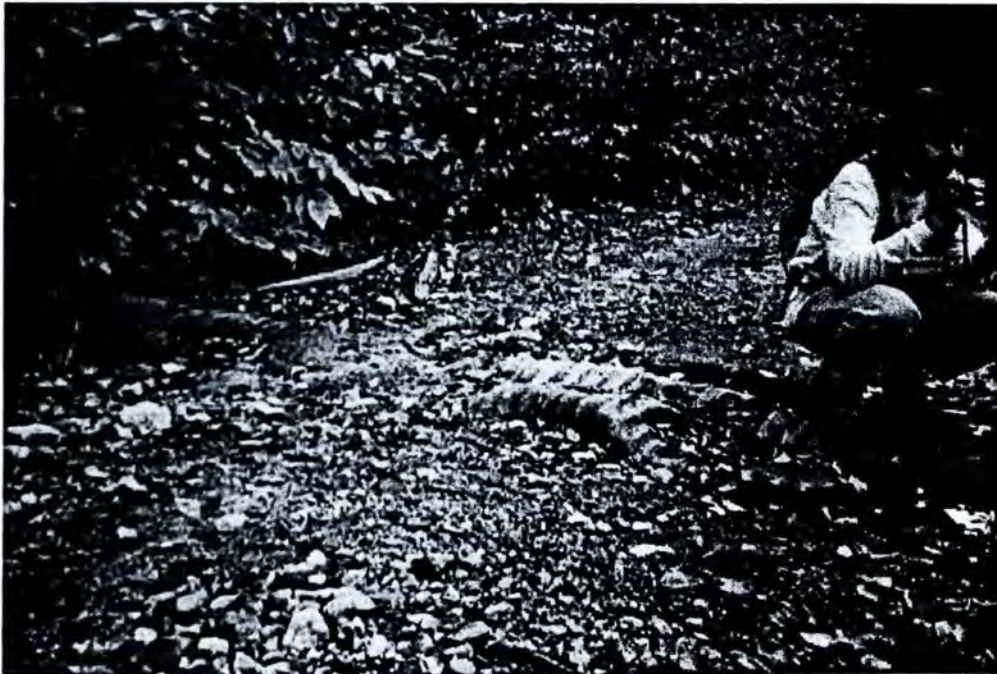
**Figure 45. A poorly placed culvert in a dirt road which has not been properly maintained. This culvert should have been placed further below the road surface.**
