Land Use Patterns in Relation to Lake Water Quality in the Lake Wesserunsett Watershed

Problems in Environmental Science course (Biology 493), Colby College

LAND USE PATTERNS IN RELATION TO LAKE WATER QUALITY IN THE LAKE WESSERUNSETT WATERSHED

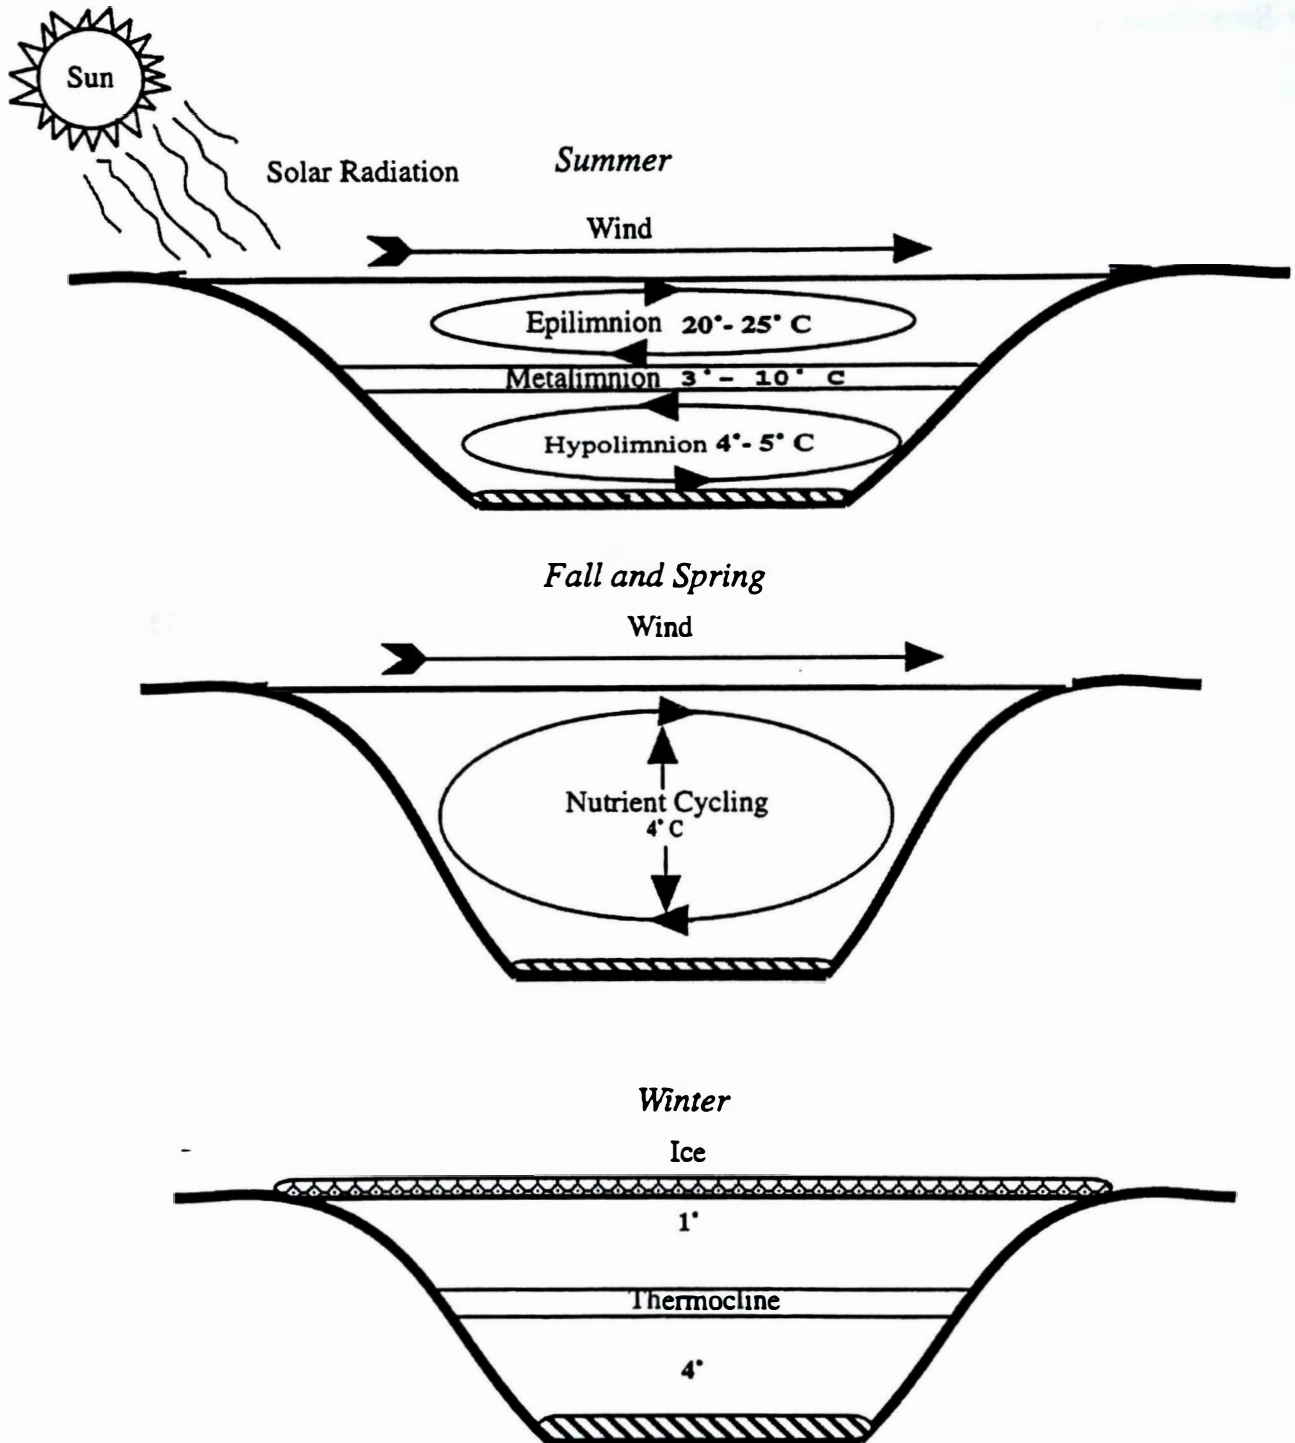
Figure 1. Mixing by means of lake turnover. During the summer, lakes are stratified into three layers (epilimnion, metalimnion, and hypolimnion). During the fall and spring, the isothermal temperature and density facilitate lake turnover and redistribution of nutrients. In the winter, the lake is again stratified with the slightly warmer water on the bottom of the lake and ice at the surface.

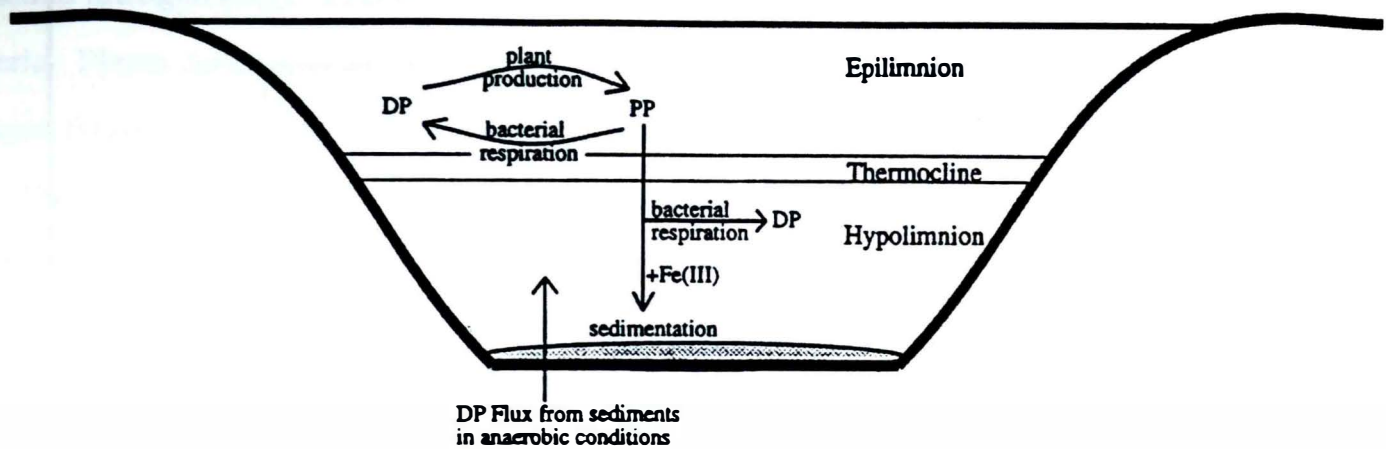
Figure 2. A model of the cycle of the major forms of phosphorus, dissolved (DP) and particulate (PP), within a lake ecosystem. The sedimentation of DP through complexation with Fe (III) contributes to the build-up of DP in the sediments. Note the production of DP in the hypolimnion due to bacterial decomposition as well as from the release of DP from the Fe complex in the sediments during anaerobic conditions. The fact that the thermocline prevents DP from mixing between the surface and bottom water is critical to the cycle because it can allow for build up of DP in bottom waters (adapted from Lerman 1978).

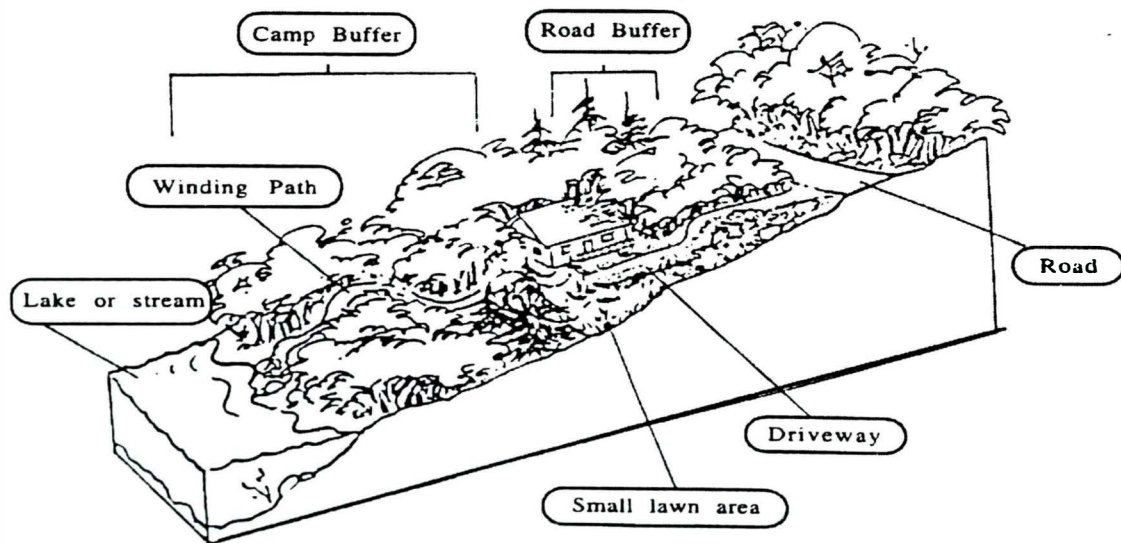
Figure 5. Diagram of an ideally buffered home.

An example of an ideally buffered home is shown in Figure 5. This home has a winding path down to the shoreline. Runoff is diverted into the woods where it can be absorbed in the forest litter. The house itself is set back from the shoreline 100 ft, and has a dense buffer strip between it and the water. The buffer is composed of a combination of canopy trees, understory shrubs and

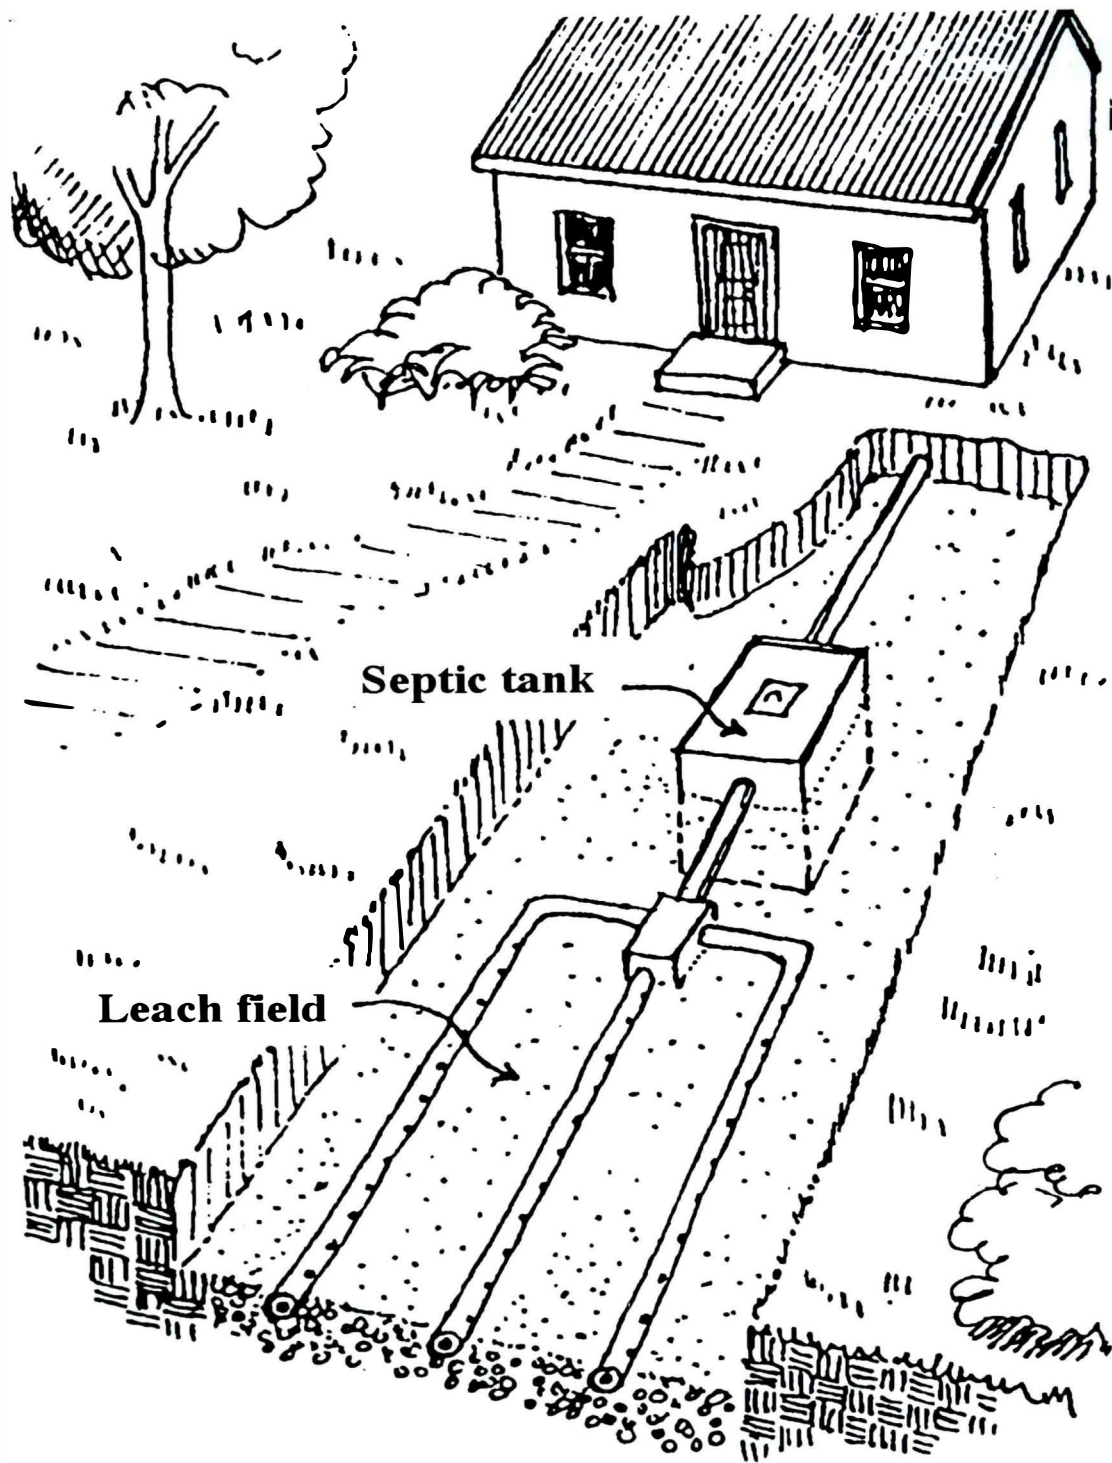
Figure 6. The layout of a typical septic system (Williams 1992)

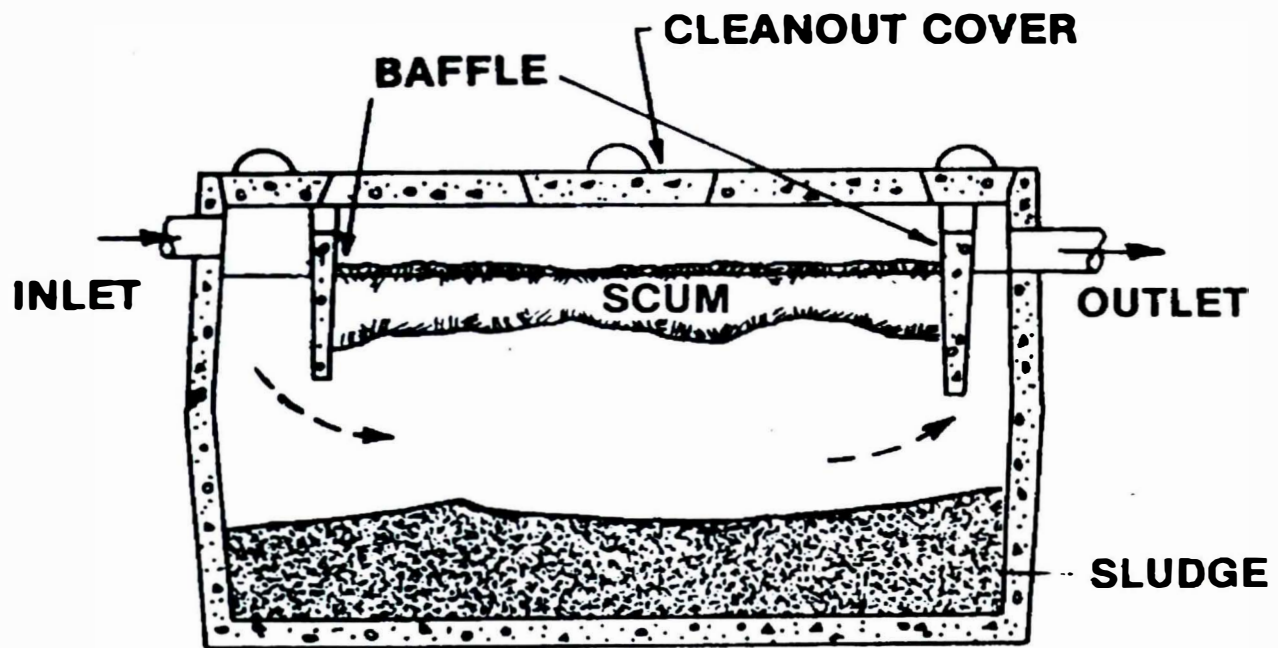
Figure 7. The cross-section of a typical treatment tank showing the movement of effluent through the tank as well as the separation of the scum and sludge (MDHS 1983).

the solids that sink to the bottom of the tank. Over time, much of the scum and sludge is broken down by anaerobic digestion. The effluent then travels through the effluent line to the disposal area.

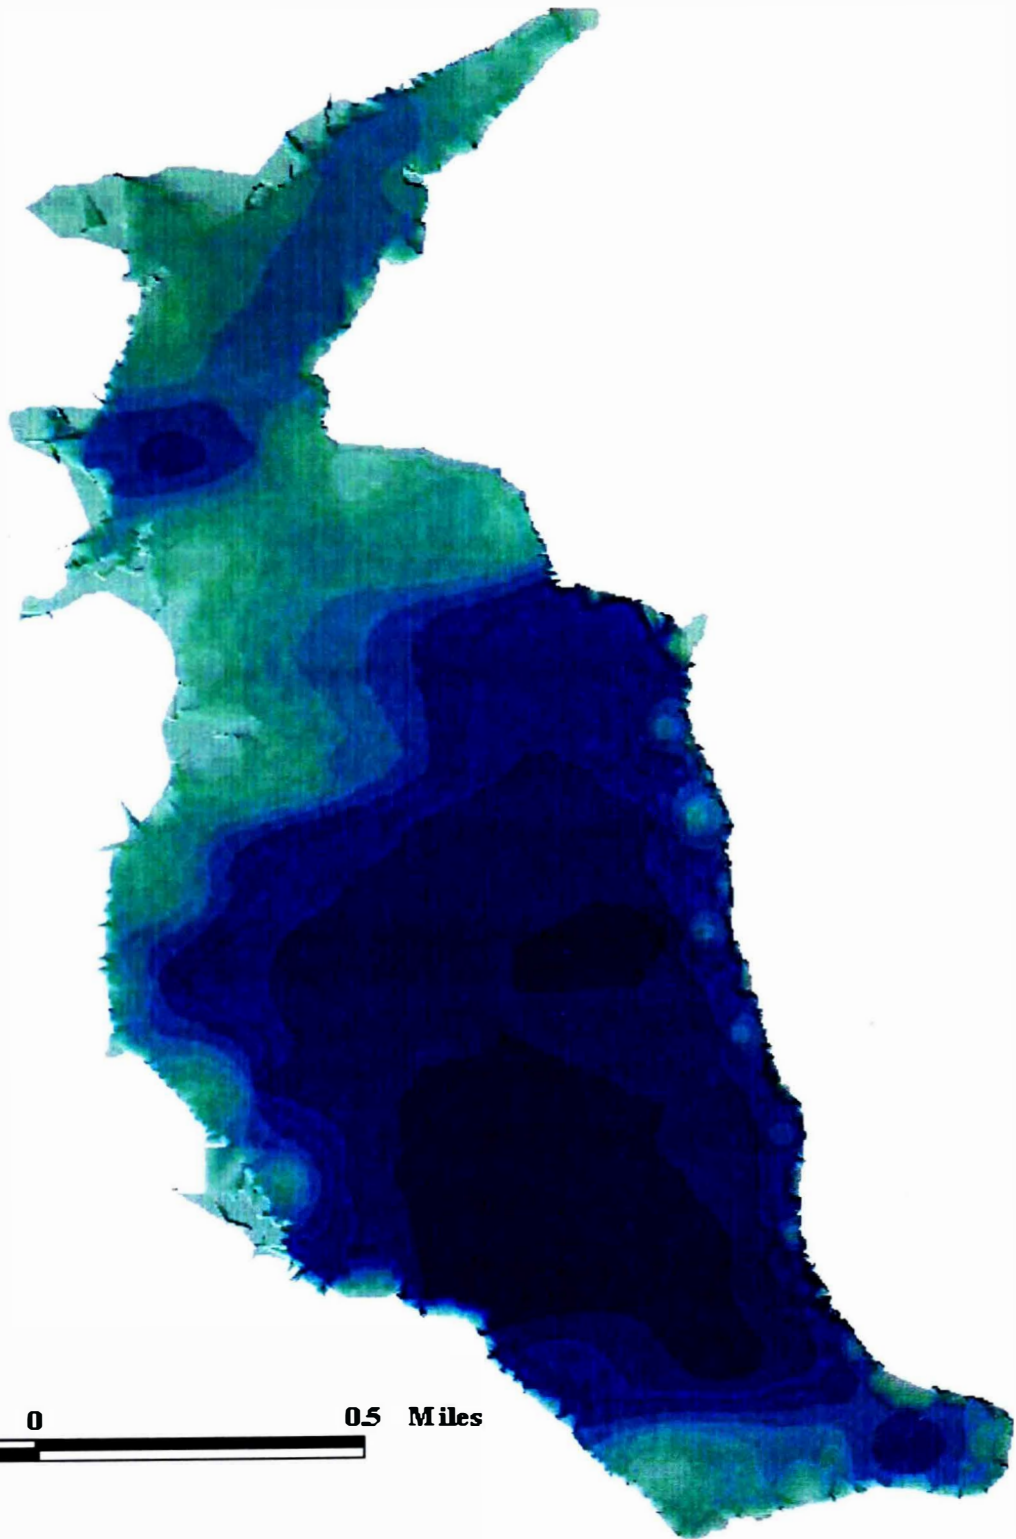
Figure 8. Bathymetry map of Lake Wesserunsett. Data adapted from Somerset County Wesserunsett Lake Depth Map, 1964.

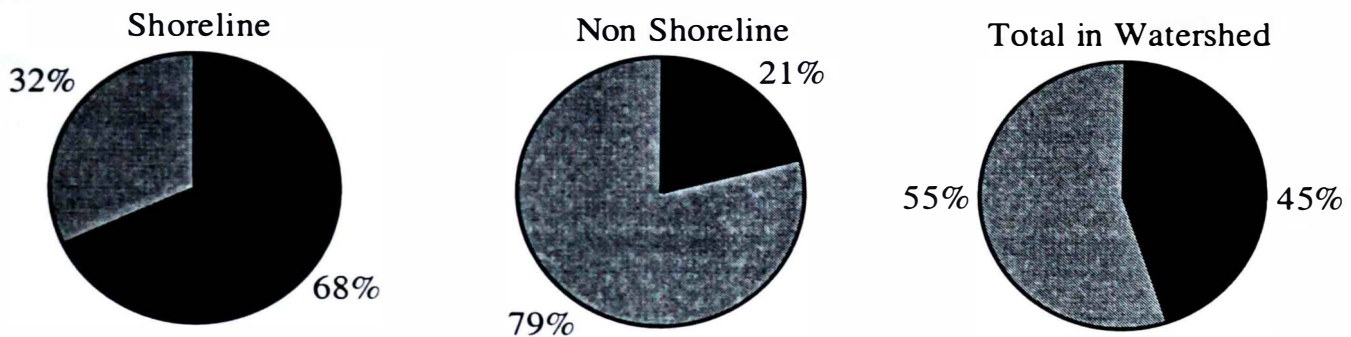
Figure 20. Percent of seasonal and year-round residences on shoreline and non shoreline areas of Lake Wesserunsett as determined from the road analysis survey on 2-Oct-00. The majority of shoreline residences are seasonal (68.1%) while the majority of residences off the shoreline are year-round (79.1%).

Results from the house count indicate that of the 533 houses in the watershed, 55 percent (293 houses) are year-round and 45 percent (240 houses) are seasonal (Figure 20). The house count survey also found that along the shoreline of Lake Wesserunsett, 68 percent of the houses are seasonal (145 houses) and 32 percent are year-round residencies (68 houses), for a total of 213 houses. According to the reference cards for the tax maps from the Madison Town Hall (2000), 71 percent (149 houses) of shoreline residences are seasonal, while 29 percent (61 houses) are year-round, for a total of 210 houses. Current total residences on the shoreline from the house survey and tax map

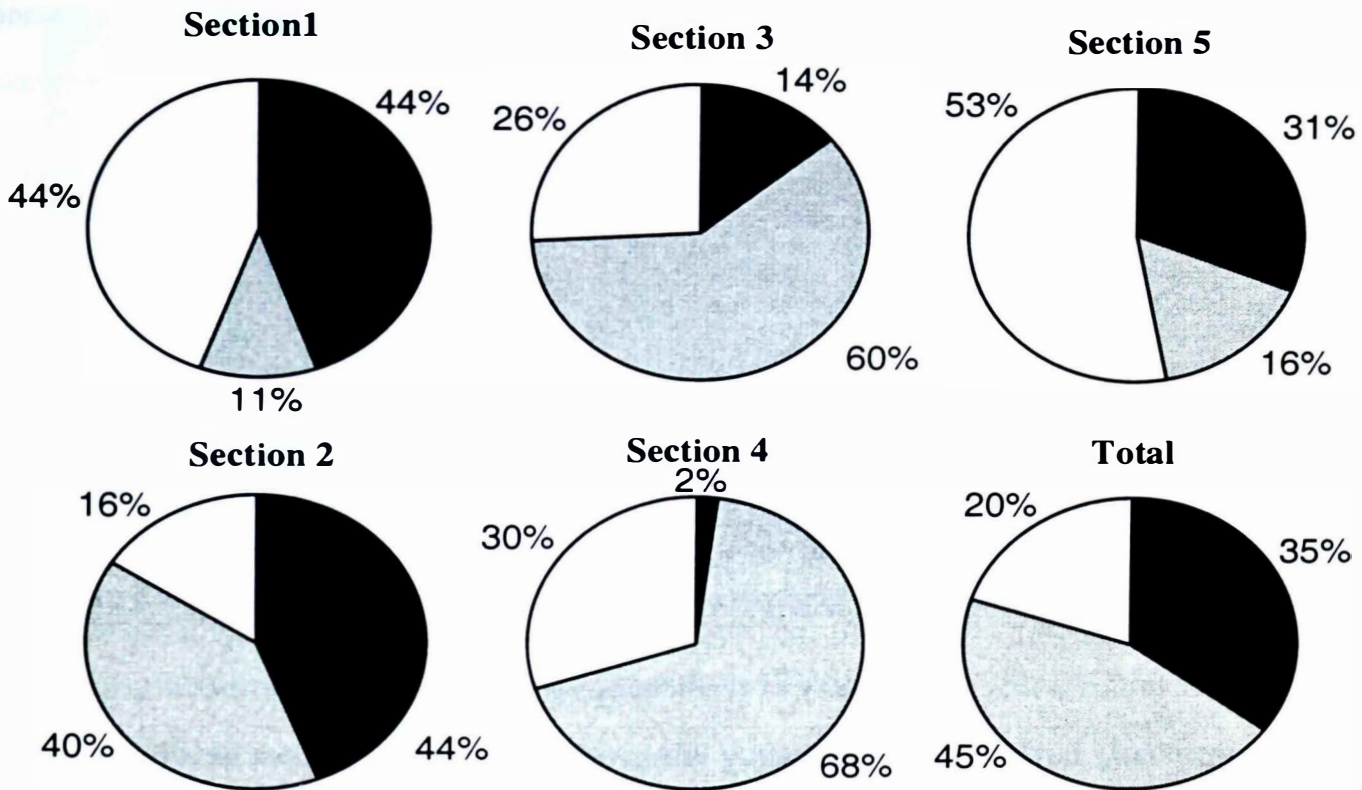
Figure 23. Risk potential of buffer strips for nutrient loading on Lake Wesserunsett during Fall 2000, divided into lake section based on geography of the lake (see section map for shoreline survey, Figure 22). Risk potential of buffer strips for total shorefront of Lake Wesserunsett.

In Section 1, located in the northwest corner of Lake Wesserunsett, 44 percent of the buffer strips are adequate. Section 1 contains 12 percent at risk buffer strips, and an additional 44 percent of high-risk category buffer strips. The potential benefit of the 44 percent of adequate buffers in this section of Lake Wesserunsett is offset by the additional 44 percent of high-risk buffer strips (Figure 23).

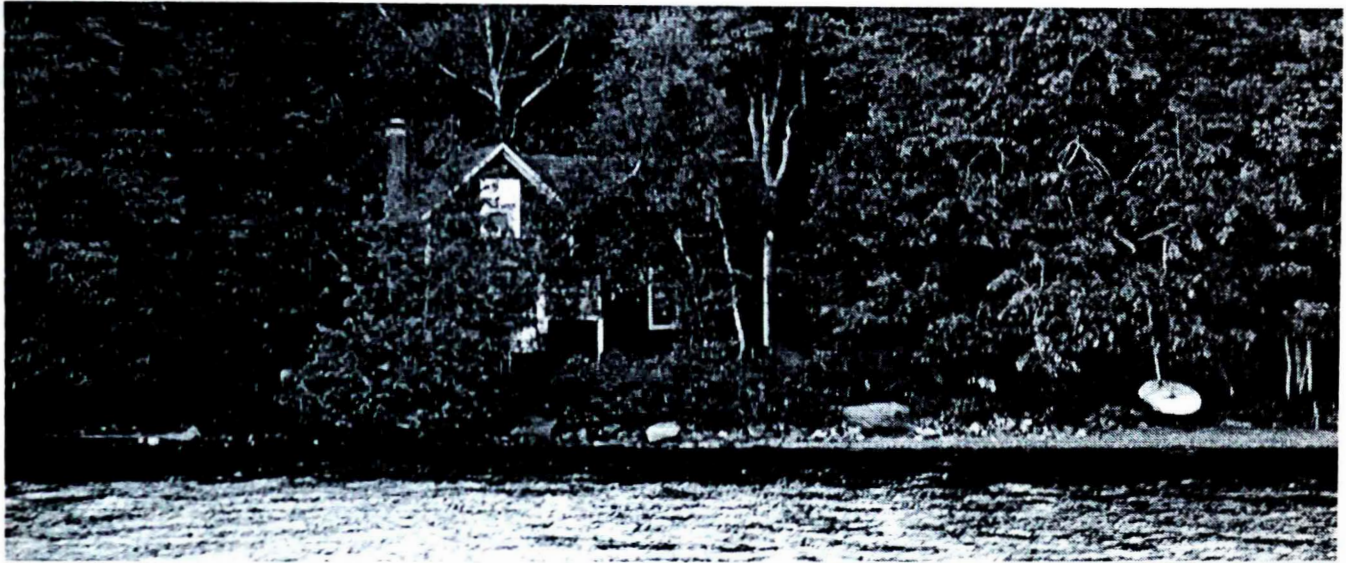
Figure 24. An example of a well buffered property on Lake Wessernsett, Fall 2000.

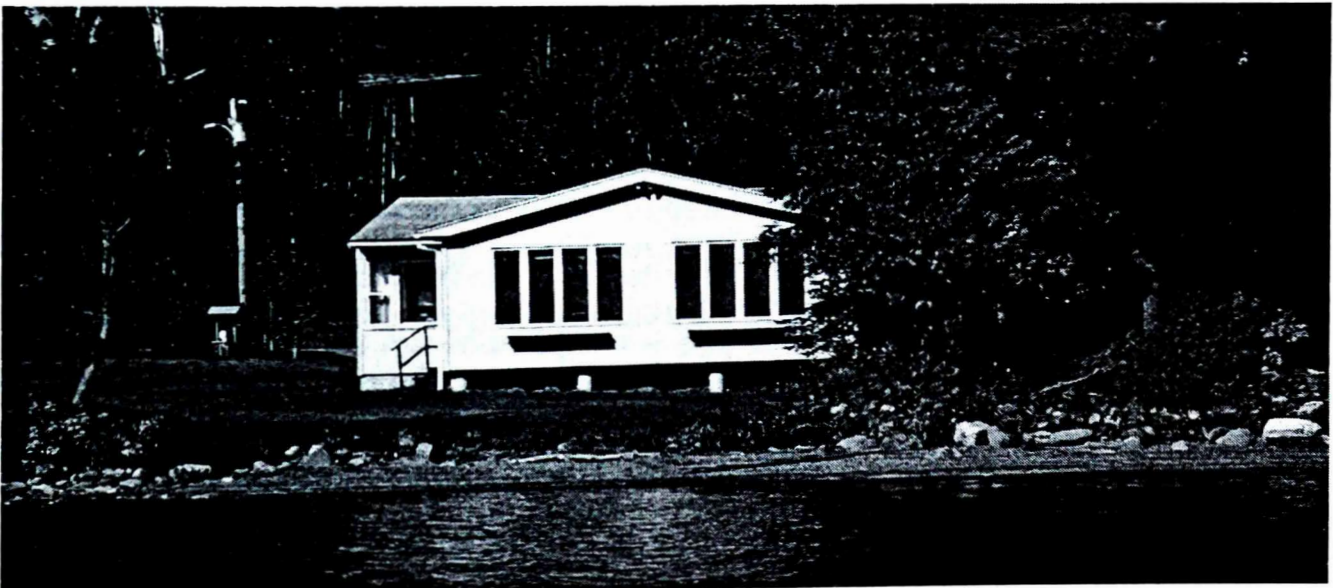
Figure 25. An example of a poorly buffered property on Lake Wesserunsett, Fall 2000.

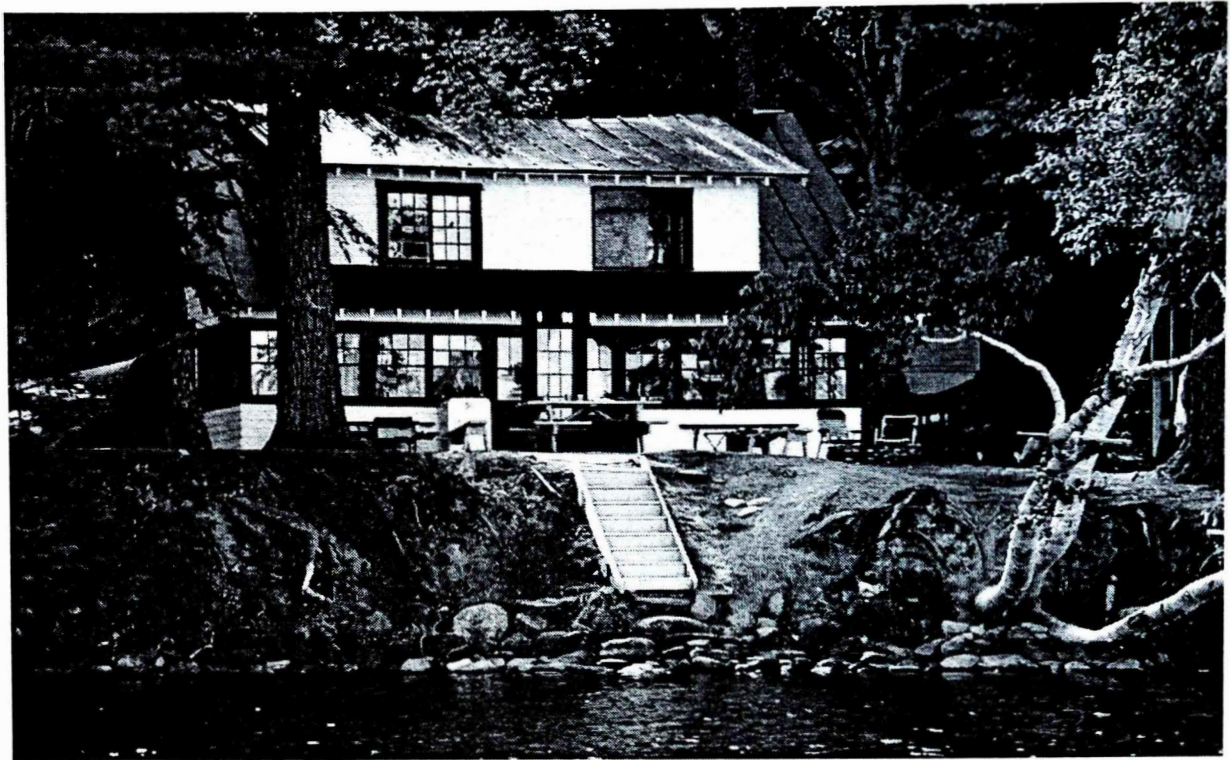
Figure 26. An example of severe erosion on the bank of shorefront property of Lake Wesserunsett, Fall 2000.

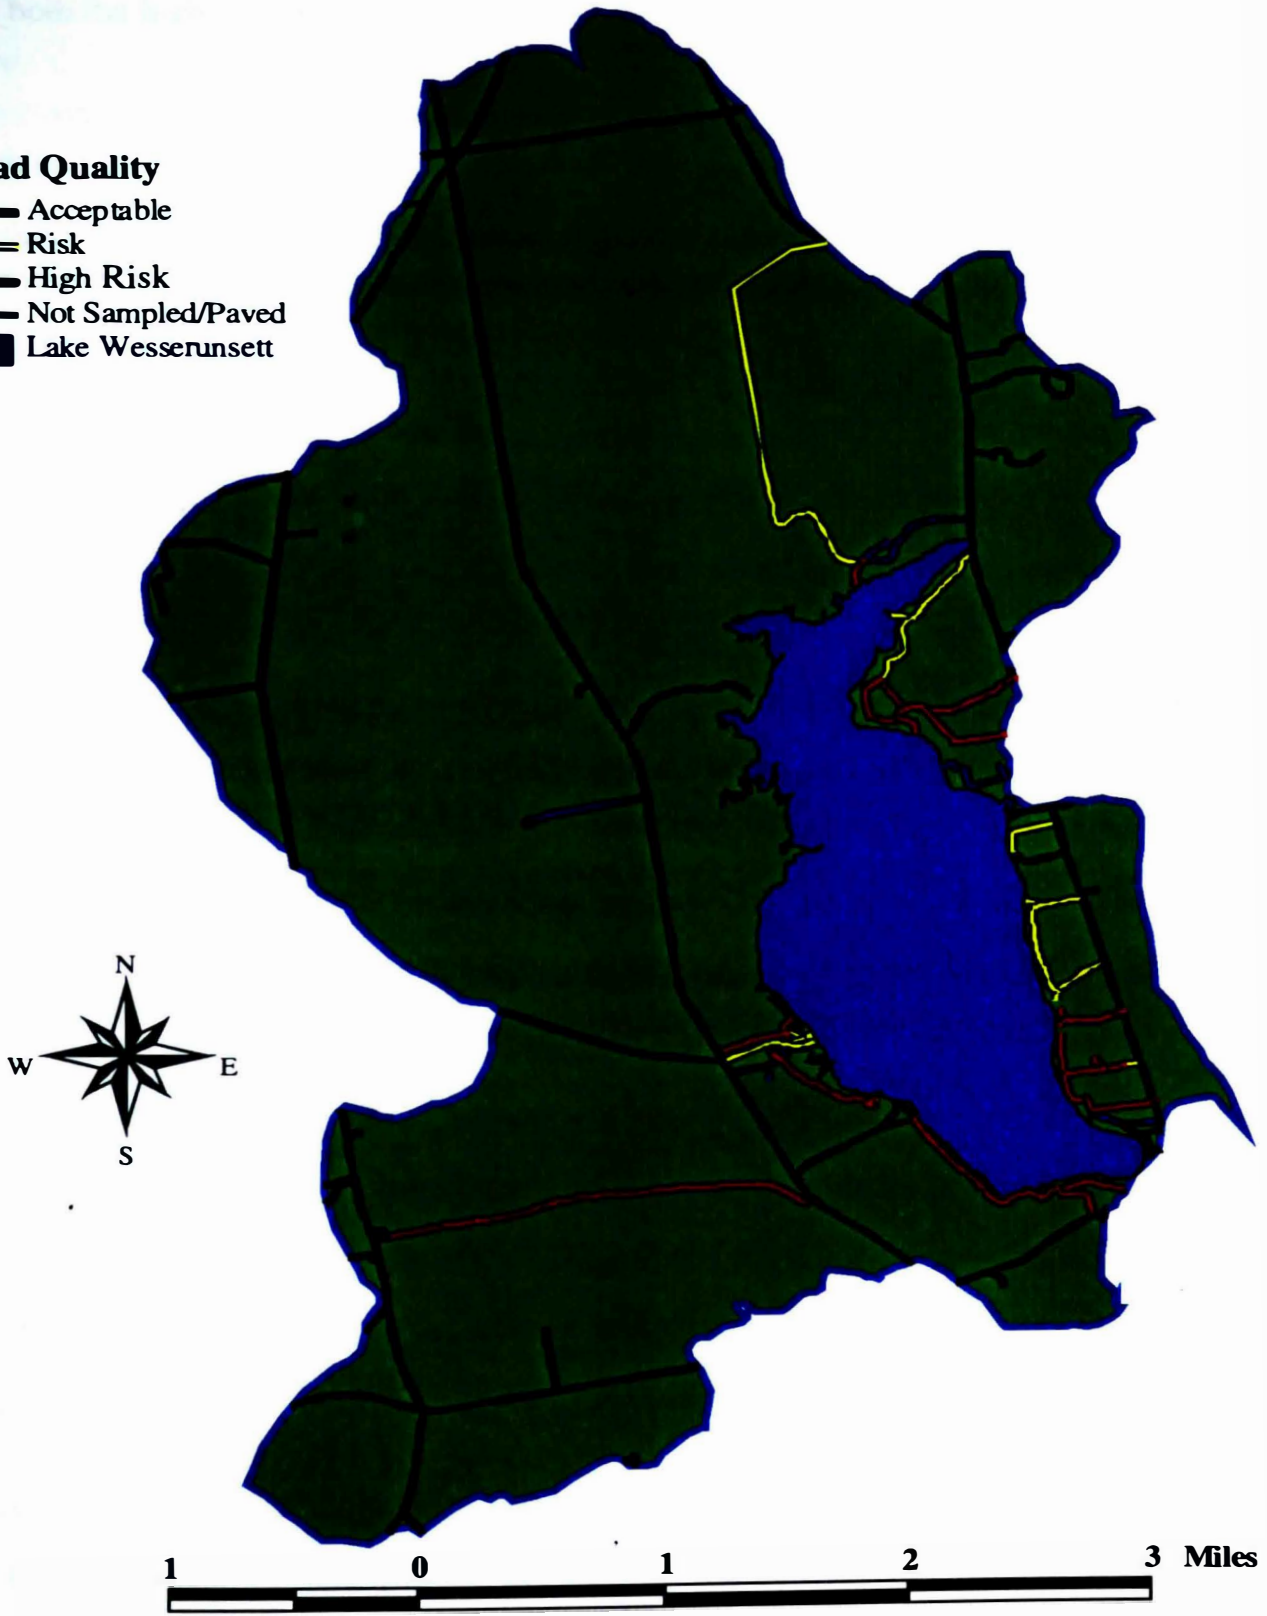
Figure 27. Condition of detailed surveyed roads in the Lake Wesserunsett watershed based on road ranking data from Table 10. High risk roads in close proximity to the lake should receive priority in maintenance to prevent adverse water quality effects.

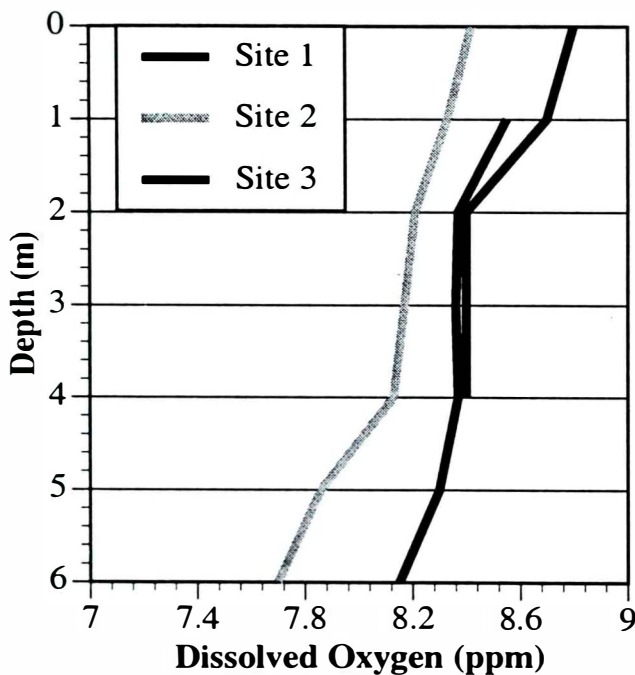
Figure 33. Dissolved oxygen (ppm) of Lake Wesserunsett plotted against depth (m) at Sites 1, 2, and 3 on 13-Sep-00. See site map for locations (Figure 32).

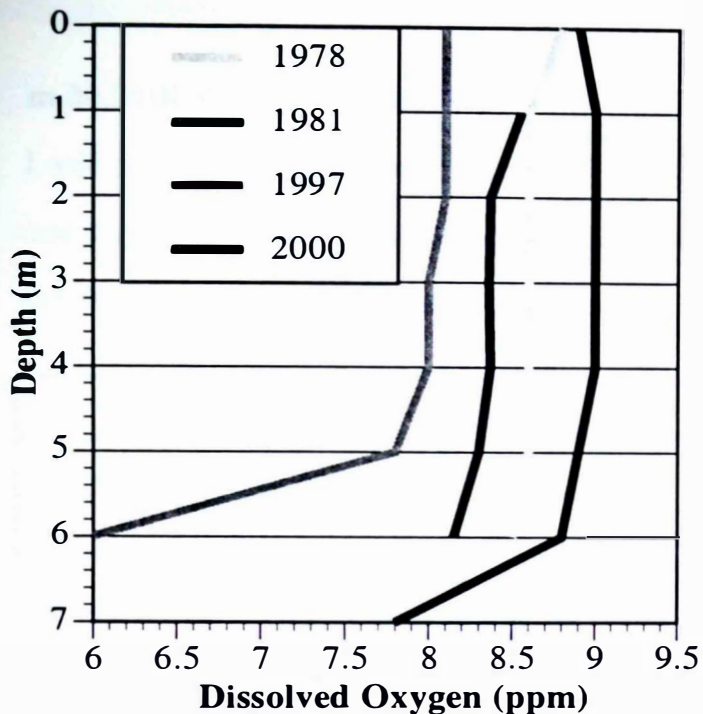
Figure 34. Dissolved oxygen (ppm) of Lake Wesserunsett plotted against depth (m) at Site 1 for 1978, 1981, 1997, and 2000 (MDEP MIDAS data 2000). See site map for location (Figure 32).

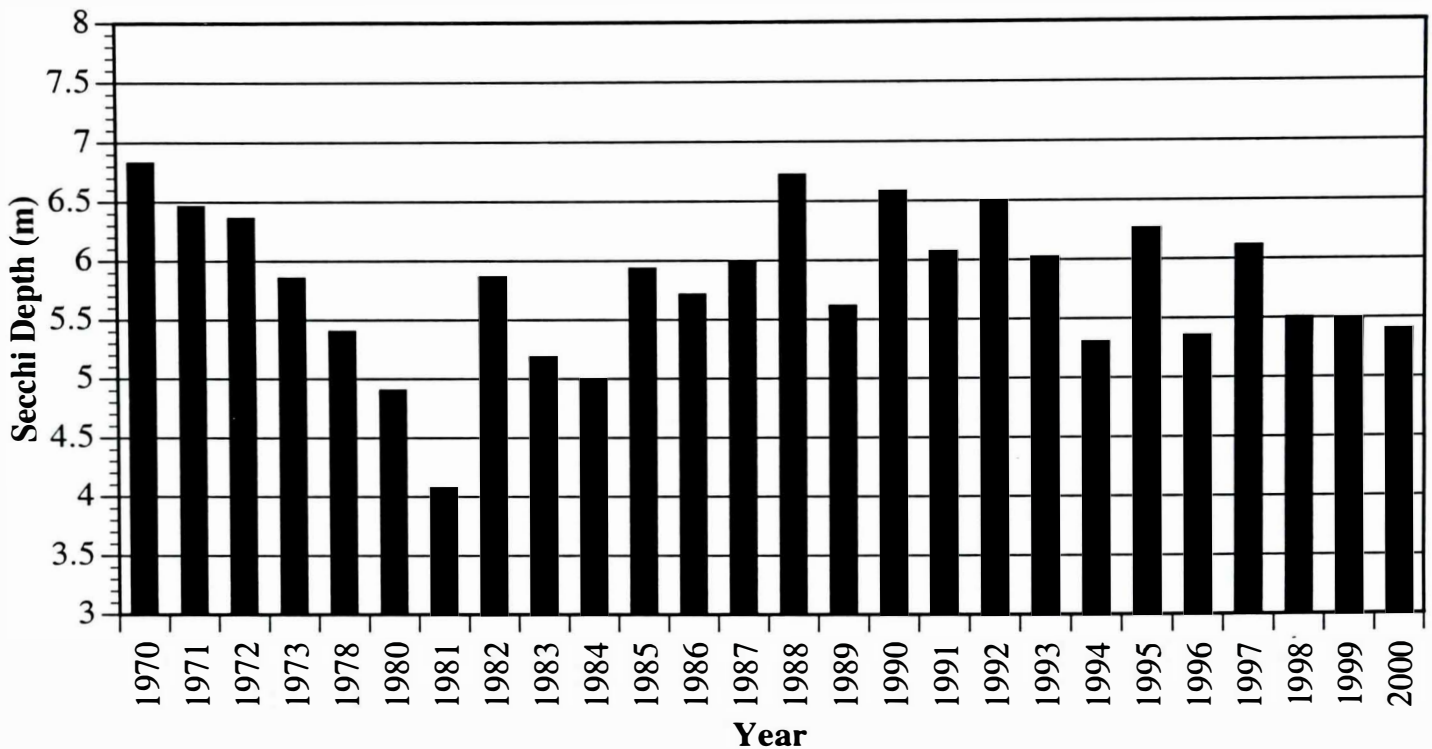
Figure 35. Average Secchi disk transparency levels for Lake Wesserunsett Site 1 for selected years between 1970 and 2000 (MDEP MIDAS data 2000). See site map for location (Figure 32).

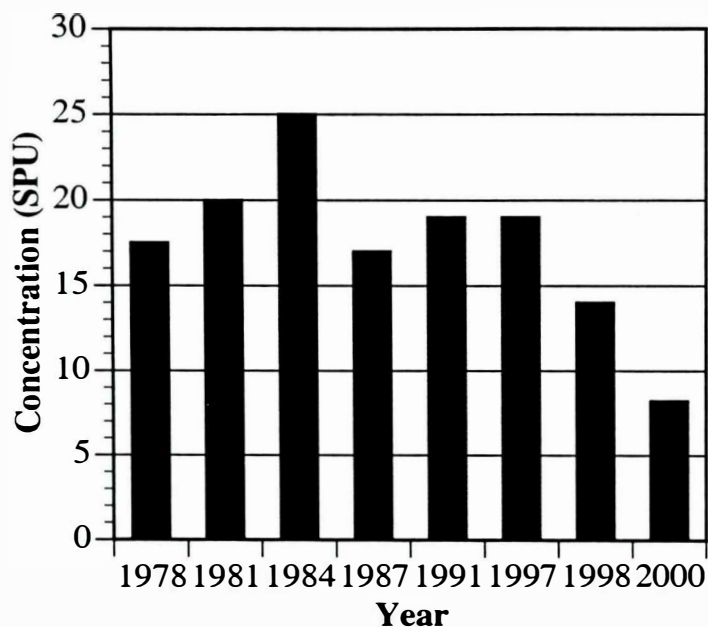
Figure 36. Mean color concentrations (SPU) for Lake Wesserunsett Site 1 for years sampled from 1978 to 2000 (MDEP MIDAS data 2000). See site map for location (Figure 32).

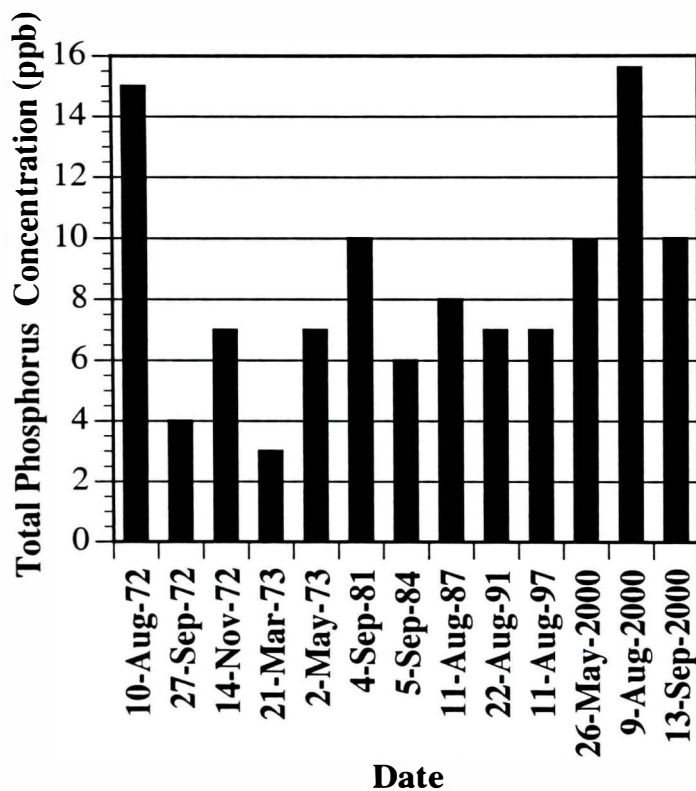
Figure 37. Total phosphorus levels for Lake Wesserunsett sampled at Site 1 over an 18 year period from 1972 to 2000 (MDEP MIDAS data 2000). See site map for location (Figure 32).

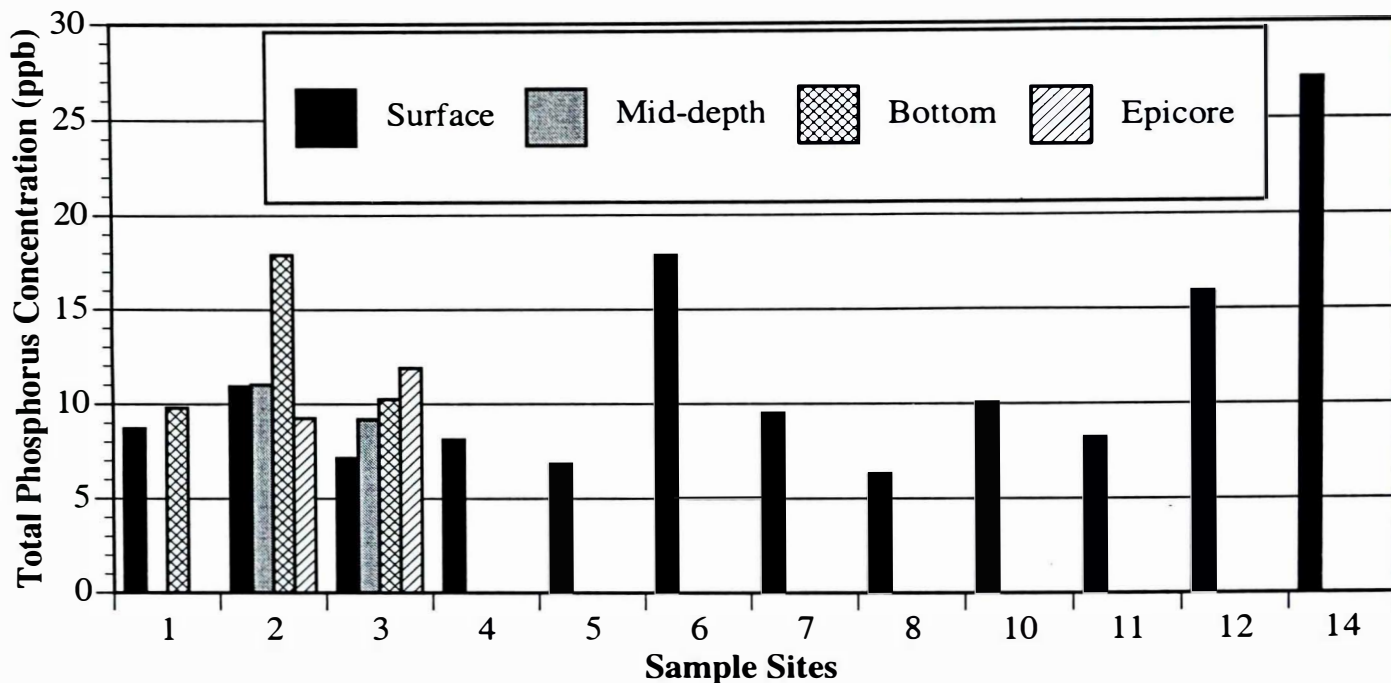
Figure 38. Total phosphorus levels for 12 sample sites on Lake Wesserunsett. Samples were taken at the surface, mid-depth, bottom or as an epicore on 13-Sep-00. Site 2 surface, 3 surface, 3 epicore, 7 surface and 10 surface each had duplicate samples taken. Data shown are an average value of the sample and duplicate sample. See site map for locations (Figure 32).

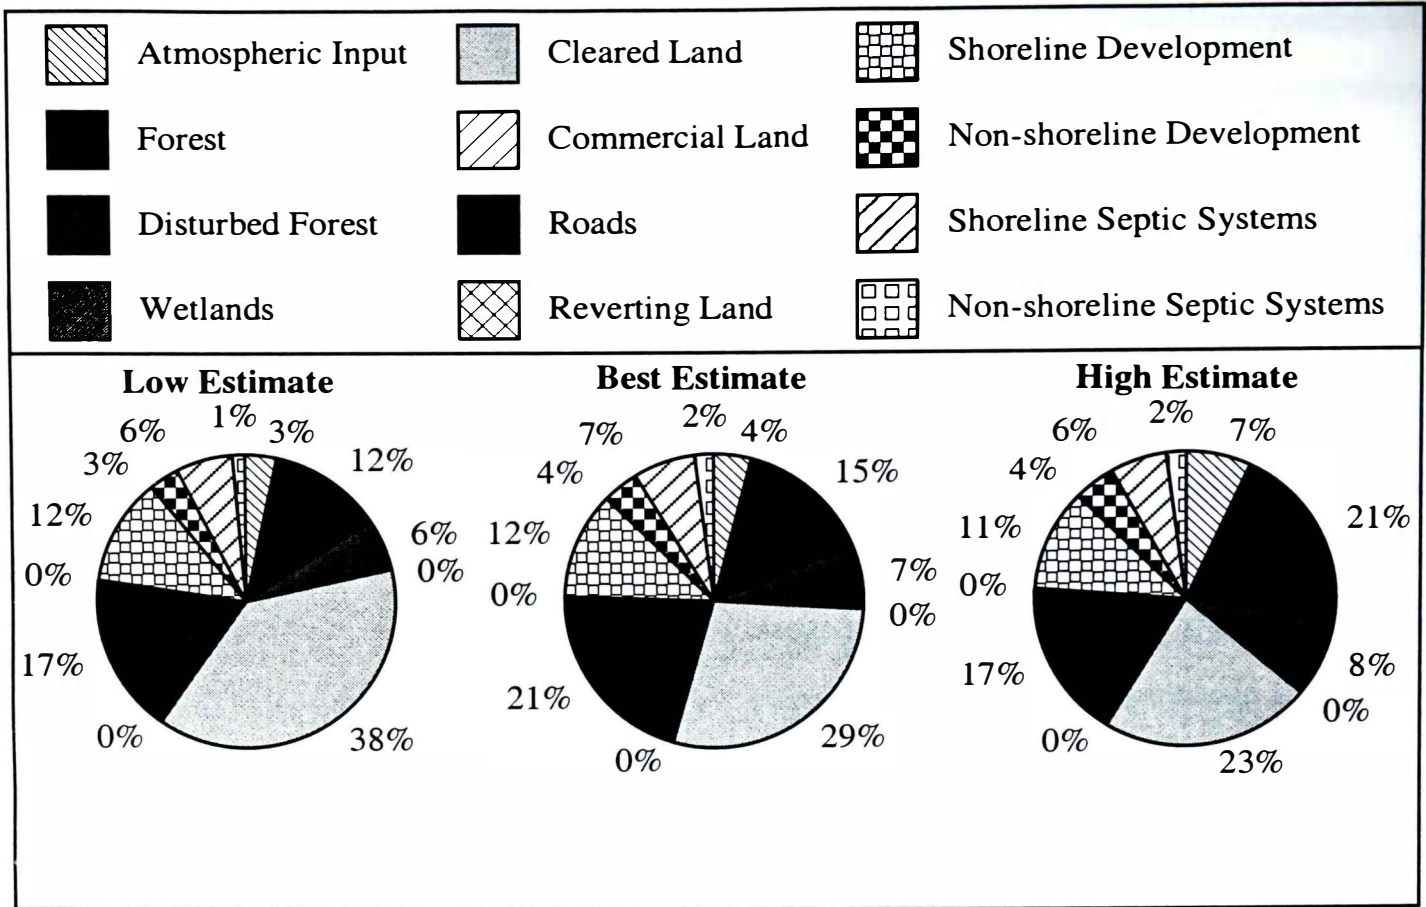
Figure 39. Low, high and best estimates of yearly percent contribution of watershed land use types to phosphorus loading in Lake Wesserunsett in 2000. Percentages based upon phosphorus loading for each land use category from the Phosphorus Loading Model.
