Land Use Patterns in Relation to Lake Water Quality in the Lake George and Oaks Pond Watersheds

Problems in Environmental Science course (Biology 493), Colby College

LAND USE PATTERNS IN RELATION TO LAKE WATER QUALITY IN THE LAKE GEORGE AND OAKS POND WATERSHEDS

BI 493
Problems in Environmental Science
Colby College
Waterville, ME 04901
2001

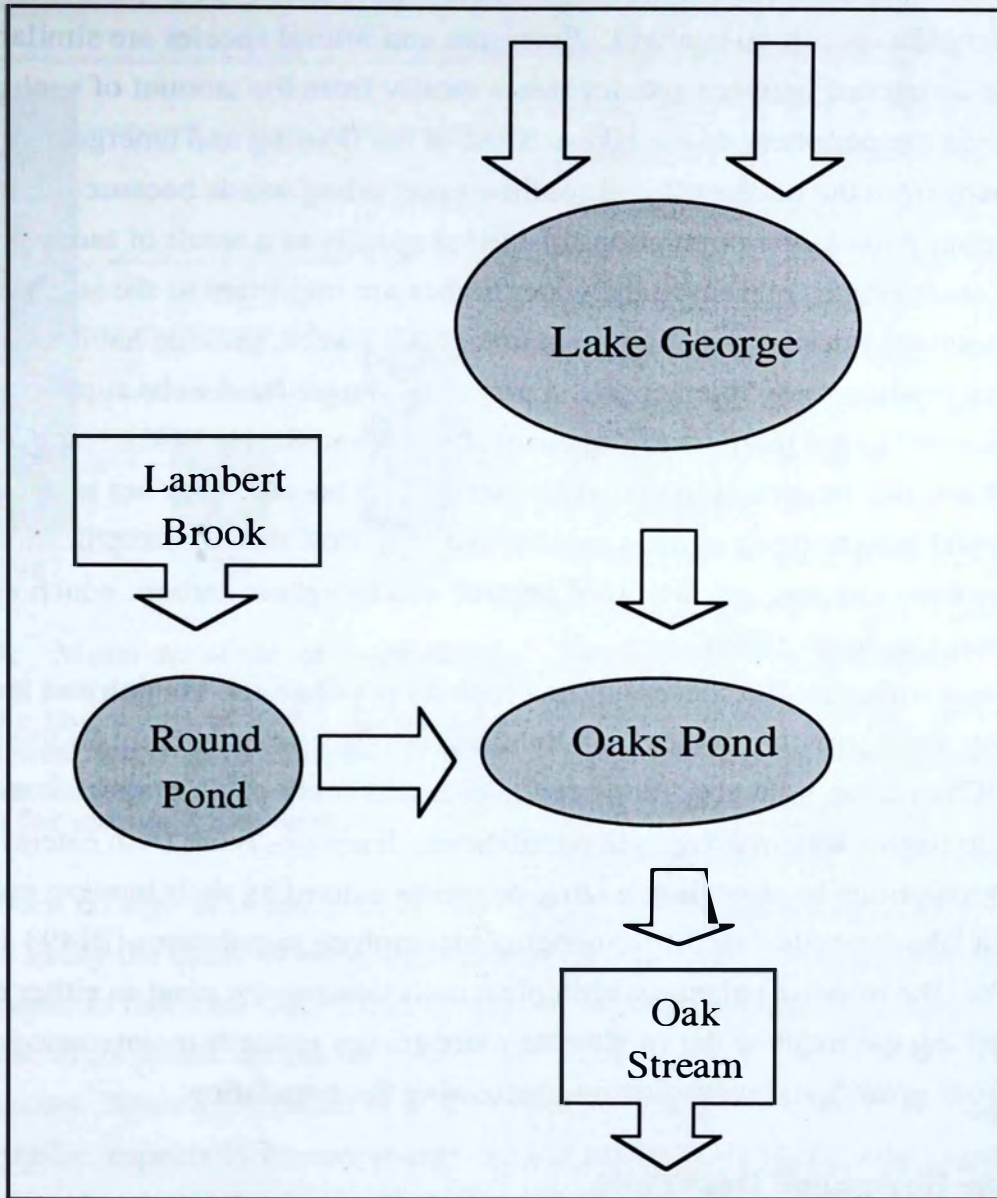
Figure 8. A schematic representation of the inflow and outflow of Lake George and Oaks Pond. Unlabeled sources have no name.

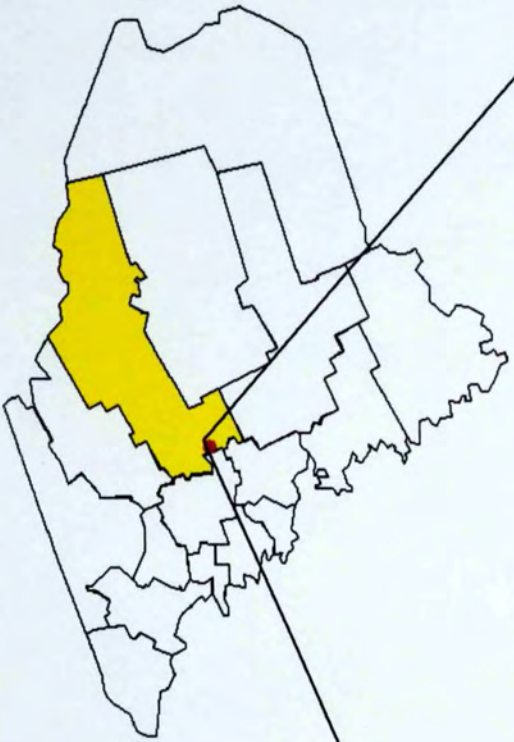
Figure 11. The location of Lake George and Oaks Pond watersheds in the State of Maine. The watershed boundaries are outlined in black. Data adapted from the Maine Office of GIS (MEGIS 2001).

The CEAT lake water quality assessment investigated both the Lake George and Oaks Pond watersheds, which are located in southern Somerset County, Maine (Figure 11). The watershed boundaries used in this study were acquired from the Maine Office of GIS (MEGIS 2001). In this study, the Lake George watershed refers to the larger watershed area, including Lake George. The Oaks Pond watershed is comprised of three sub-watersheds including the one in which Oaks Pond is located (Figure 12).

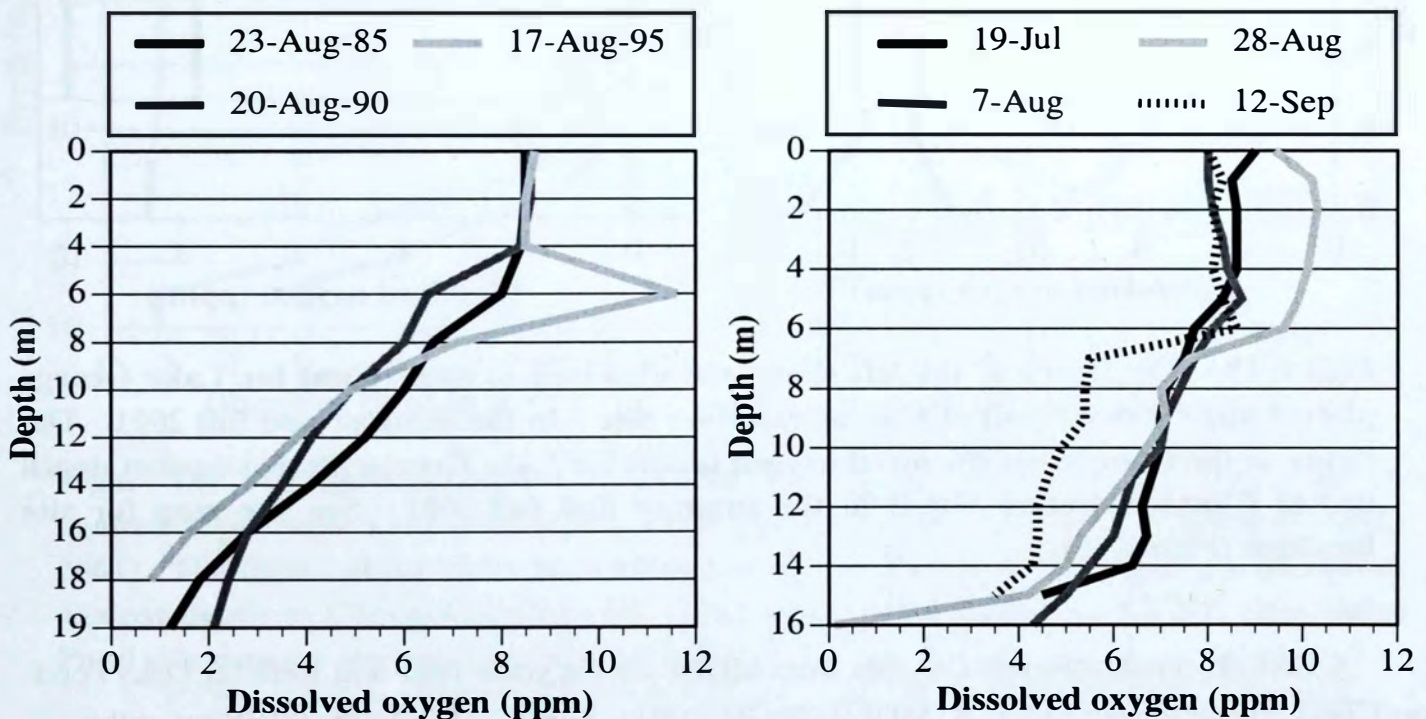
Figure 17. The figure at the left shows dissolved oxygen (ppm) for Lake George near CEAT Characterization Site 1 plotted against depth (m) from 1985, 1990, 1995, and 2001 (MDEP PEARL 2001). The figure at the right shows dissolved oxygen (ppm) for Lake George collected by CEAT plotted against depth (m) at Characterization Site 1 on 19-Jul-01, 7-Aug-01, 28-Aug-01, and 12-Sep-01. See Lake George site map for site location (Figure 15).

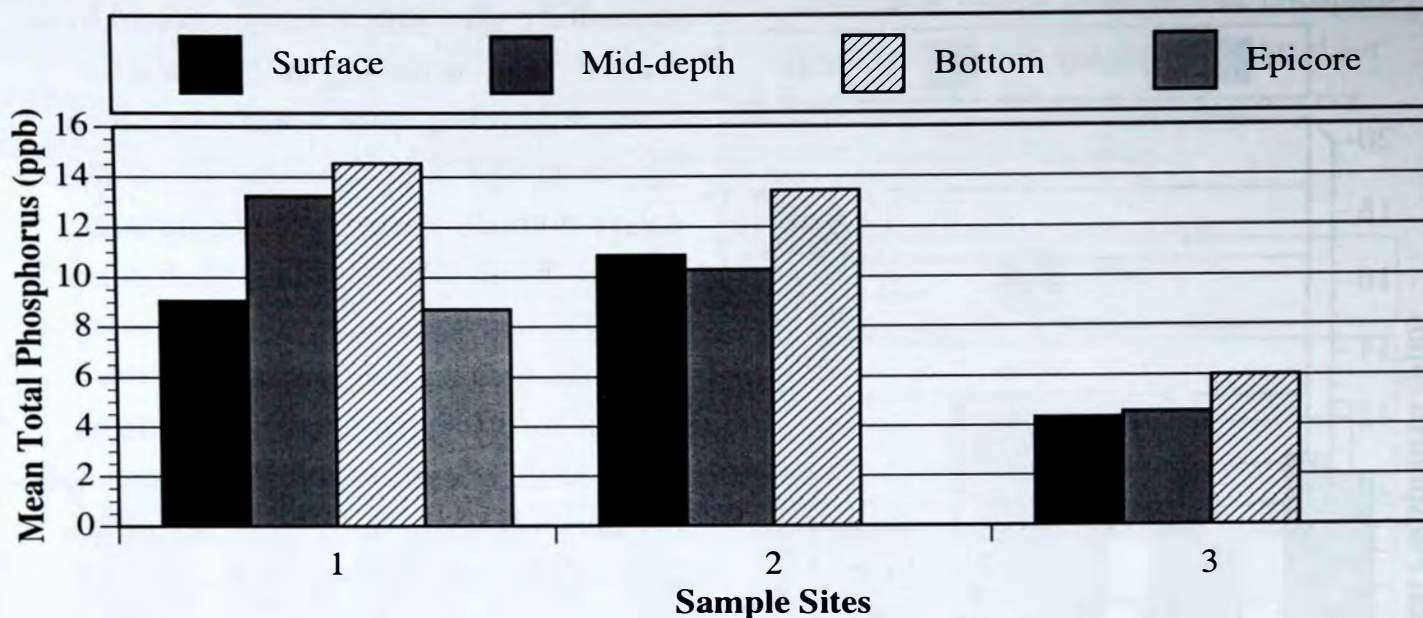
Figure 24. Mean total phosphorus concentration for summer samples collected at Characterization Sites 1, 2, and 3 on Lake George. Samples were collected at the surface, mid-depth, and bottom on 19-Jul-01 and 7-Aug-01. Epicore samples were also obtained at Characterization Site 1 on 7-Aug-01. See Lake George site map for site locations (Figure 15).

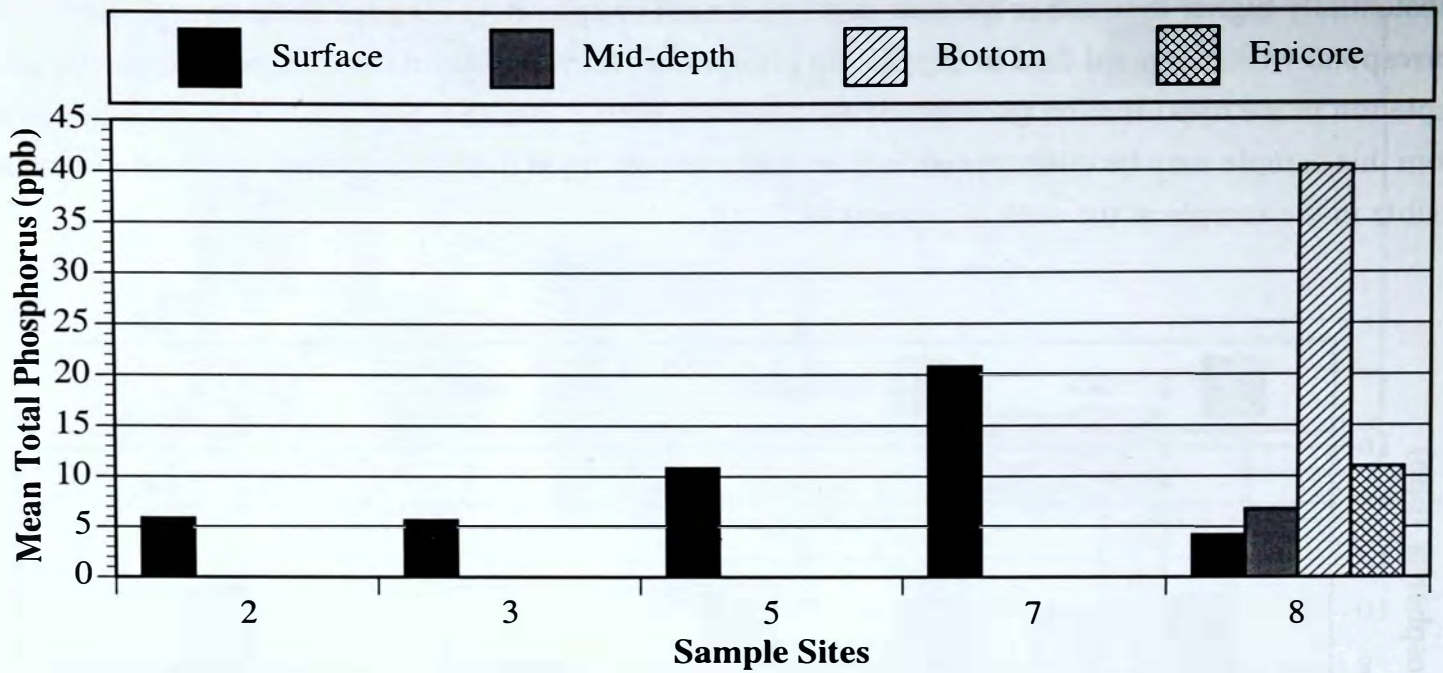
Figure 26. Mean total phosphorus concentrations for Oaks Pond characterization and spot sites sampled on 17-Sep-01 by CEAT. Samples were taken at the surface, mid-depth, bottom and as an epicore. See Oaks Pond site map for site locations (Figure 16).

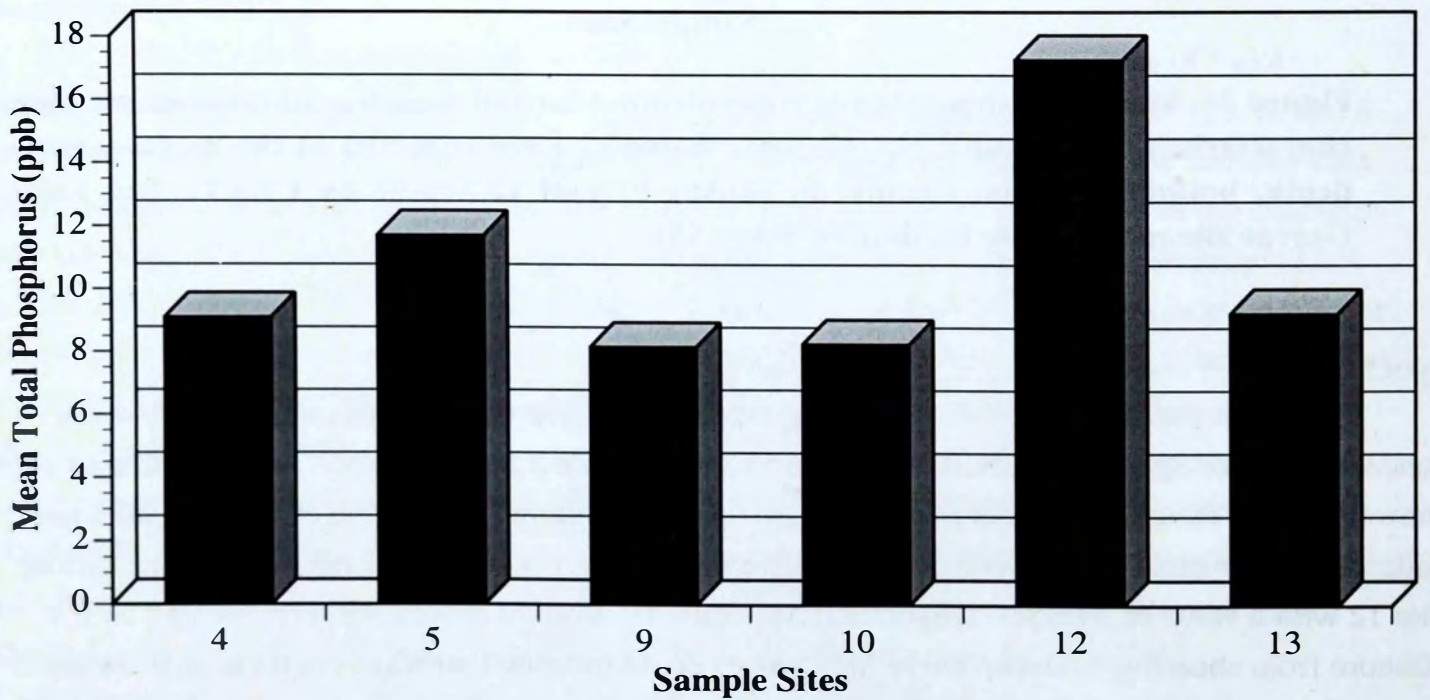
Figure 27. Mean total phosphorus concentration for six spot sites on Lake George. Samples were collected as surface samples on 12-Sep-01 by CEAT. See Lake George site map for site locations (Figure 15).

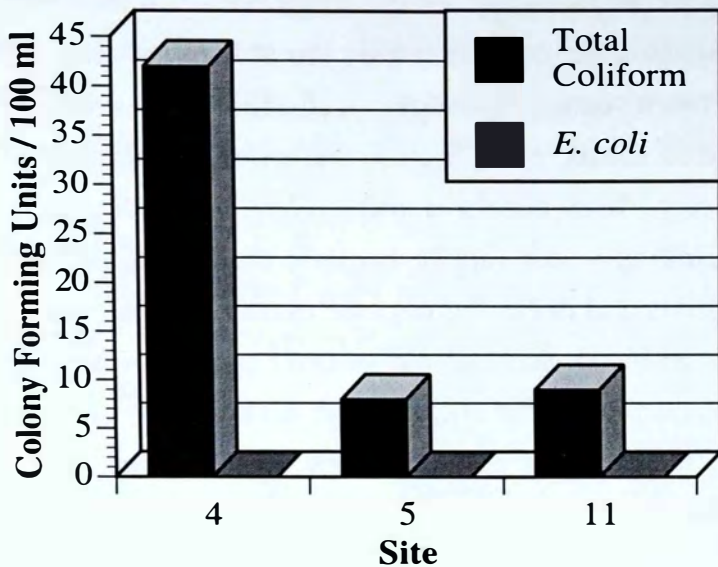
Figure 28. Total coliform and *E. coli* readings for Lake George at Spot Sites 4, 5, and 11 on 12-Sep-01. Spot Sites 4 and 11 were sampled to test for possible septic system problems with the park facilities. Spot Site 5 was sampled off shore from camps as a spot site for possible septic system problems. See Lake George site map for site locations (Figure 15).

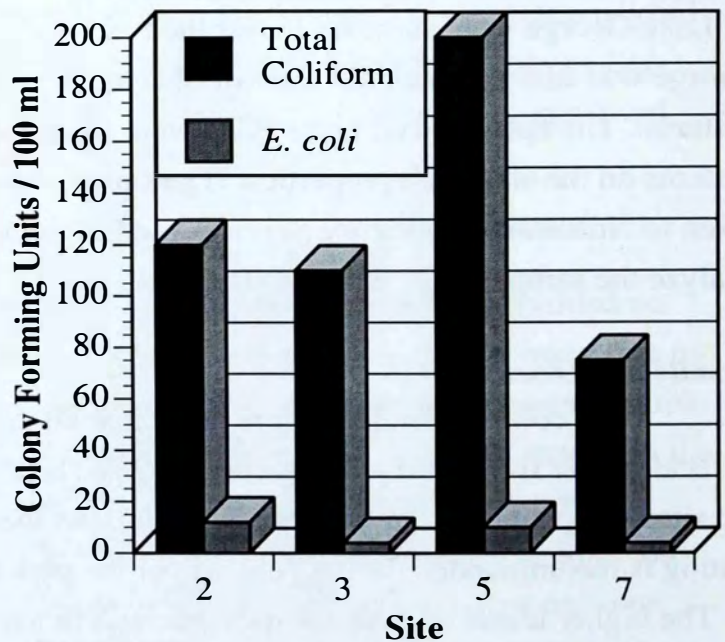
Figure 29. Total coliform and *E. coli* readings for Oaks Pond at Spot Sites 2, 3, 5, and 7 sampled on 17-Sep-01. These sites were established as spot sites to test for possible septic system problems. Total coliform at Spot Site 5 is recorded as 200 on the graph, but the actual value is >200 CFU/100 ml. See Oaks Pond site map for site locations (Figure 16).

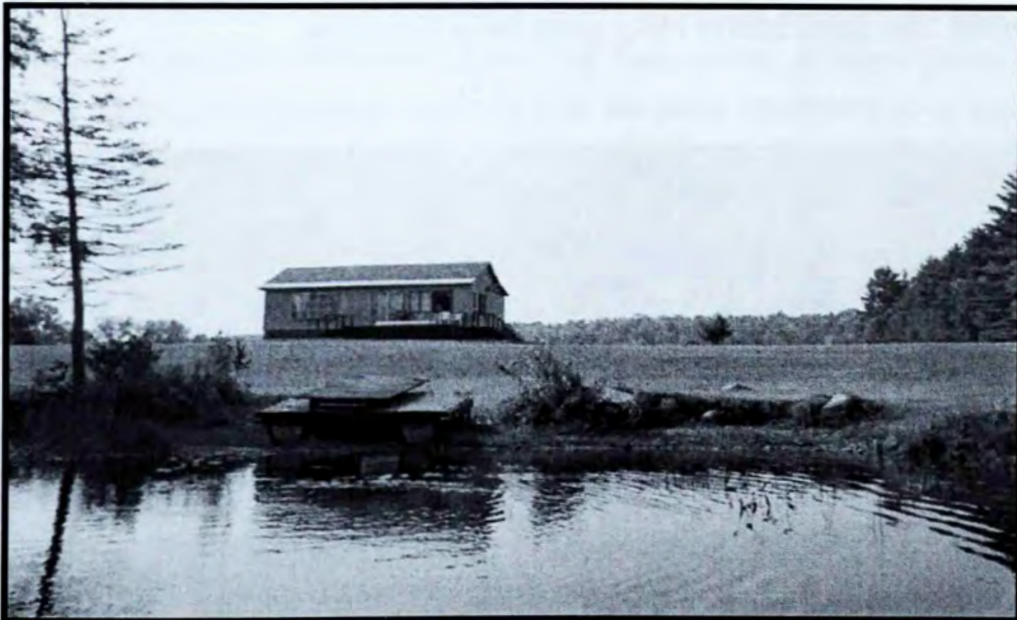
Figure 36. An example of a buffer strip rated as partial by the buffer strip survey. Lakeshore coverage is between 1 and 25 percent; the buffer depth is approximately one foot. The slope between the house and the shore is between 0 and 11 degrees. The buffer composition is 50 percent trees and 50 percent shrubs/flowers. Partially buffered houses do not pose as great a threat to water quality as poorly buffered houses, however, improvements are certainly necessary to create a more effective buffer strip.

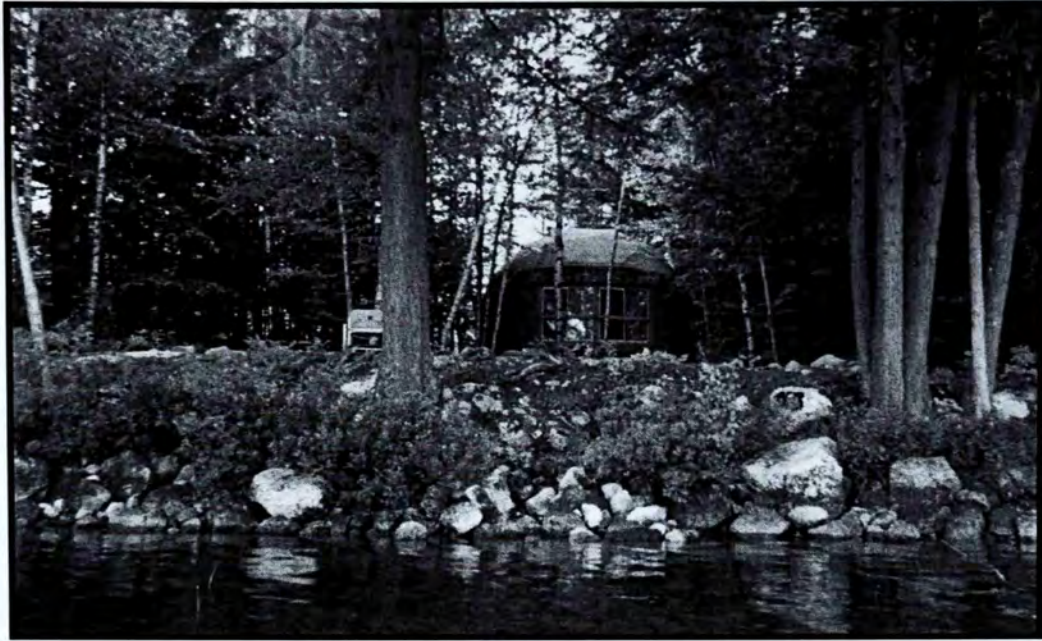
Figure 37. An example of a buffer strip rated as adequate by the buffer strip survey. Lakeshore coverage is between 26 and 50 percent; the buffer depth is approximately two feet. The slope between the house and the shore is between 0 and 11 degrees. The composition is 50 percent trees and 50 percent shrubs/flowers. This property has many of the characteristics of a good buffer, however, there are improvements that could be implemented to make this good buffer strip even more effective.

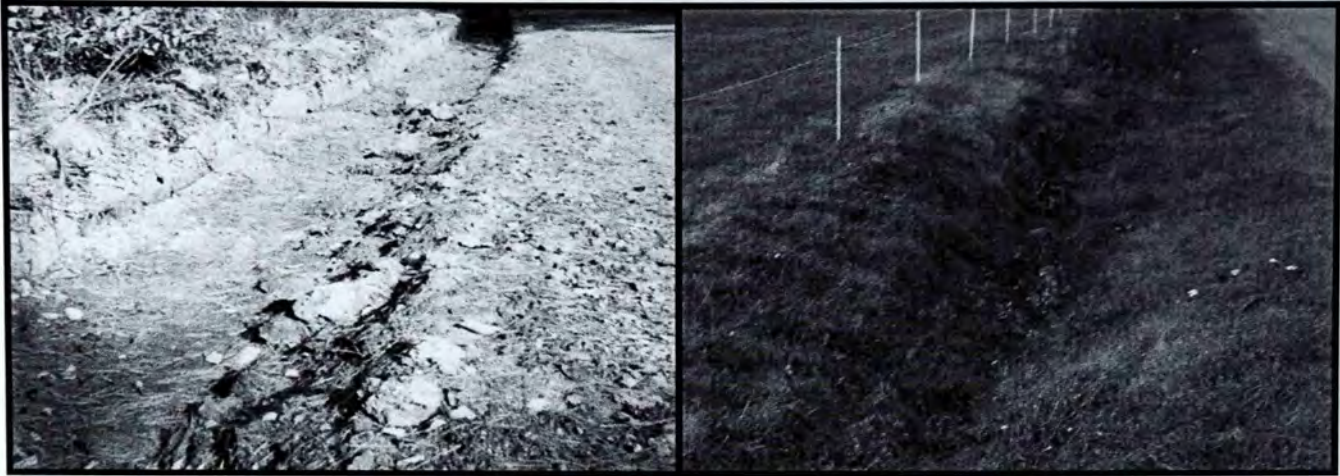
Figure 41. The photograph at the left is an example of a bad ditch because it is square in shape and is composed of bare soil. The photograph at the right is an example of a good ditch because it is parabolic in shape and is vegetated.

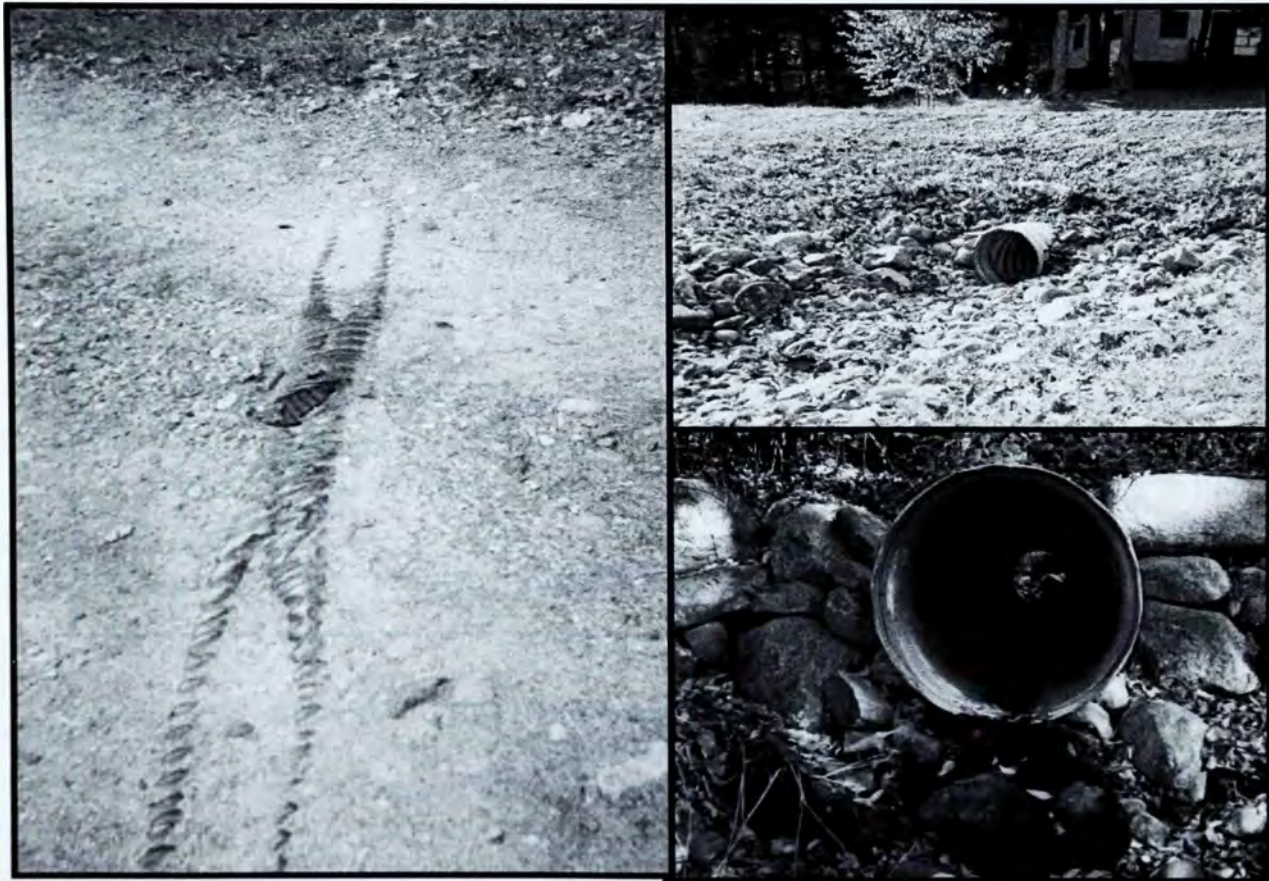
Figure 42. The photograph at the left is an example of a bad culvert because it is exposed, caved in, rusting, and full of debris. The photographs at the upper and lower right are examples of good culverts because they are of proper size and depth and are clear of debris.

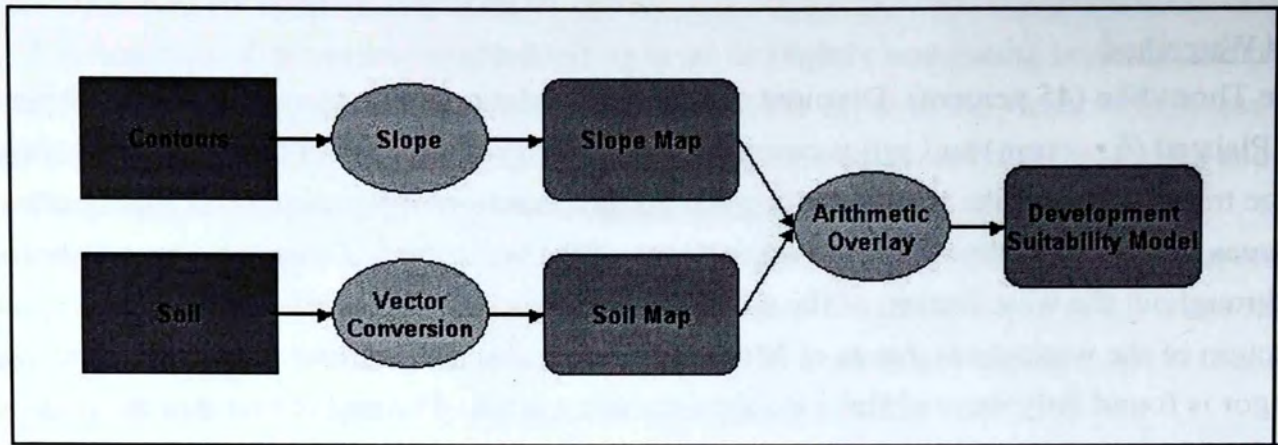
Figure 48. Flow chart depicting the steps taken in the creation of the development suitability model. Rectangular boxes indicate data that were inputted into ModelBuilder. Ovals represent functions that are performed by ModelBuilder. Rounded rectangular boxes are output data that are generated by ModelBuilder. Figure adapted from ModelBuilder.

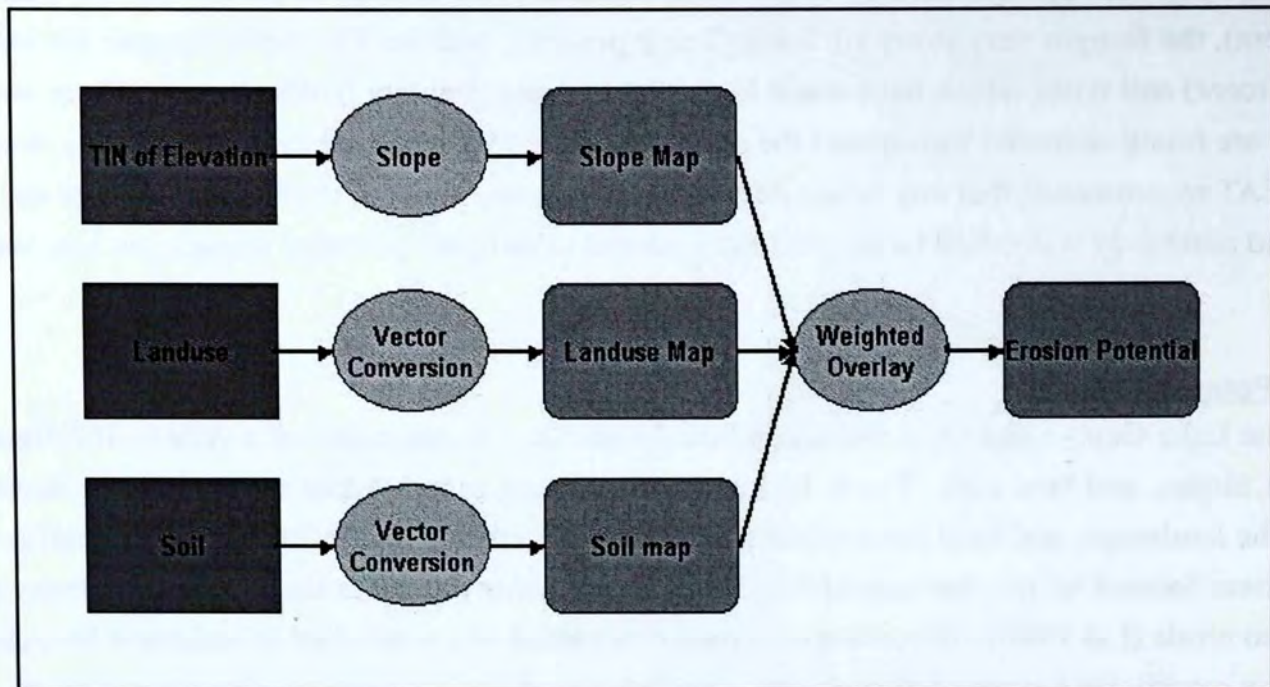
Figure 50. Flow chart depicting the steps taken in the creation of the erosion potential model. Rectangular boxes indicate data that were inputted into ModelBuilder. Ovals represent functions that are performed by ModelBuilder. Rounded rectangular boxes are output data that are generated by ModelBuilder. Figure adapted from ModelBuilder.

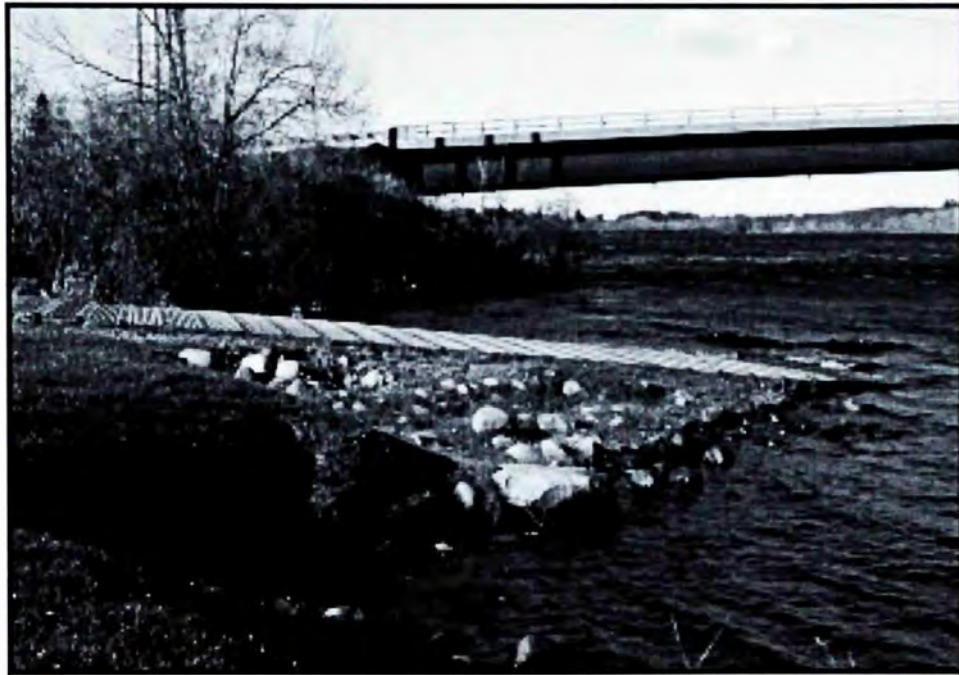
Figure 58. Hinckley boat launch located on the Kennebec River. This launch is more ecologically friendly than the Lake George public boat launch because it is narrow, more buffered, and made of concrete.

Another alternative is to completely replace the boat launch. A boat launch similar to the Hinckley boat launch on the Kennebec River could be installed, but may be expensive (Figure 58). Positive attributes of the Hinckley boat launch are that it is narrow, made of concrete, and the surrounding areas are more vegetated and buffered than the LGPBL. A public boat launch similar to the Hinckley boat launch would likely add less phosphorus to the water than the current, or modified,
