# A Spatial Analysis of Impervious Surfaces at Colby College in 1965 and 2005

Environmental Studies 212, Colby College, Waterville, ME

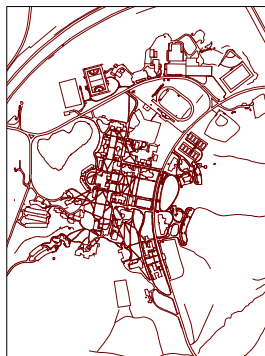
Original Polyline Layer

I started with a CAD layer from the Colby PPD that had been converted to a shapefile. After editing the layer to close any gaps in the lines outlining all of the features on the Colby campus, I created a new layer with polygons using the "feature to polygon" tool.

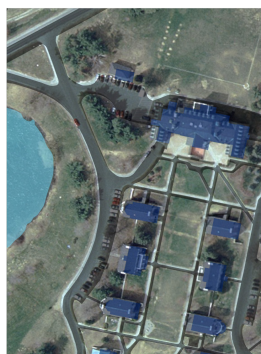
Semi-transparent polygon layer overlaying the ortho photo tile

Once all of the features had been converted to polygons, I created a new attribute called surface type and labeled each polygon as Building, Pavement, Other Impervious Surface, or Other. To help with this process, I used an ortho photo tile of Waterville underneath my partially transparent polygon layer.

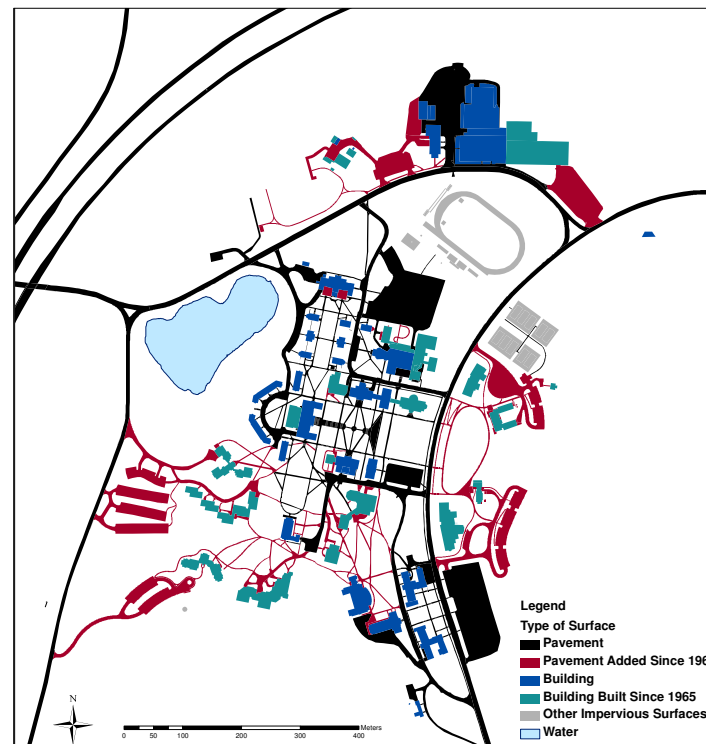
Map of Colby by Surface Cover

I calculated the area of every polygon by surface type to obtain my final estimates of the area covered by impervious surfaces.

224,280m<sup>2</sup> of the Colby campus is covered by impervious surfaces (7.8% of the land owned by Colby).

An estimated 76,546m<sup>2</sup> (34%) has been added since 1965.
